Condition Assessment Report

Lisbon Waste-To-Energy Facility

Lisbon, CT
December 16, 2025

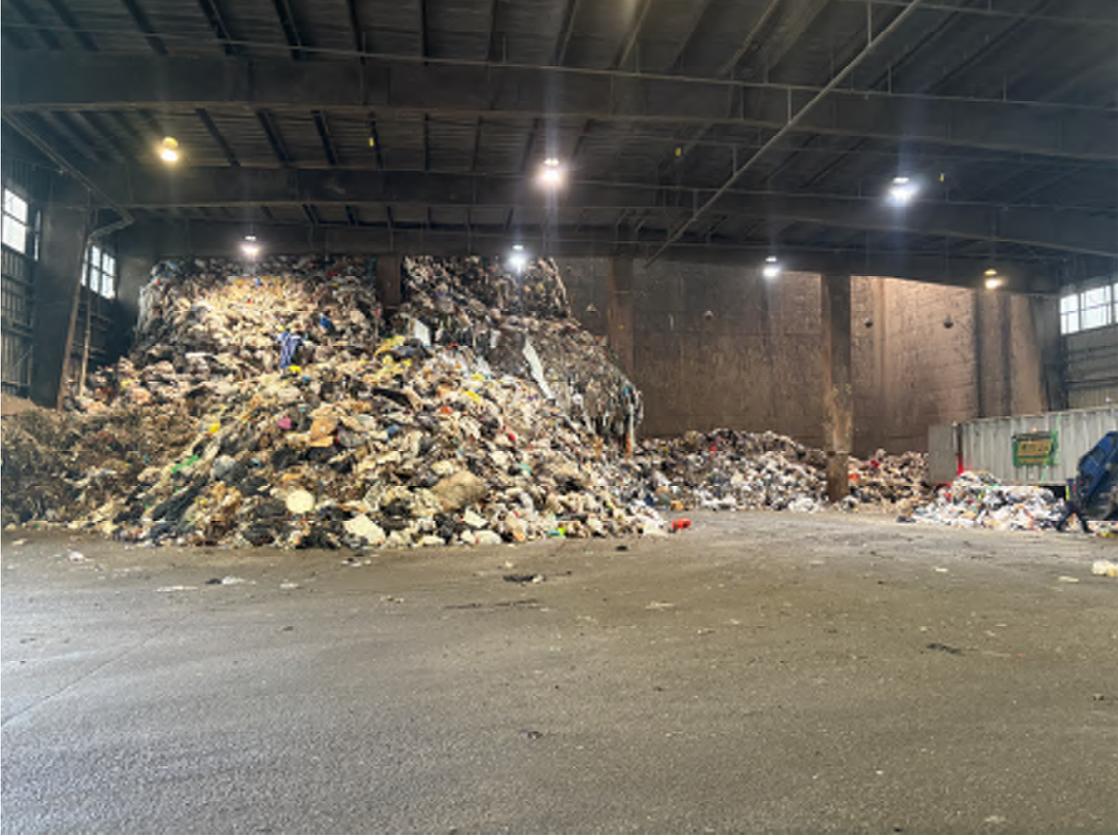
A wide-angle photograph of a large industrial tipping hall. A massive pile of mixed waste, including plastic, paper, and other debris, is the central focus. The floor is concrete and appears to be a tipping floor. The ceiling is high with several industrial lights. The walls are made of dark wood or metal panels.	<ul style="list-style-type: none">• Tipping hall appears to be in good condition• Significant amount of waste on tip floor despite half the pit being low.
Photograph #2	Remarks

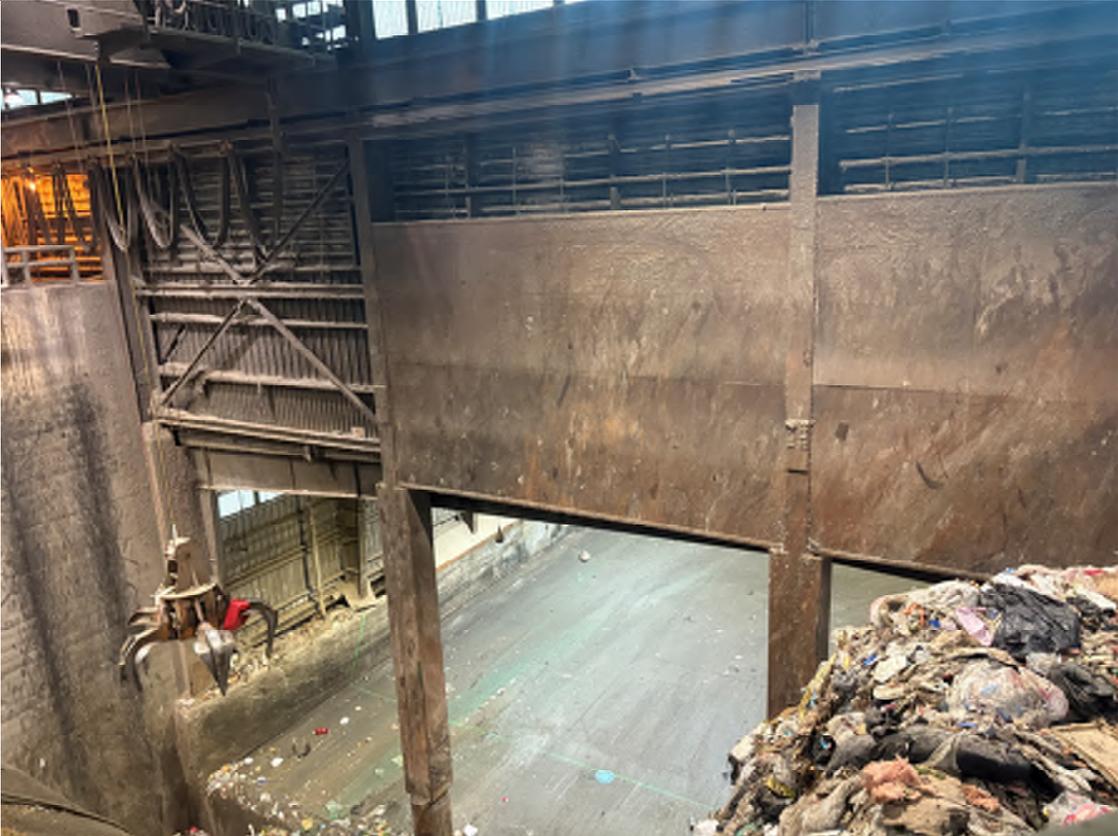
A close-up photograph of the interior of a refuse pit. The walls are made of heavy, dark metal plates. A large pile of waste is visible in the foreground on the right. The structure appears to be made of steel beams and plates, showing some wear but no significant damage.	<ul style="list-style-type: none">• Refuse pit walls appear to be in good condition with minimal damage.

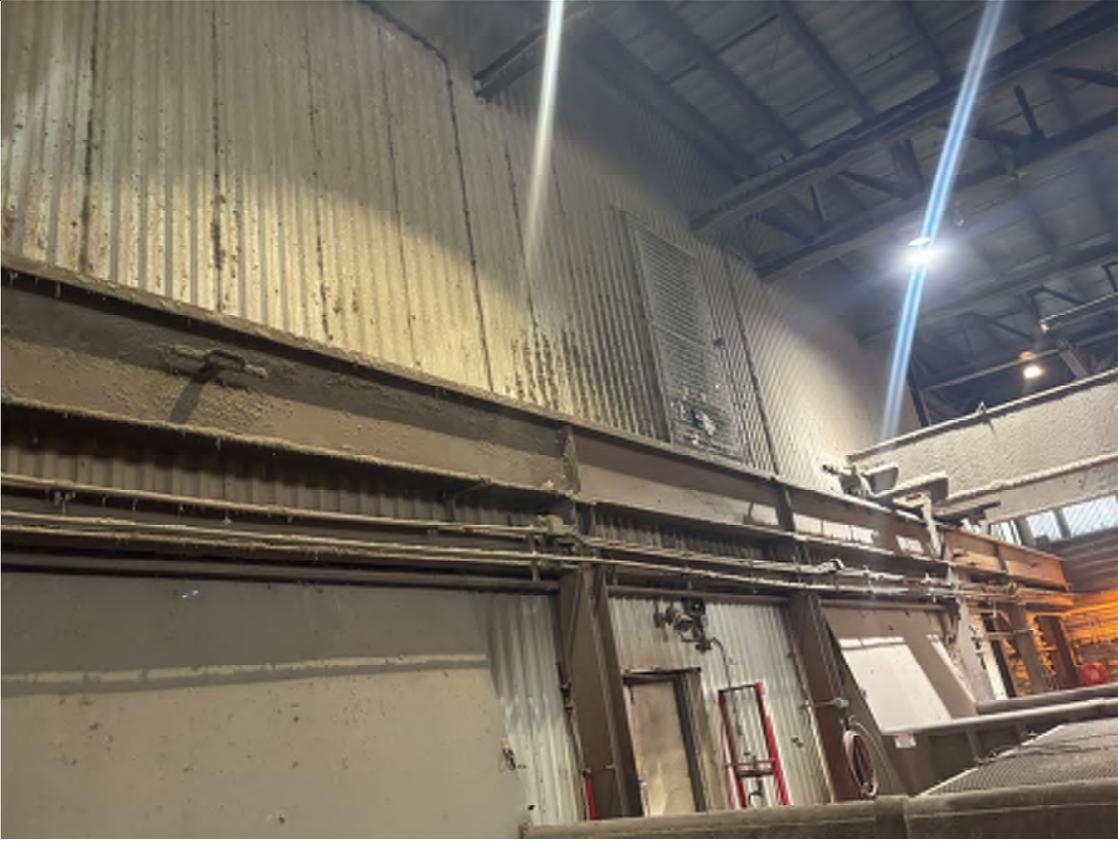
<ul style="list-style-type: none">• Combustion air intake screen above the charging deck.• Slight dust buildup on intake screen.
Photograph #4	Remarks

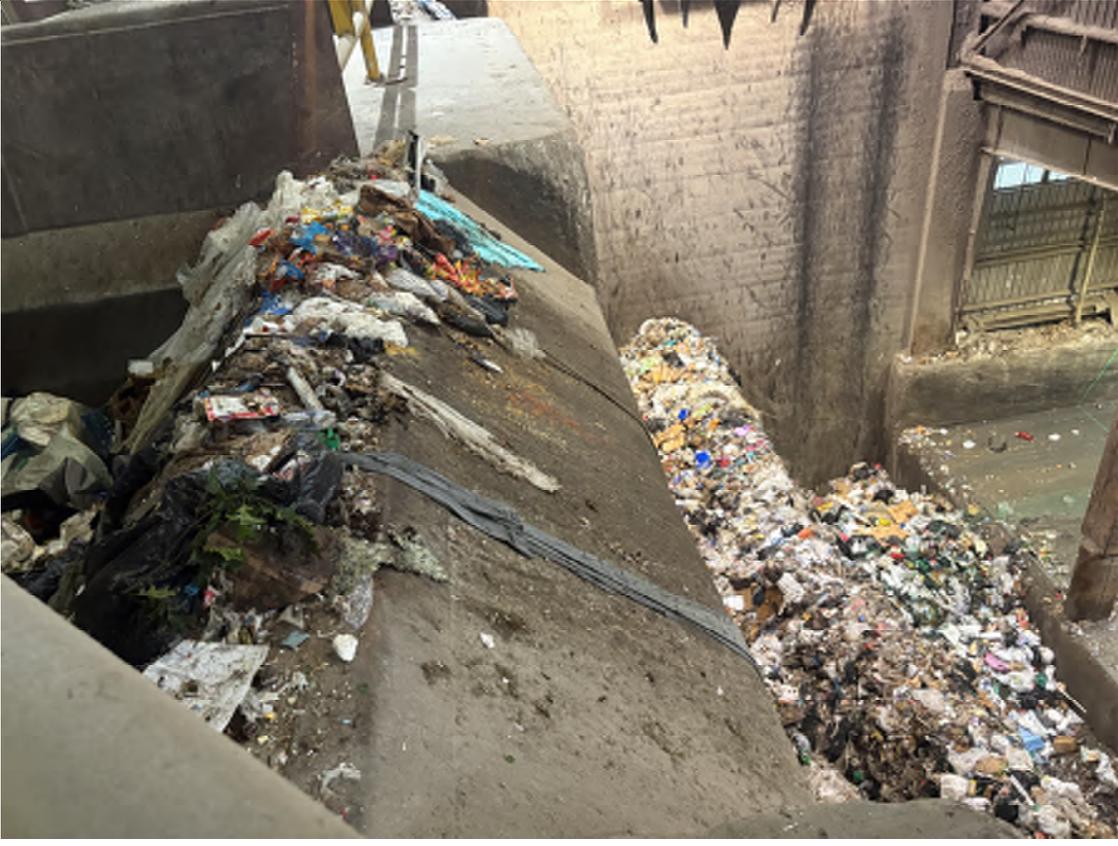
A photograph showing a large pile of refuse, including plastic bags and other debris, on a concrete ramp. The ramp leads to a feed hopper. The refuse is piled high and appears to be in good condition.	<ul style="list-style-type: none">• Refuse seal to feed hopper appears to be in good condition with minimal damage.
Photograph #6	Remarks

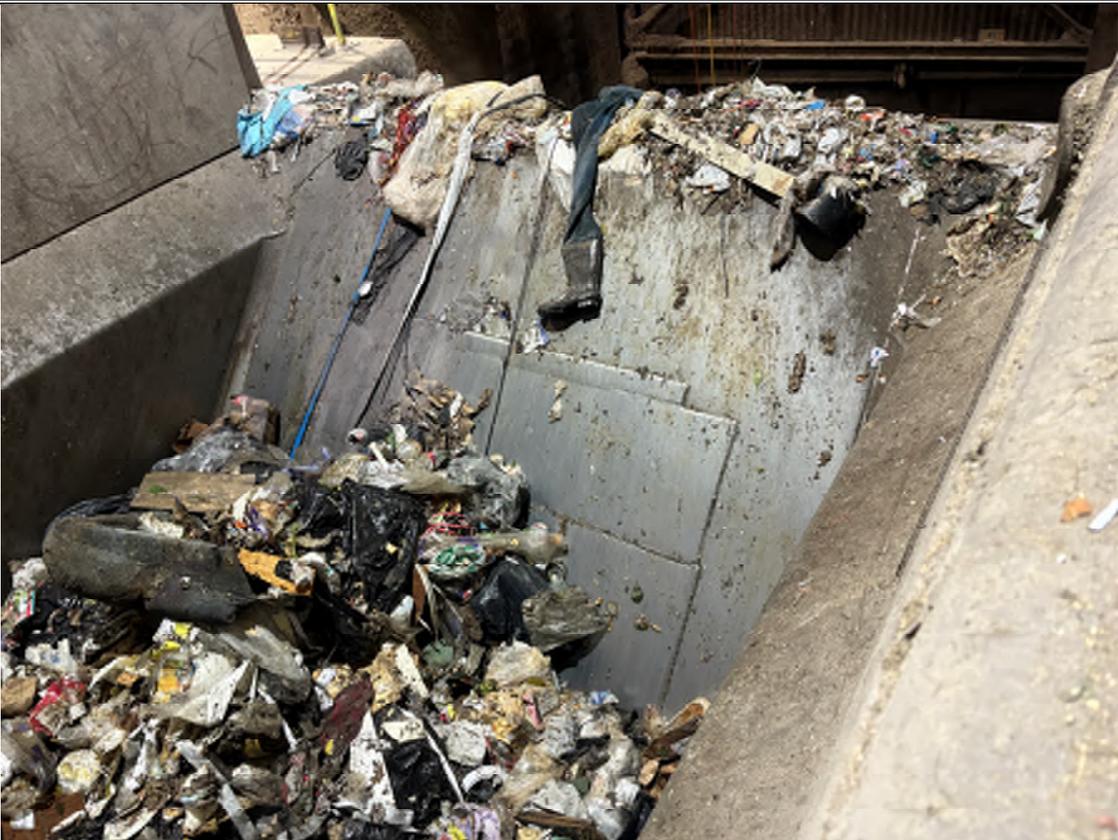
A close-up photograph of the feed hopper. The hopper is made of metal and has several patches on it. The refuse is piled up in front of the hopper.	<ul style="list-style-type: none">• Feed hopper with patches from previous repairs.

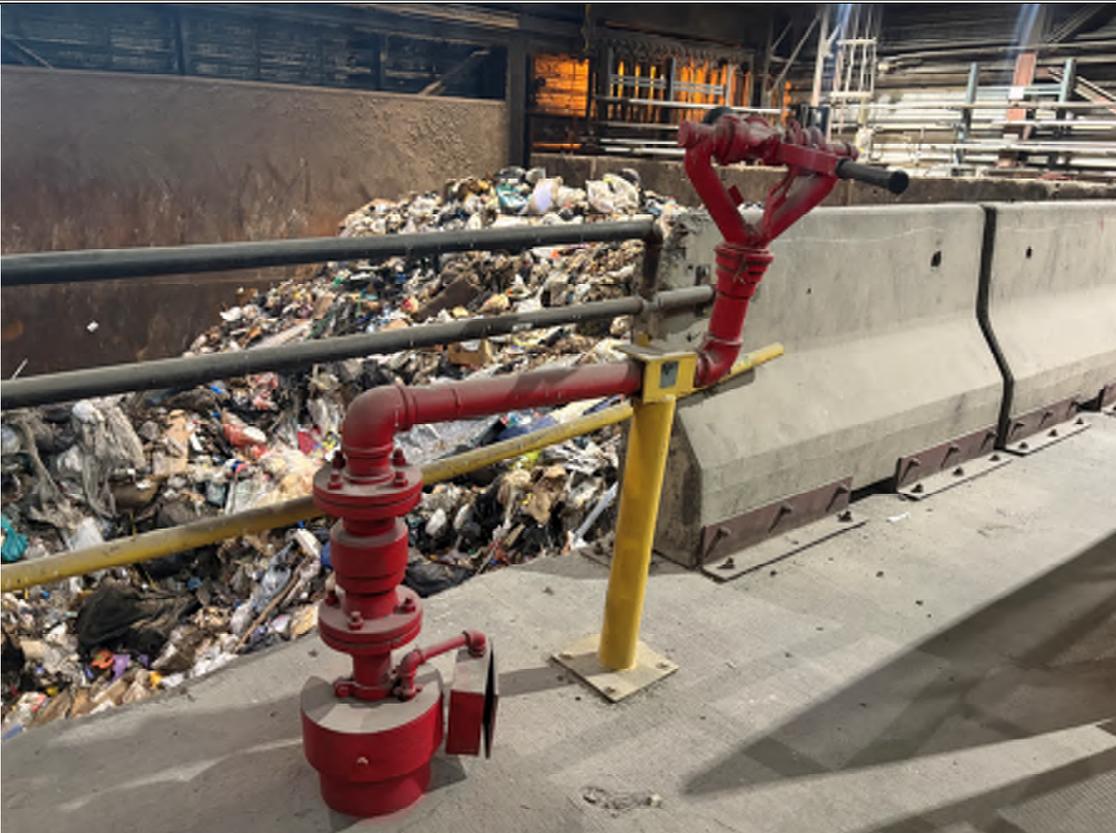
<ul style="list-style-type: none">• Fire water cannons appear to be clean and in good condition.

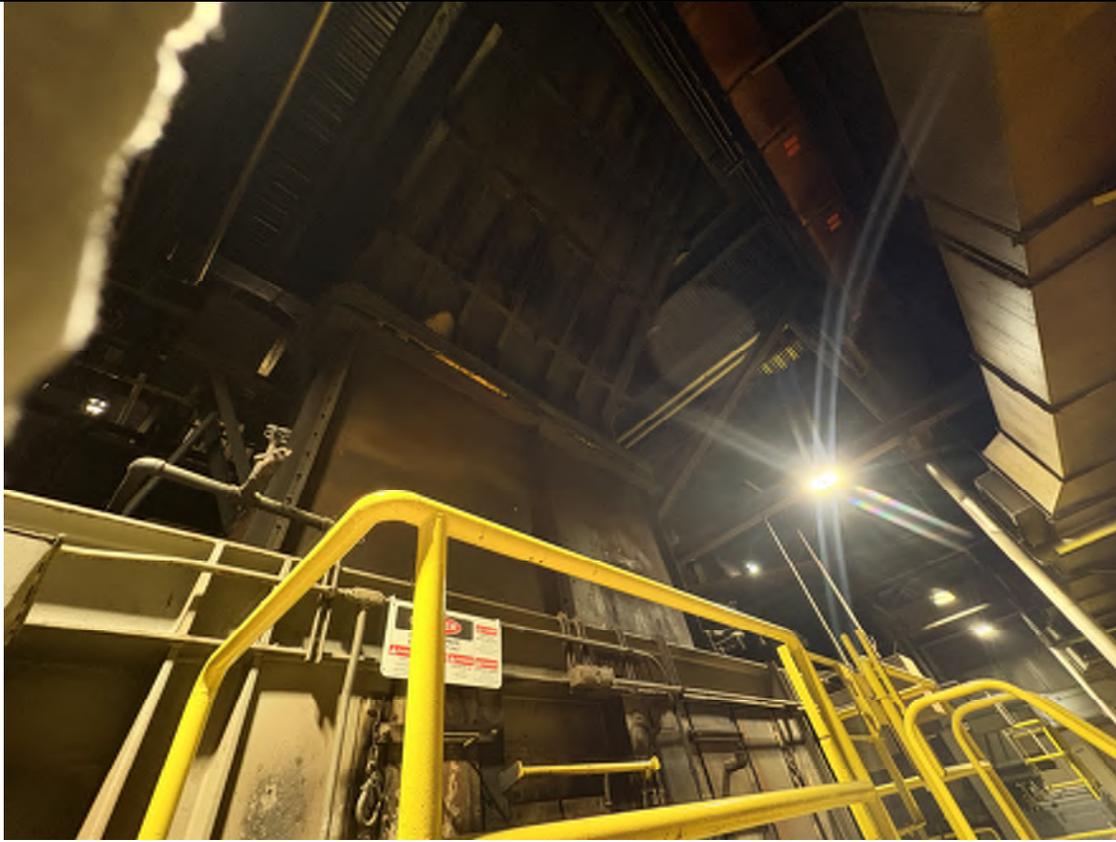
- Unit 1 feedchute exterior appears to be in good condition.

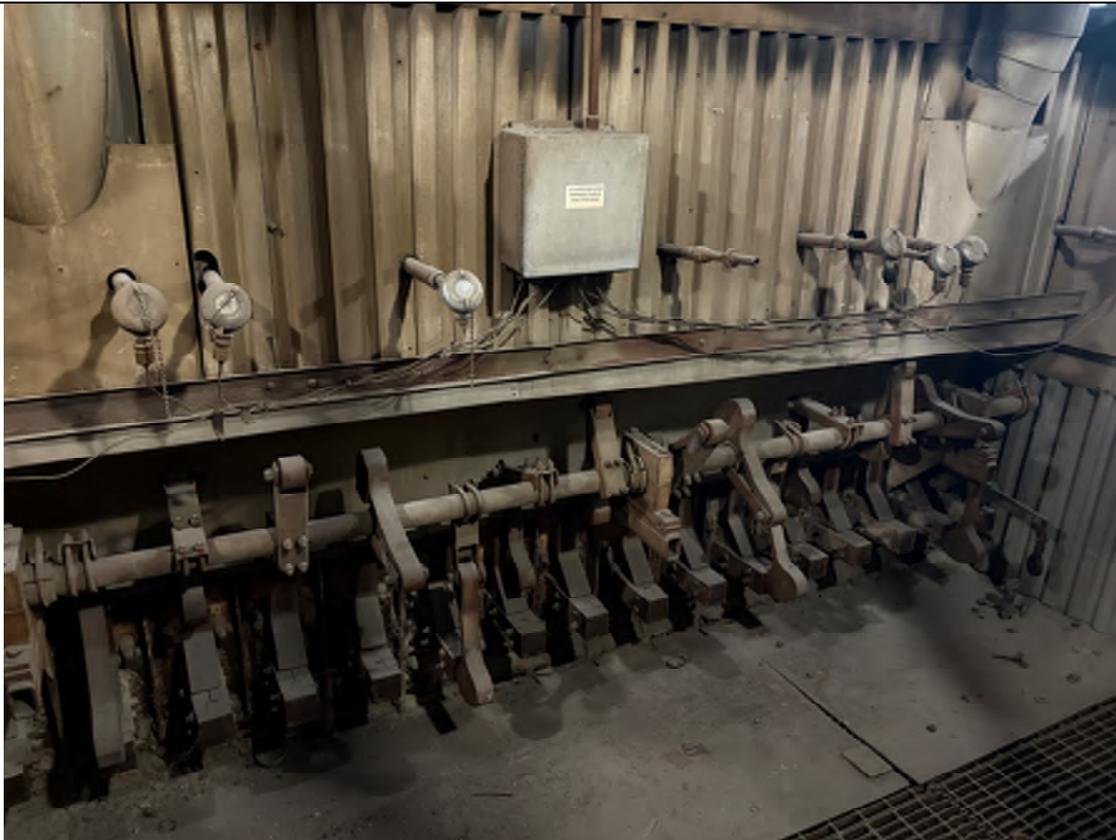
Photograph #12

- Superheater Rappers are original.

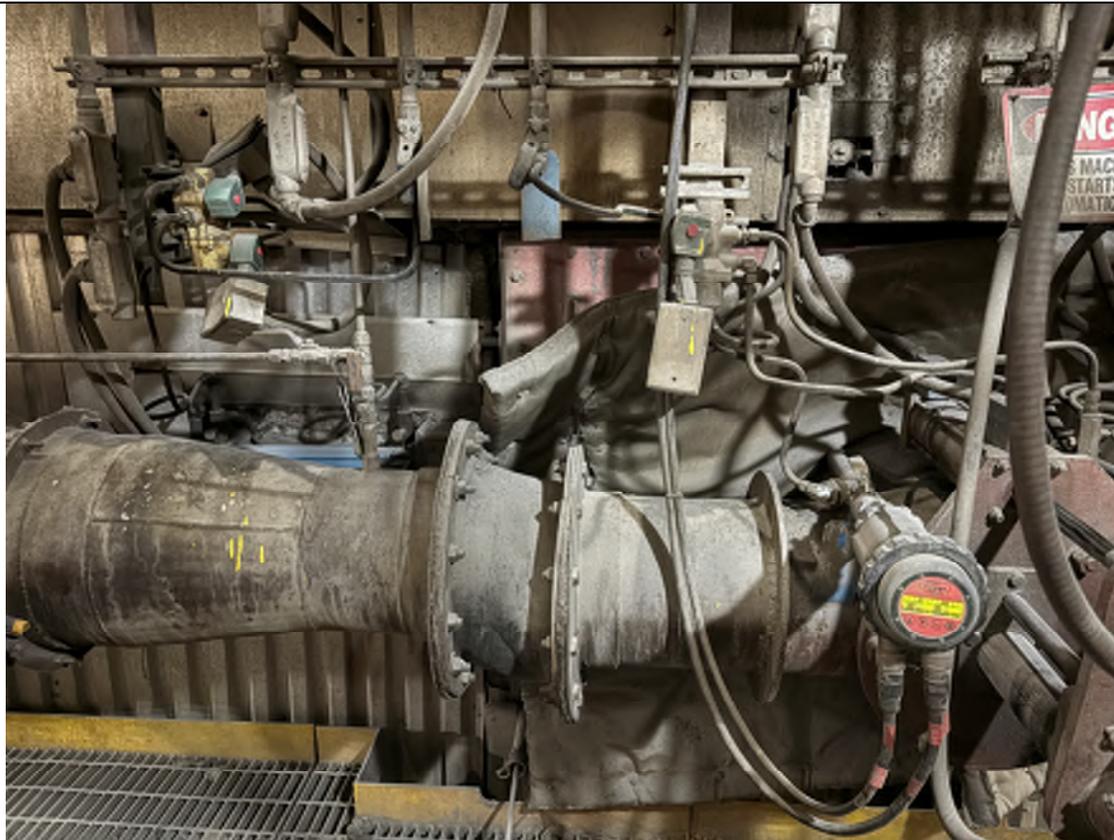
Photograph #16

- Original auxiliary burners on both units.

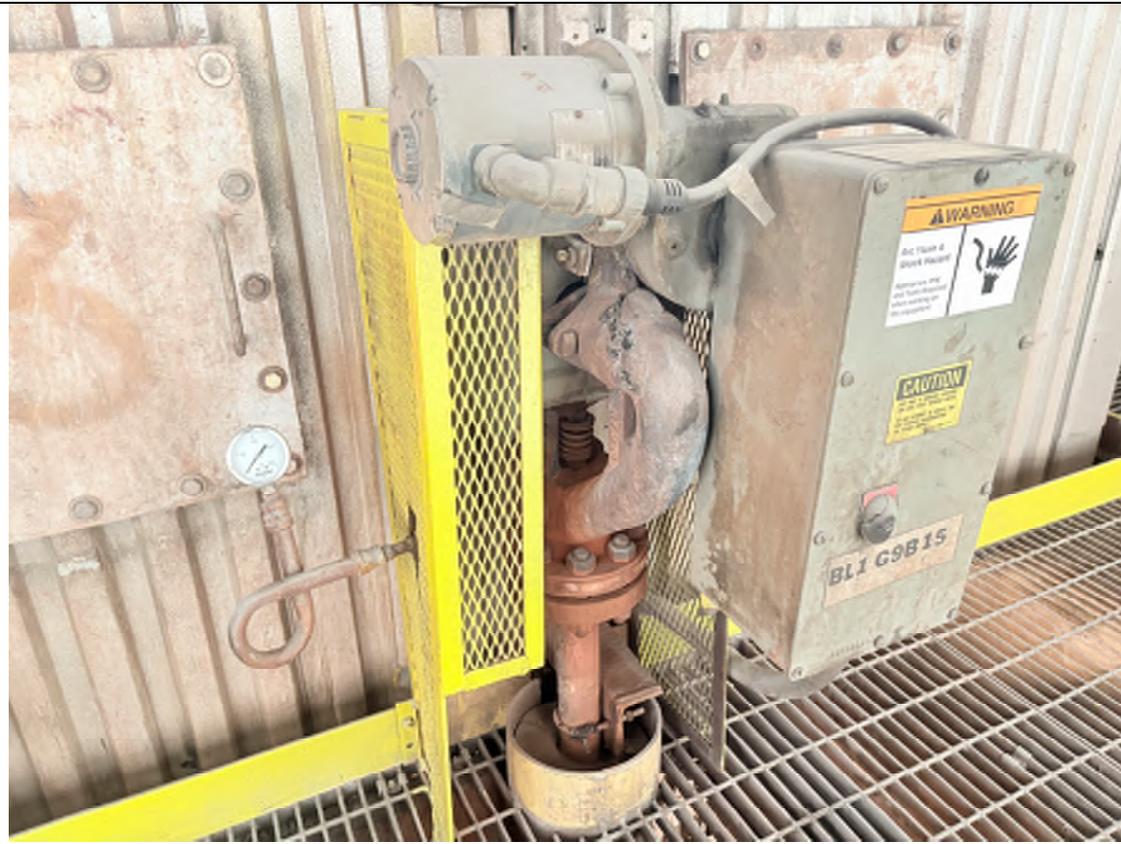
- Unit 1 original G9B-15 sootblower.

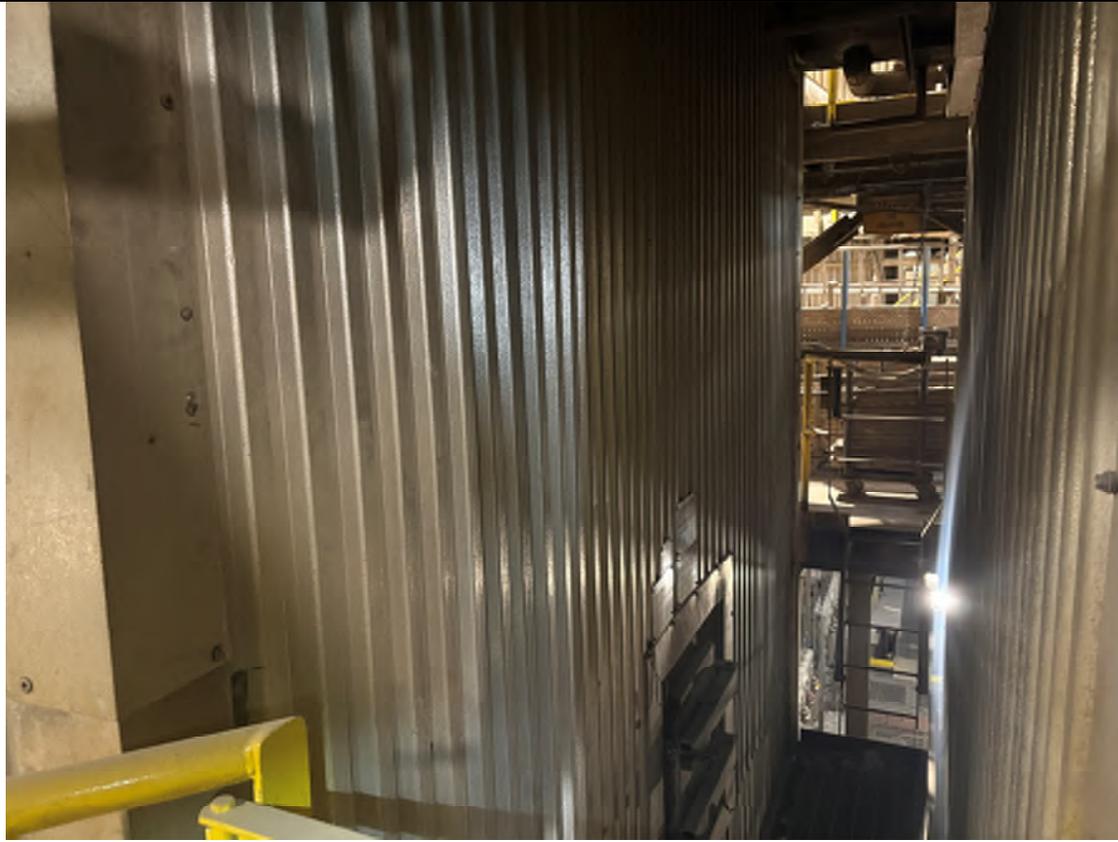
- Insulation and lagging appear to be in very good condition throughout the facility.

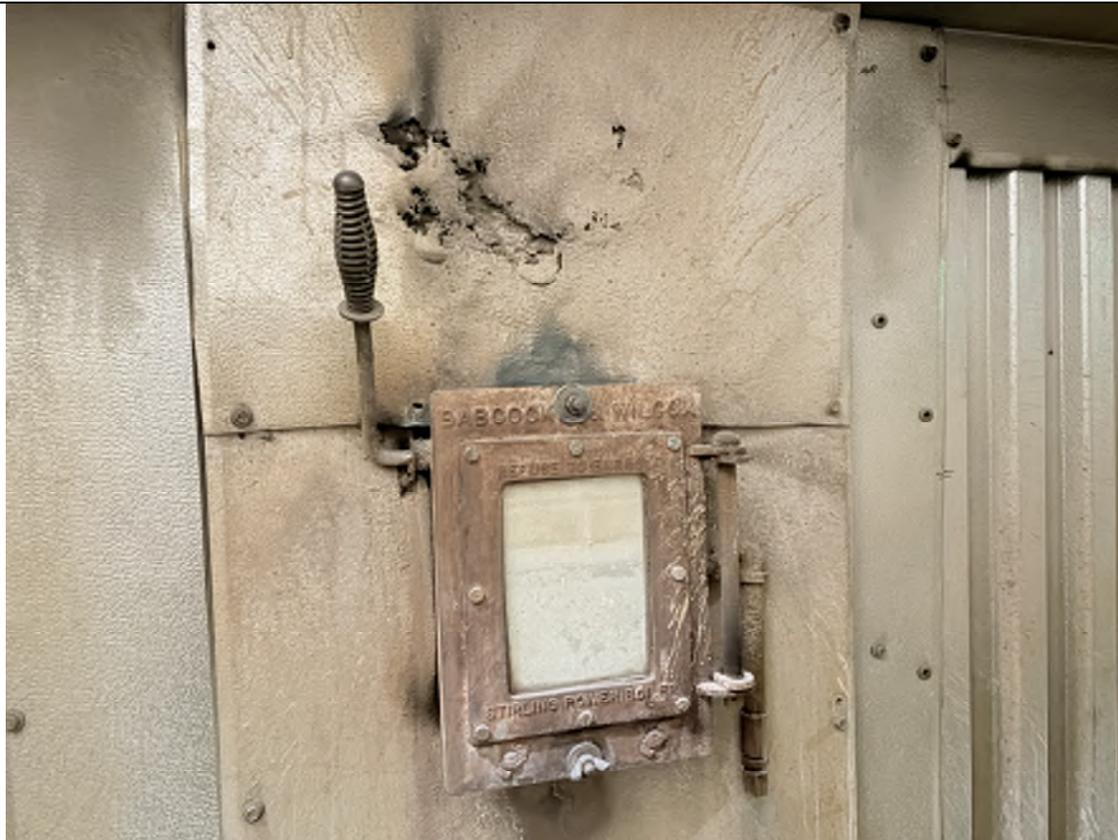
Photograph #20

- Minimal areas of damaged lagging.

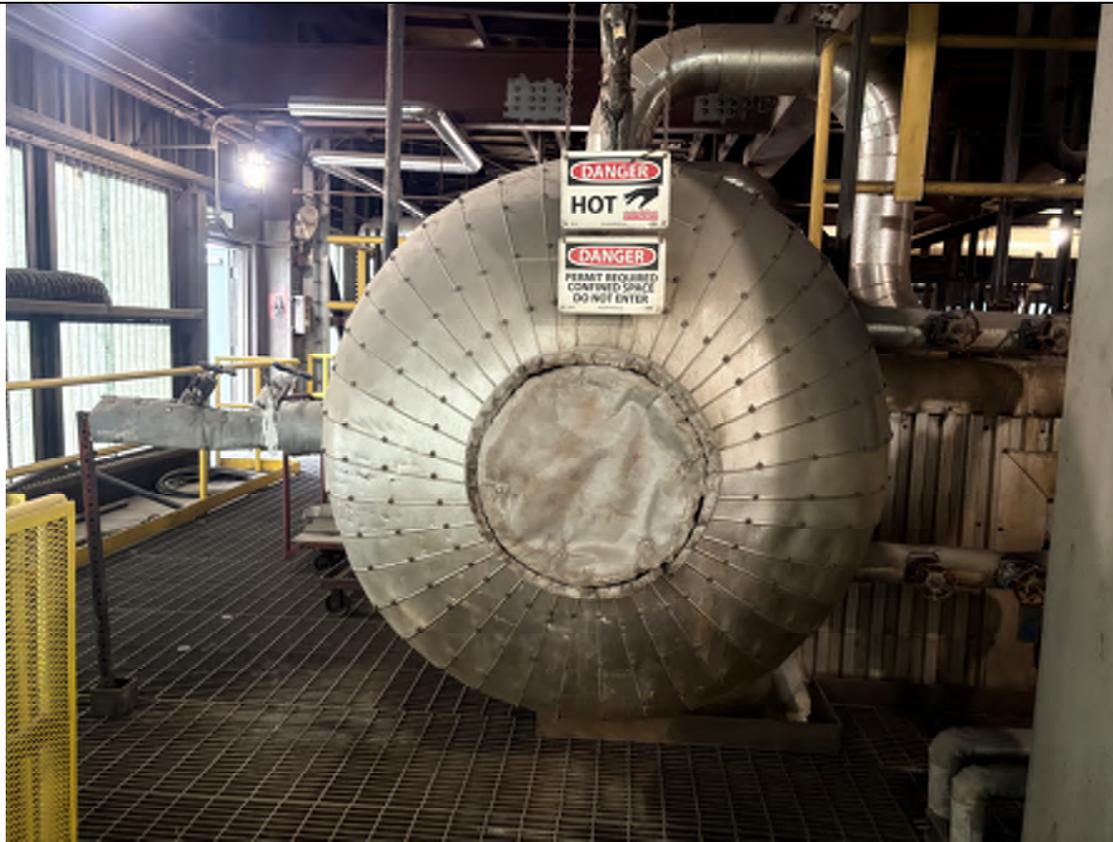
- Housekeeping and insulation around steam drum appears to be in very good condition.

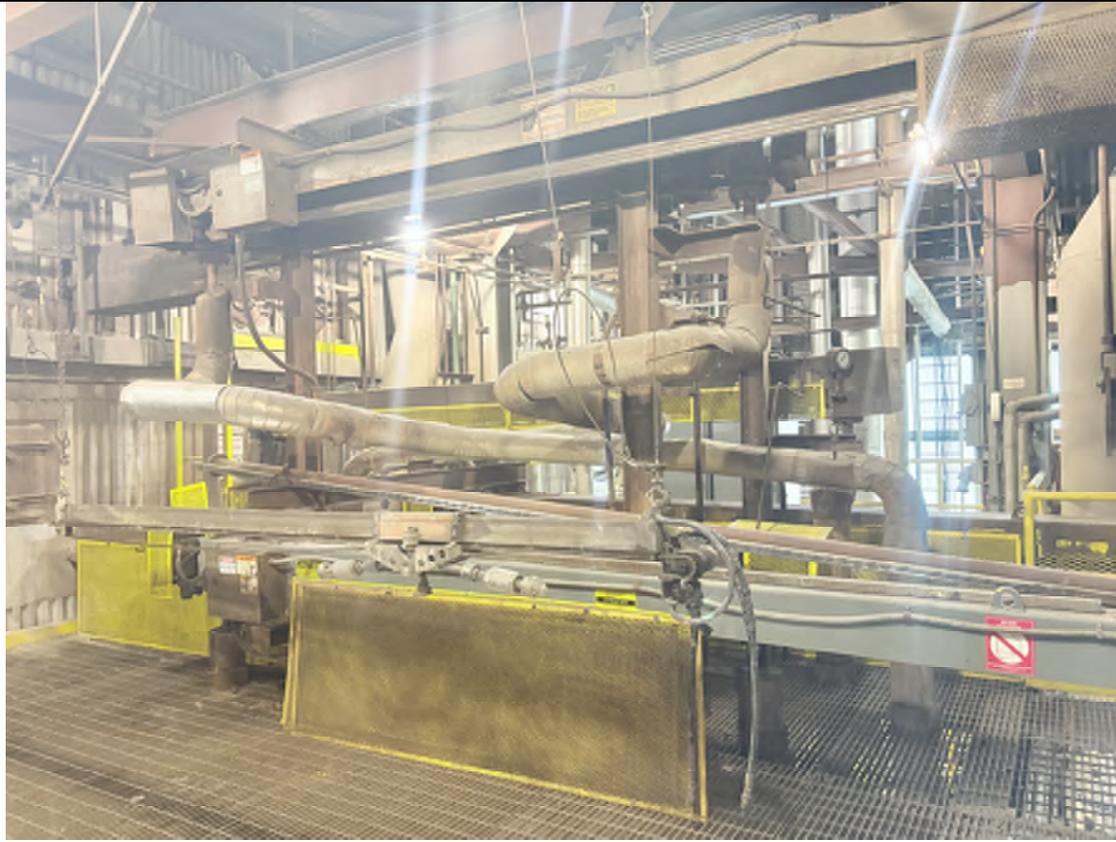
- Housekeeping on upper levels appears to be very good.
- Retractable sootblowers appear well maintained with screened guards generally in place

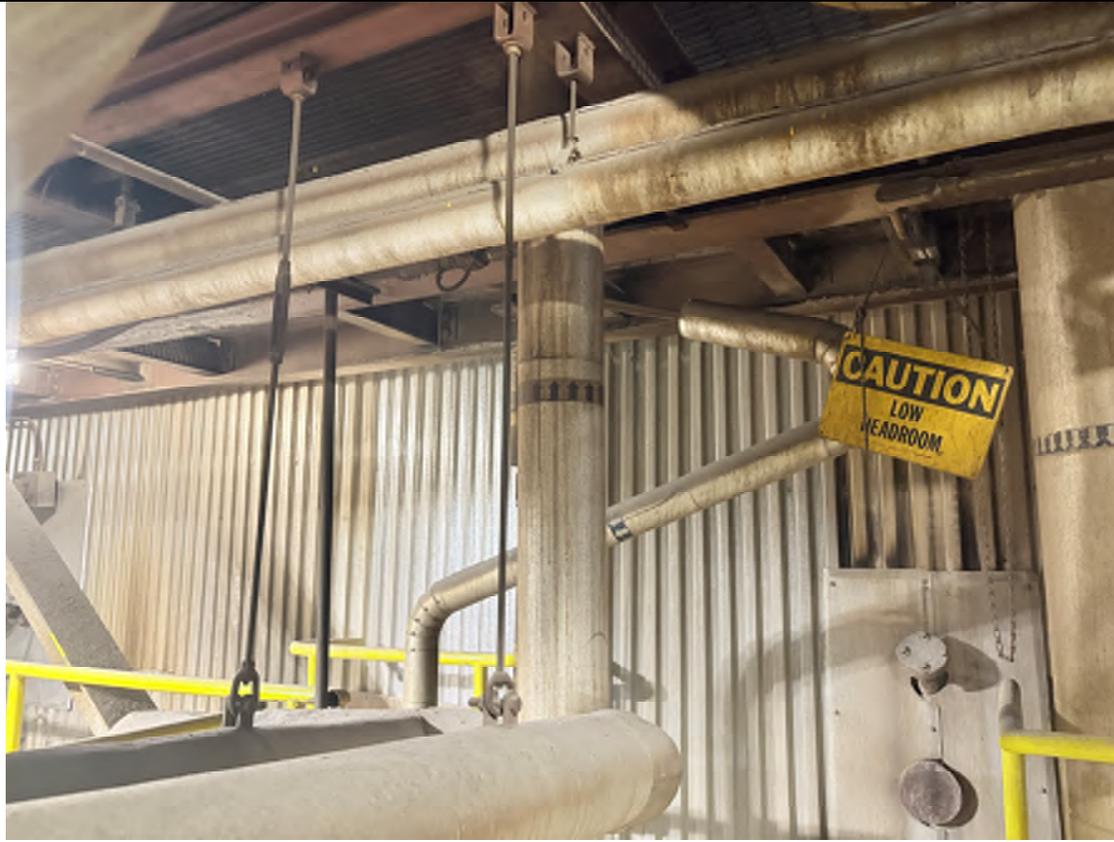
- Hangers observed around the boiler house in good condition.
- No obvious damaged or out of place hangers.

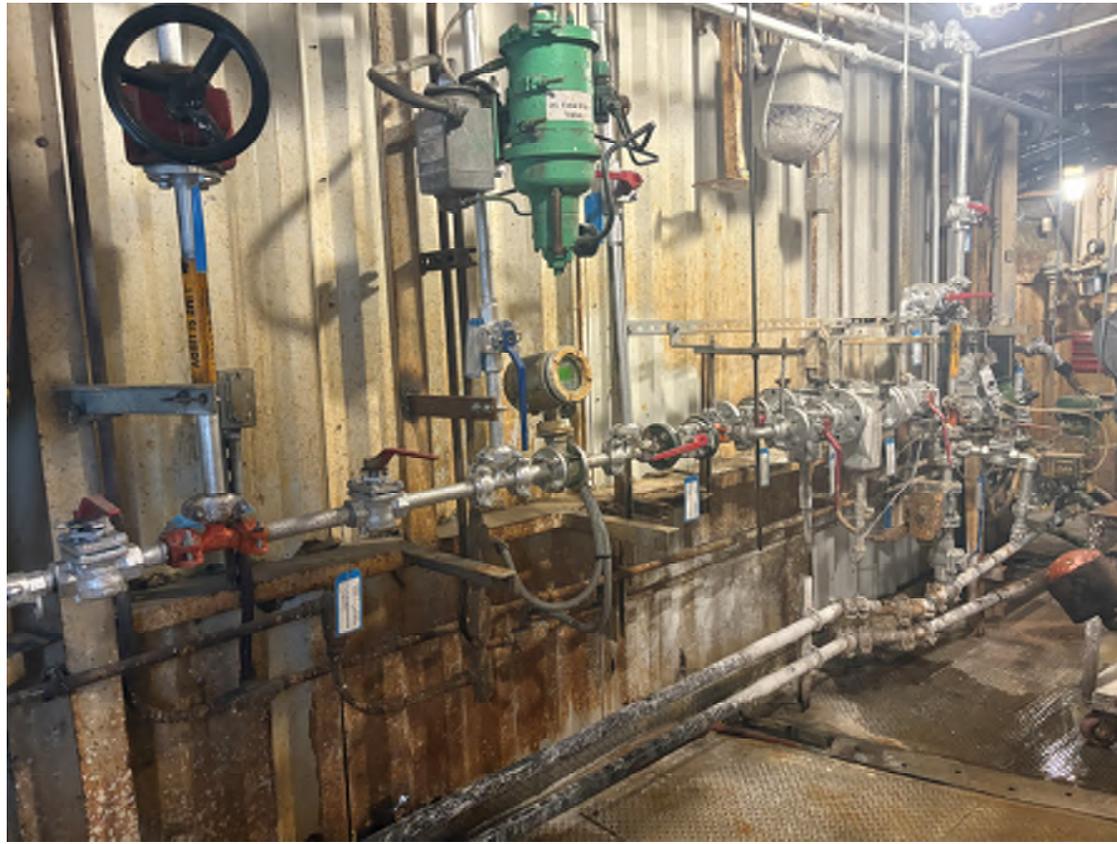
- Lime slurry and dilution water piping maintained with no leakage noted.

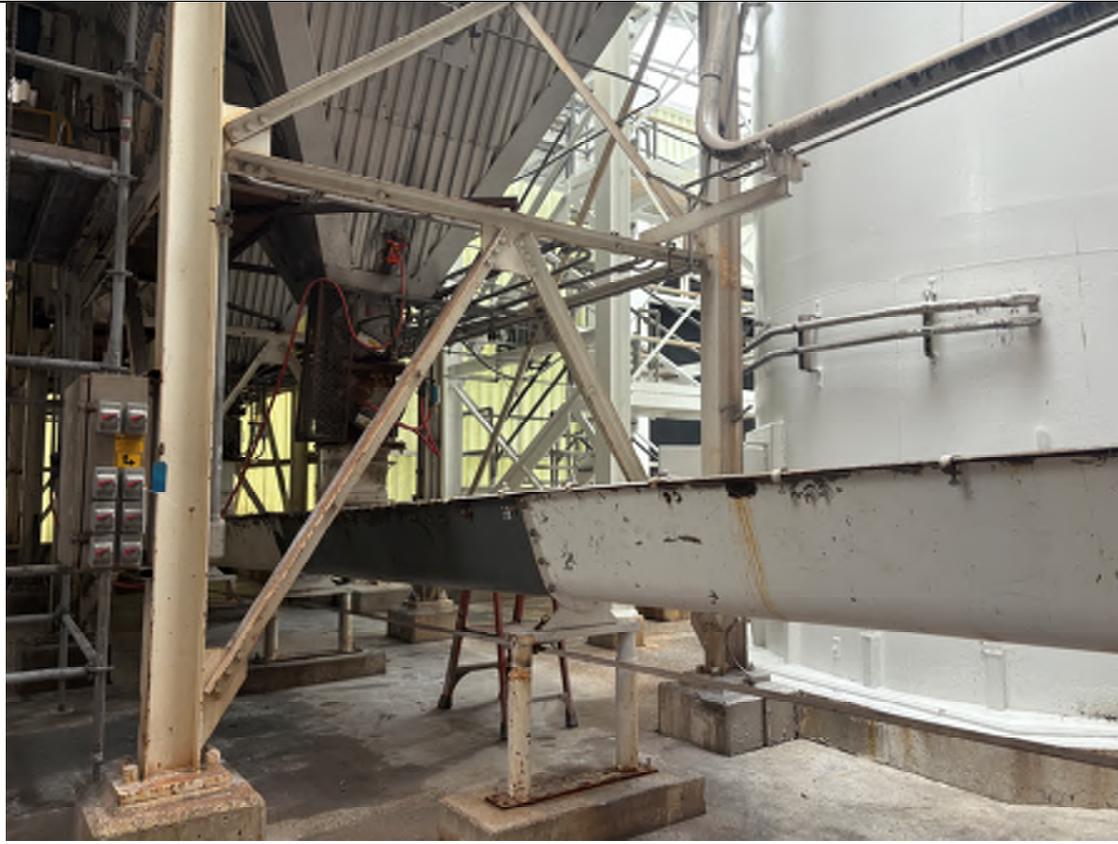
- Fly ash screw conveyors appear in good condition

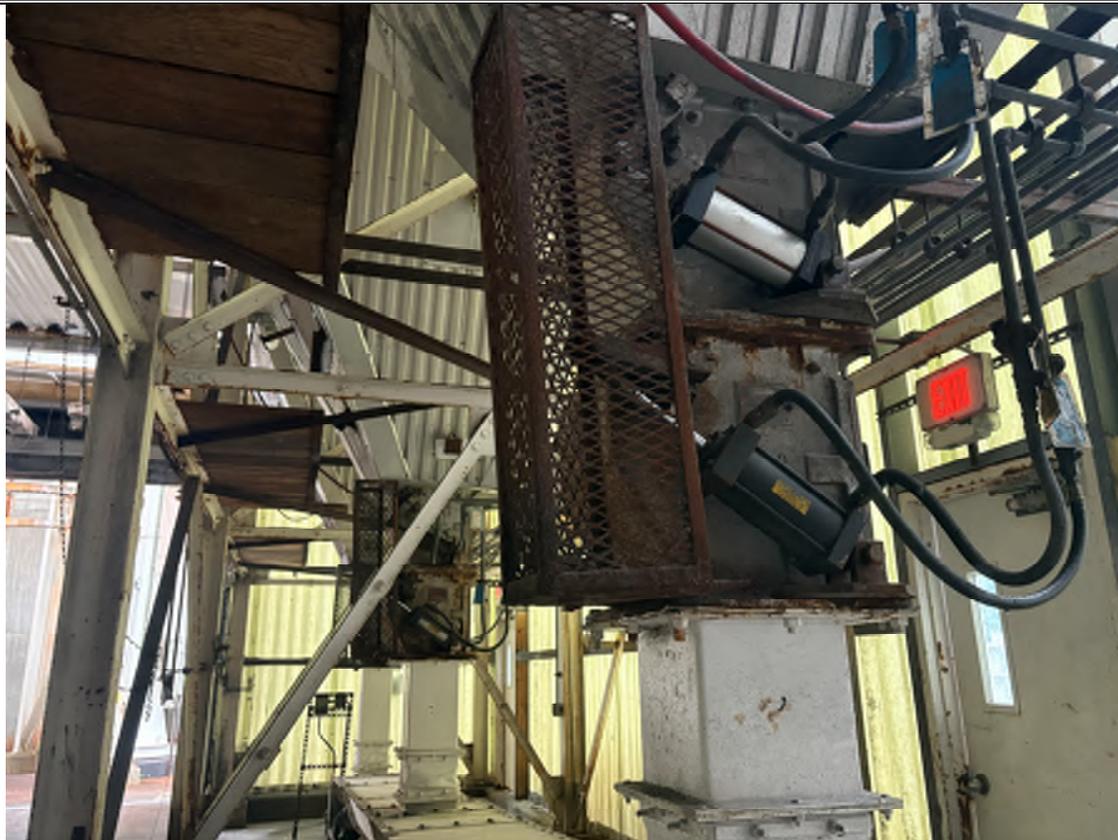
Photograph #37

- Double dump valves on baghouse hoppers appear to be functioning properly.

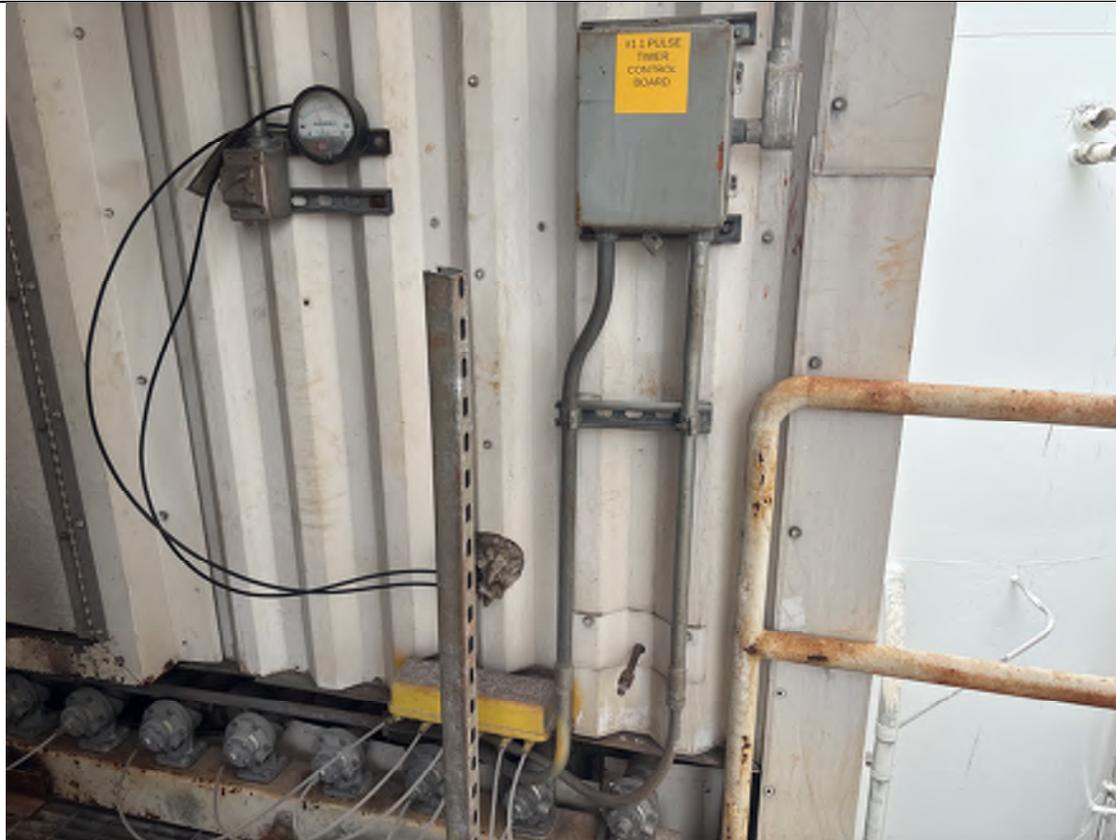
- Pulse headers on Unit 1 baghouse.
- Compartment differential pressure at 6".

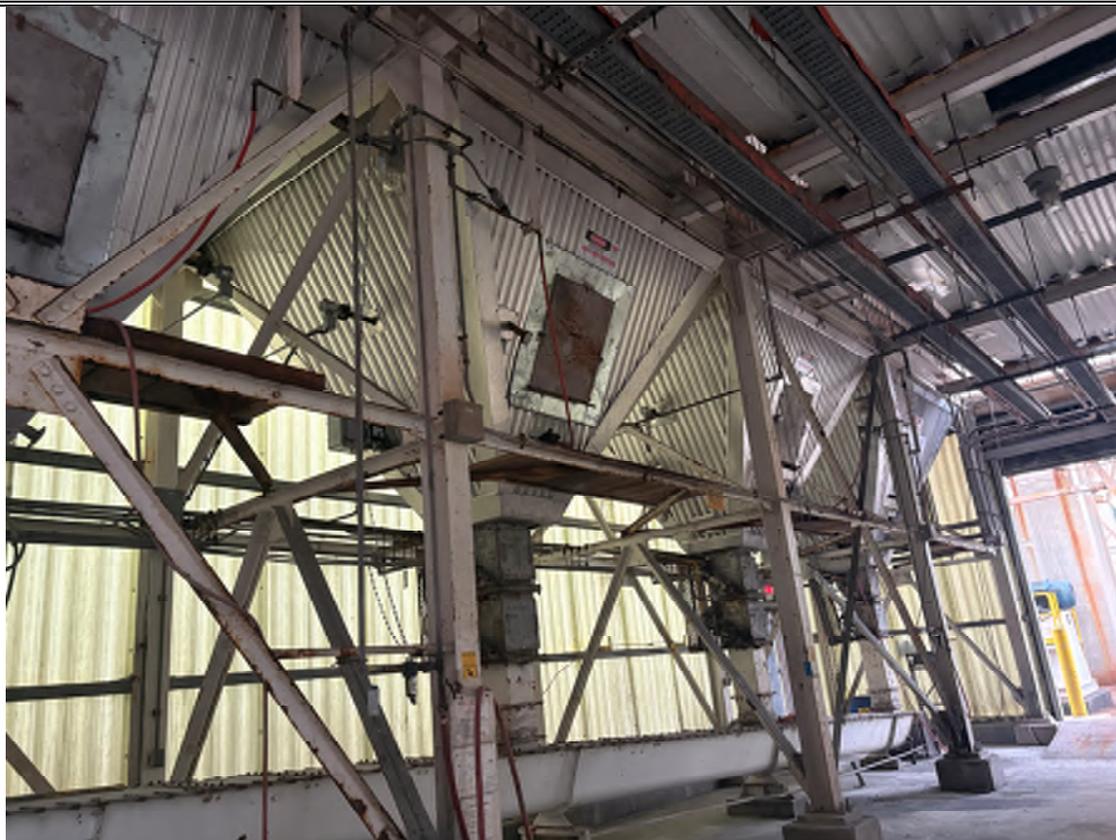
Photograph #39

- Lagging around baghouse hoppers in good condition.
- No evidence of fly ash on ground.

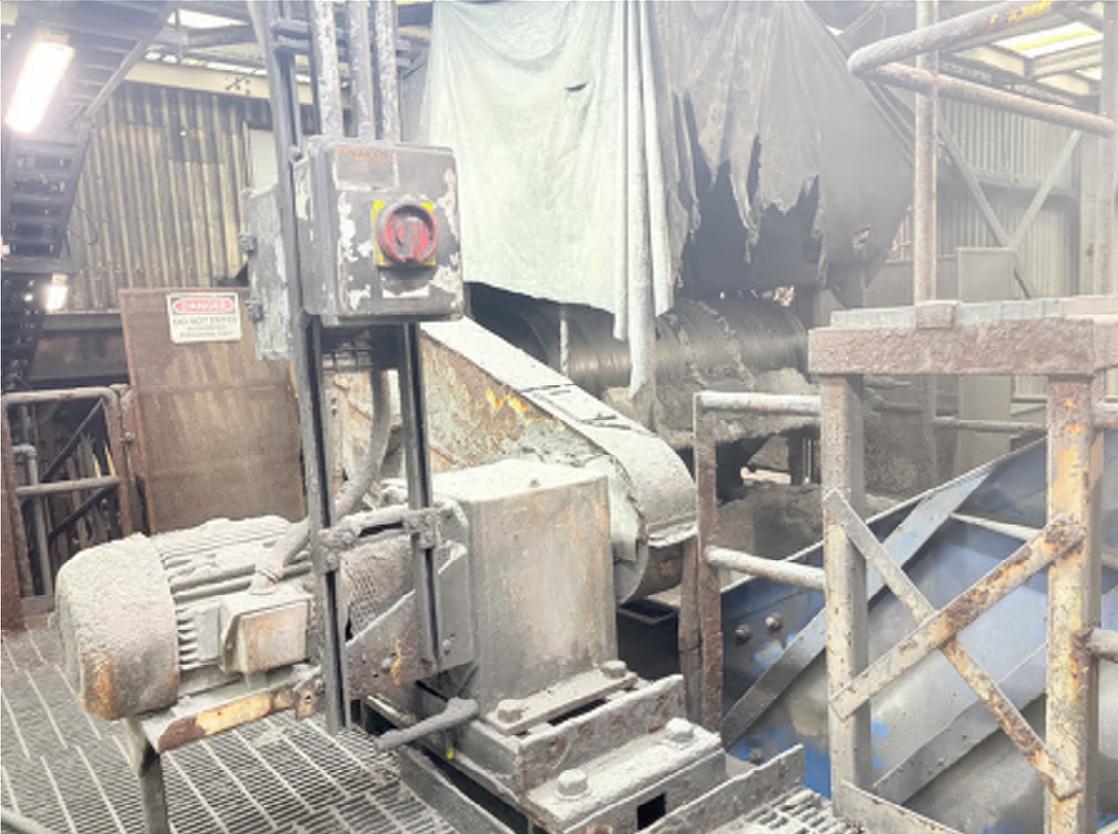
Photograph #41 shows a close-up view of industrial machinery. A large, cylindrical motor is visible on the left, connected to a complex system of pipes and structural elements. A control panel with a red emergency stop button is mounted on a vertical post. The machinery appears to be part of an ash conveyor system. The background shows a large, open industrial space with a white tarp covering some equipment.	<ul style="list-style-type: none">• Top of ash conveyor belt.• Corrosion around steel structure observed.• Dusting observed during our rounds. Pugmill control may need improvement.

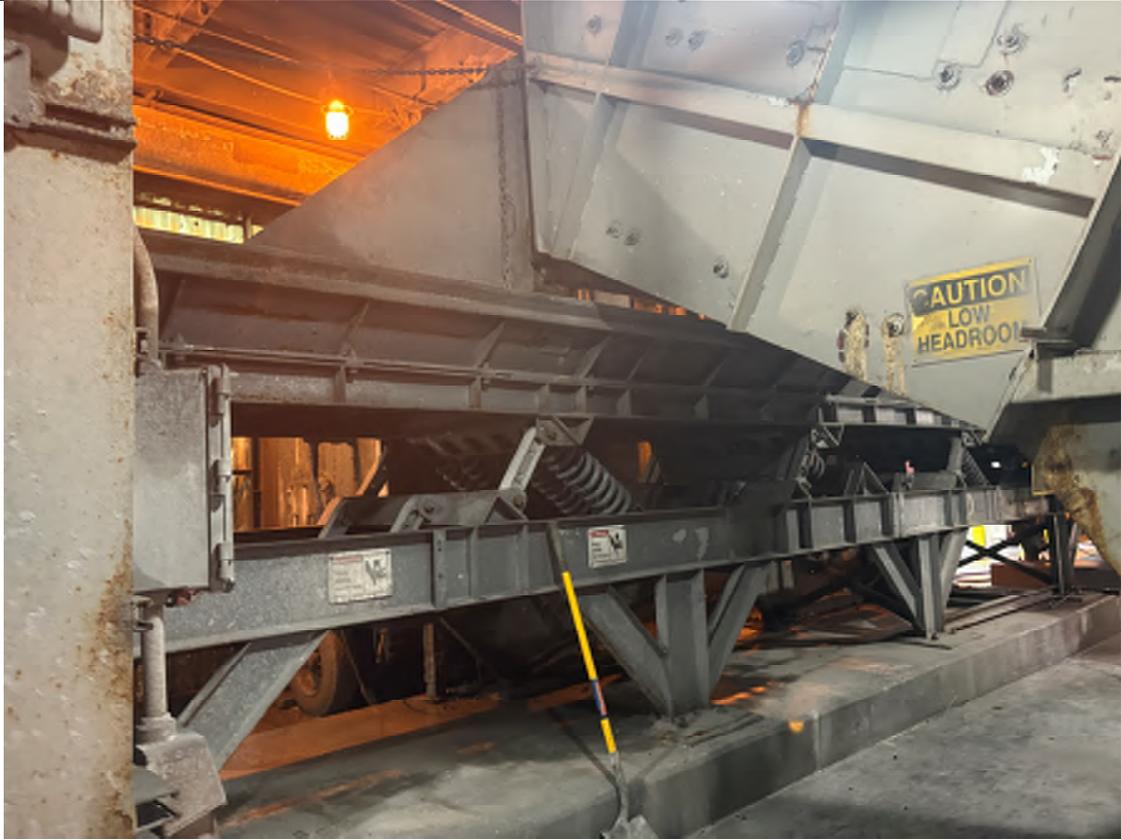
<ul style="list-style-type: none">• Springs below vibrating ash conveyor.• Good housekeeping below ash conveyor.• No bypass conveyor or bypass system for bottom ash in event of vibrating pan failure.
Photograph #43	Remarks

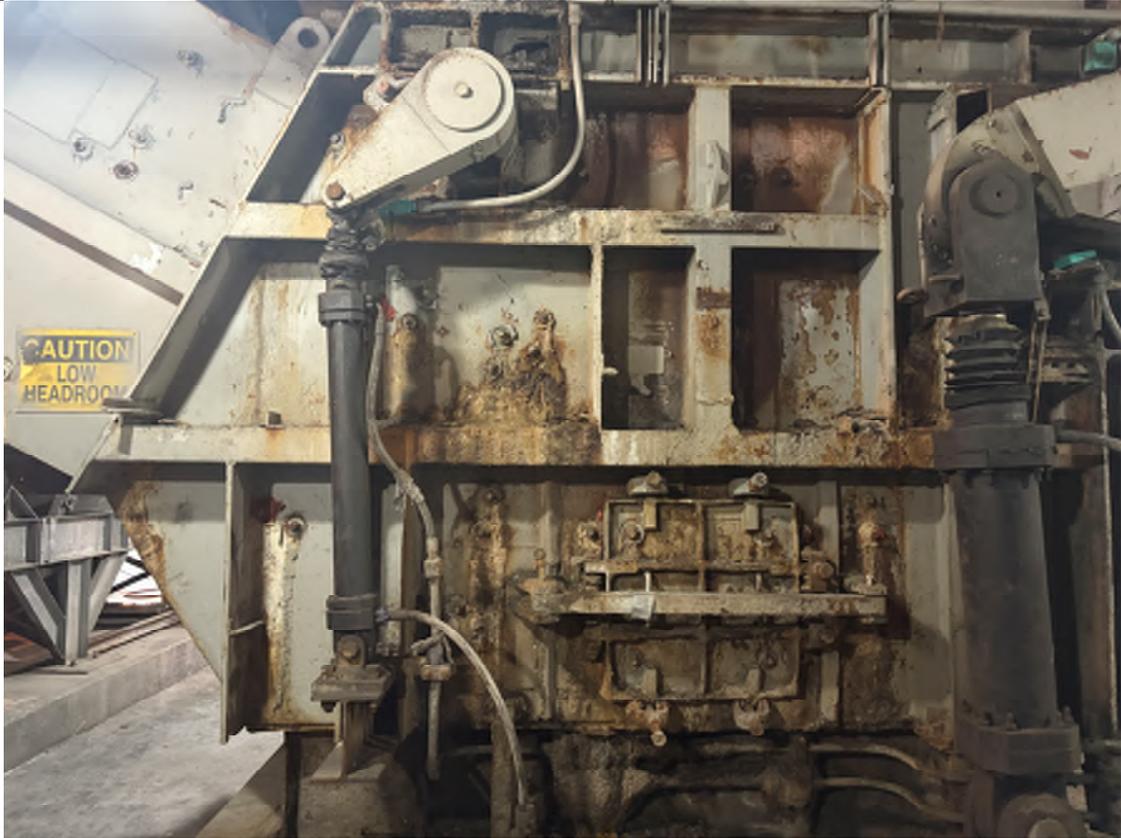
<ul style="list-style-type: none">• Corrosion observed on the quench tank of the ash discharger.• Generally in better condition than other similar facilities.
