Condition Assessment Report

Lisbon Waste-To-Energy Facility

Lisbon, CT
December 16, 2025

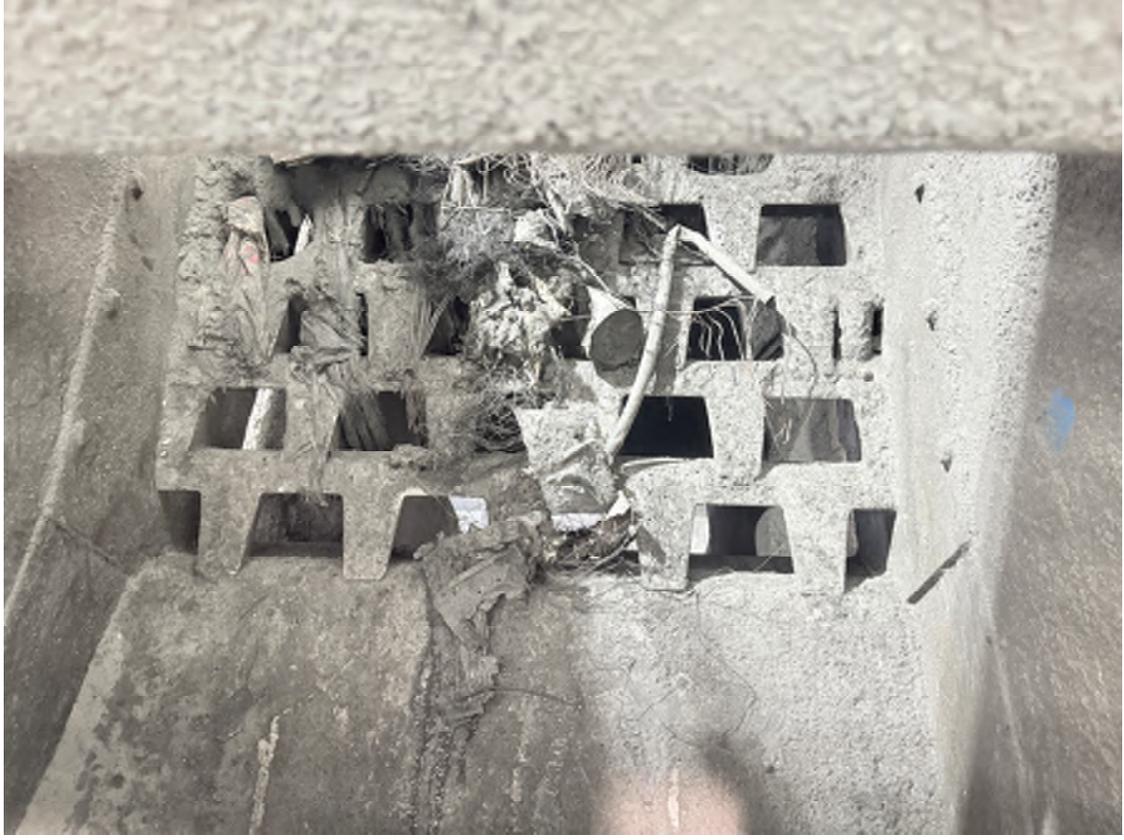
<ul style="list-style-type: none">• Grizzly screen at the end of the ash line.• The grizzly is the only metal separation at the Facility.• Ferrous and non-ferrous separation is performed at landfill
Photograph #51	Remarks

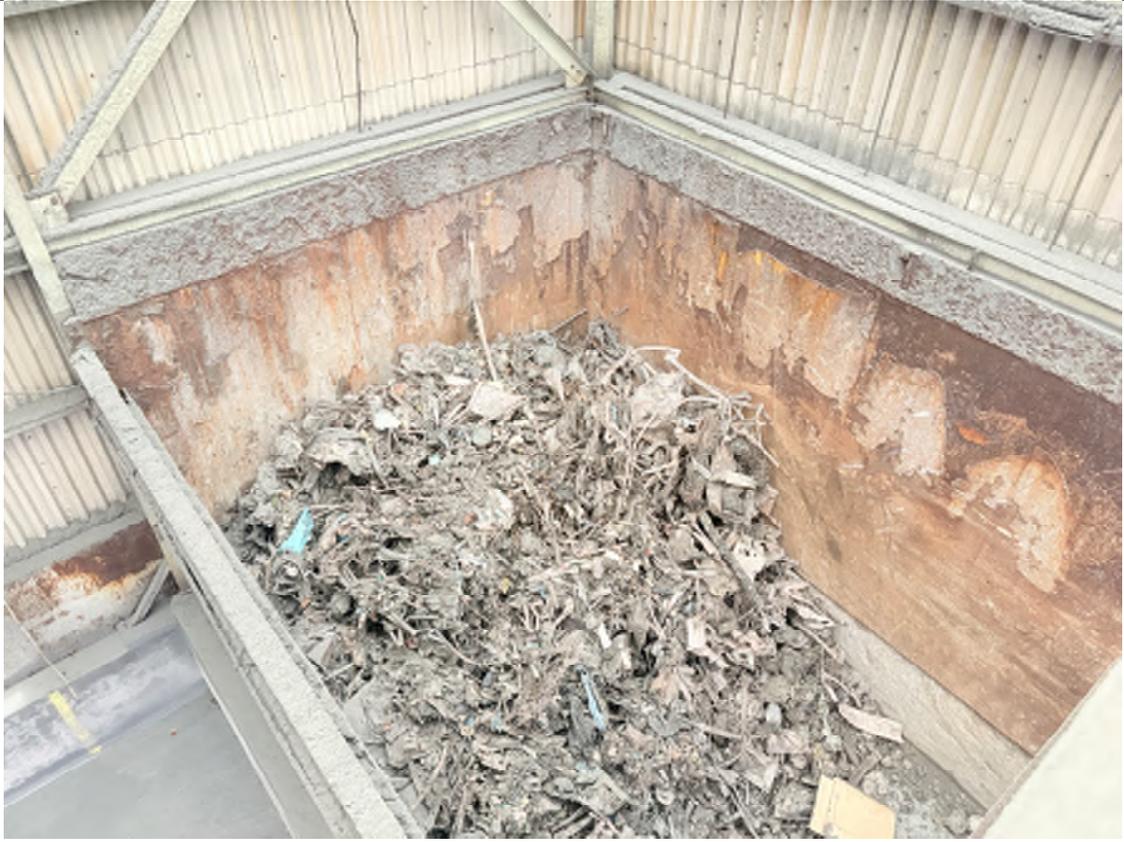
<ul style="list-style-type: none">• Grizzly oversized/metals recovery storage pit.• Walls show signs of corrosion.

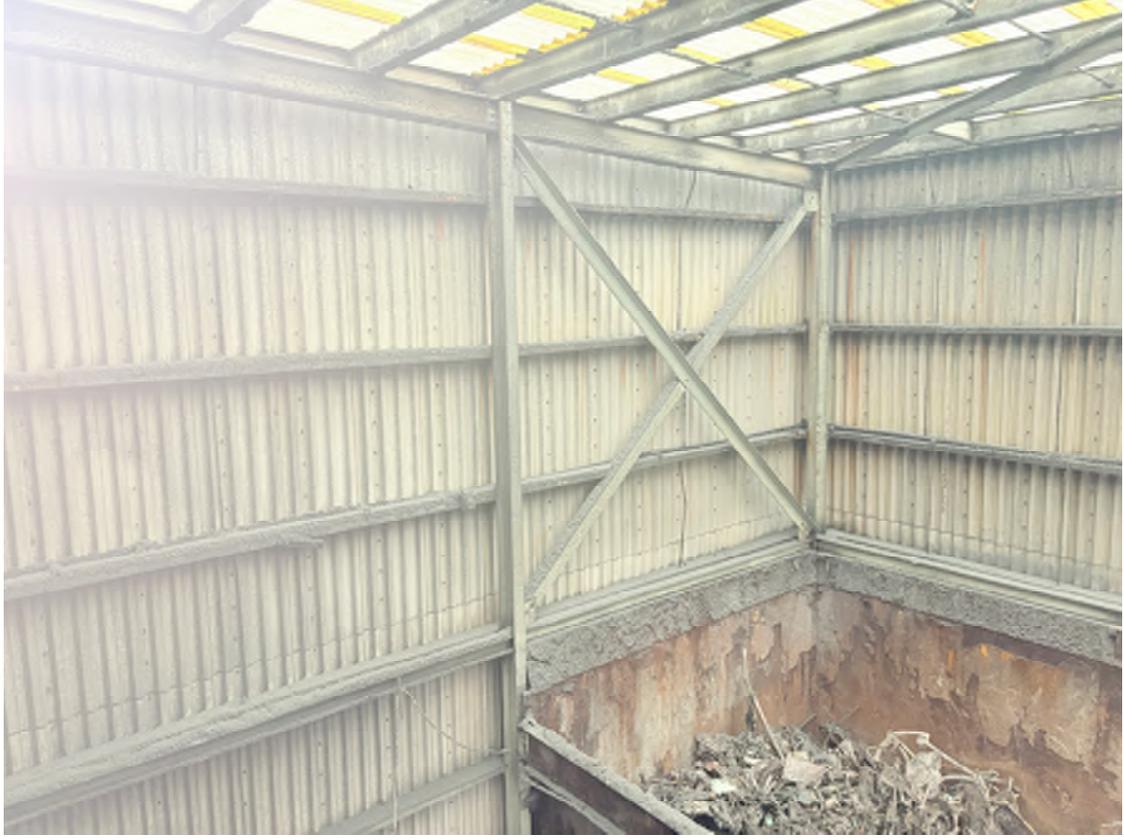
<ul style="list-style-type: none">Higher exterior walls of ash building appear to be in good condition with minimal corrosion observed.
Photograph #53	Remarks

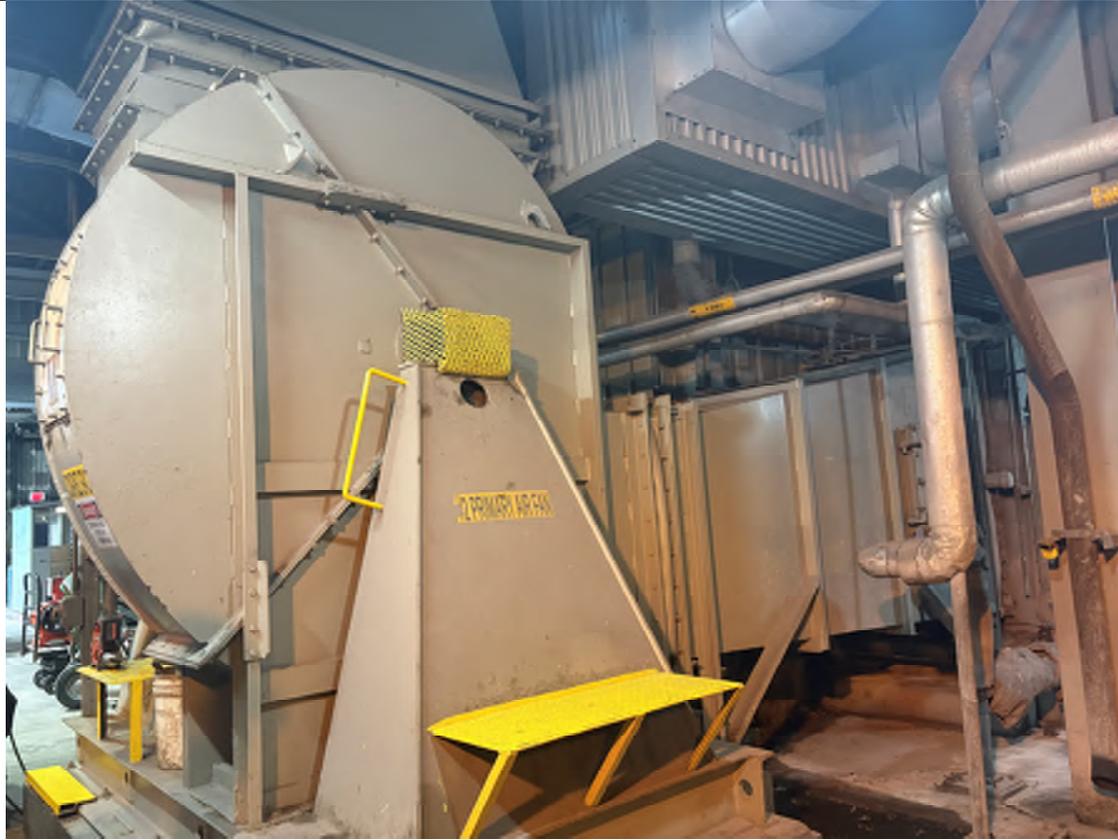
- Unit 2 Primary Air Fan appears in good condition.

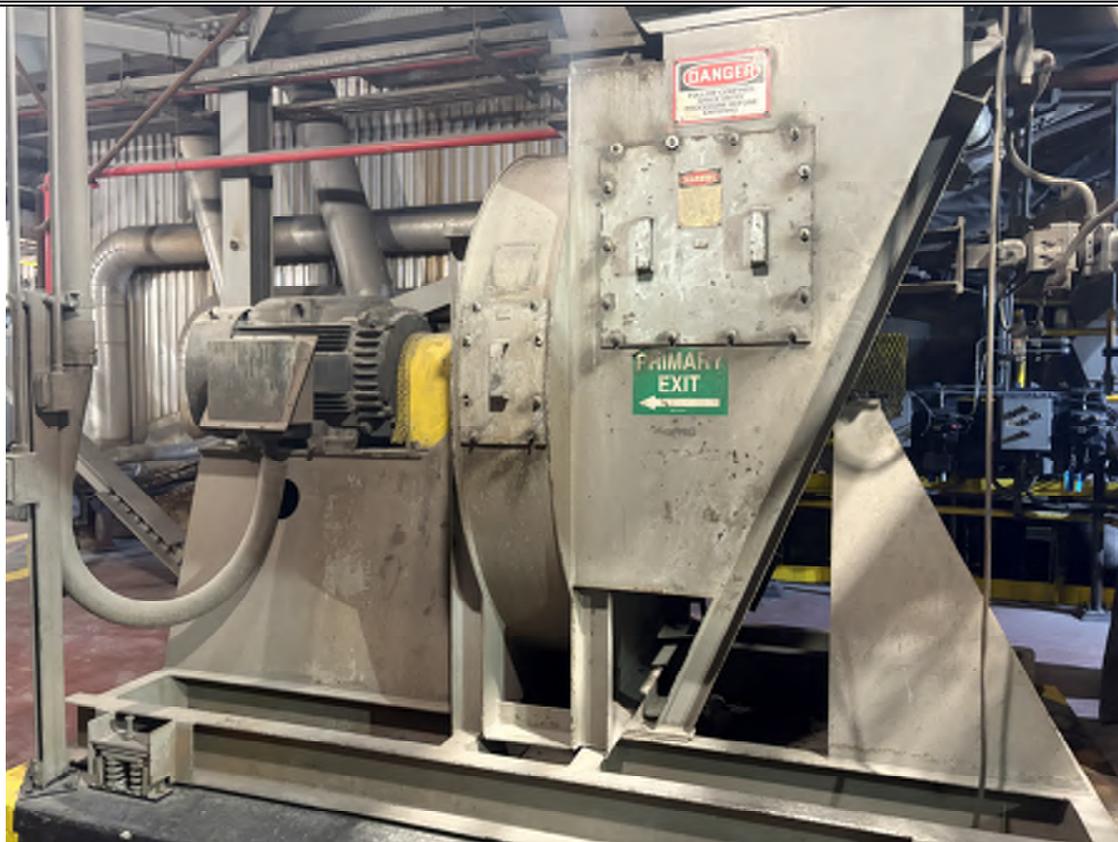
- Unit 1 Primary Air Fan appears in good condition.

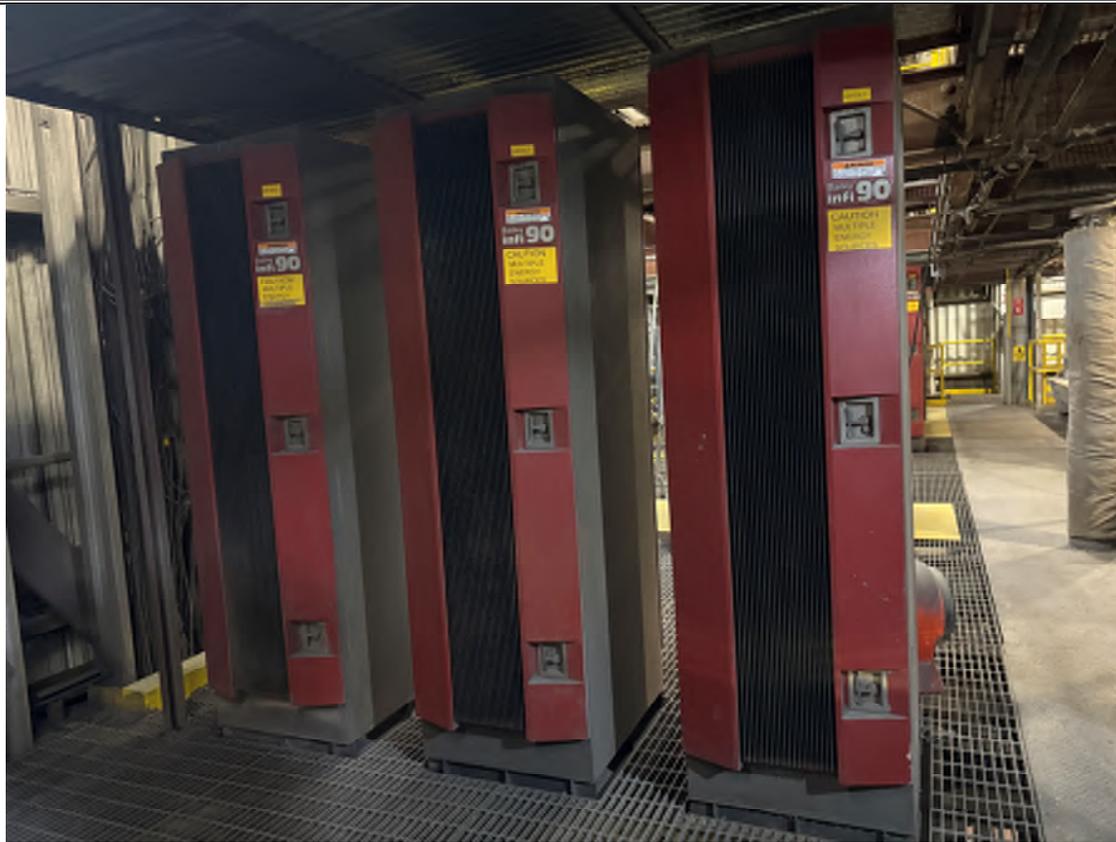
- MCCs appear to be in good condition with minimal ash build-up.

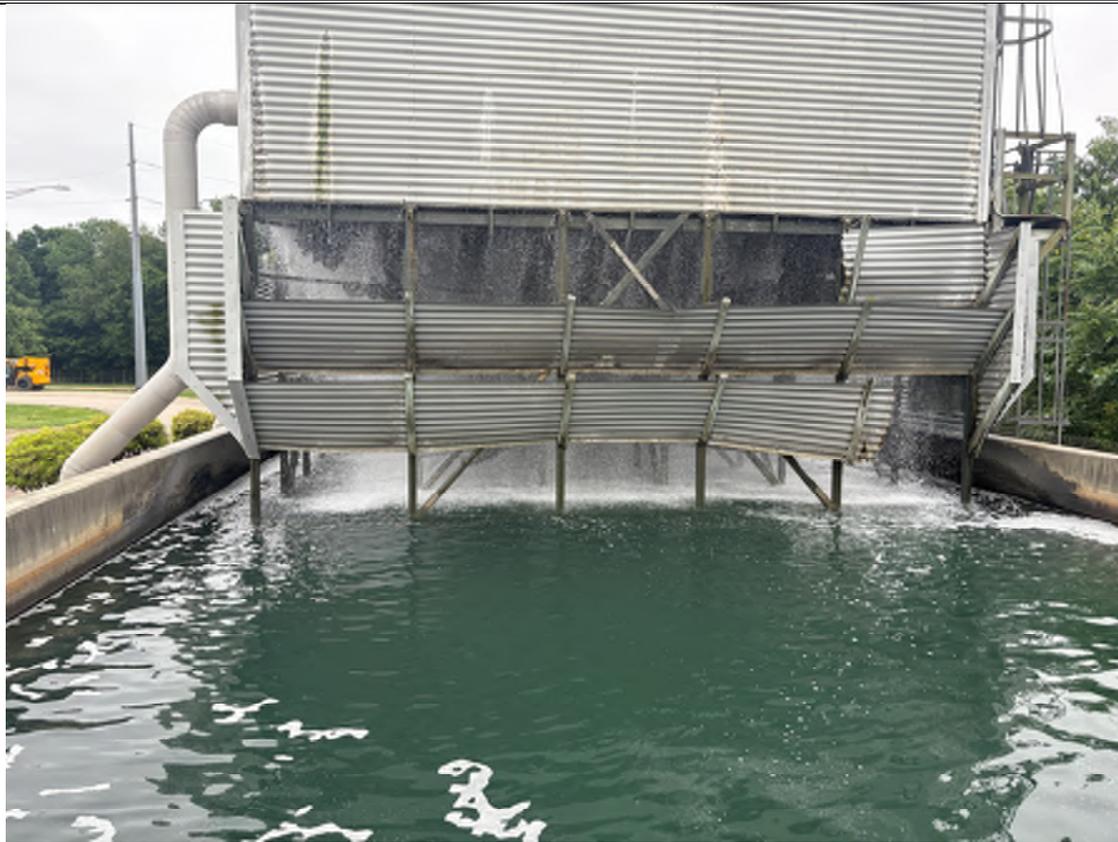
- Some deterioration of lagging apparent on cooling water tower.
