RE: Eversource R.O.W.
97 Poplar Road, Middletown, CT

**RE: Founders Ridge – Phase 2 – Ridgewood Road – Middletown, CT
P&R Job No. 143038**

RE: POND REHABILITATION/MAINTENANCE
97 Poplar Road, Middletown, CT

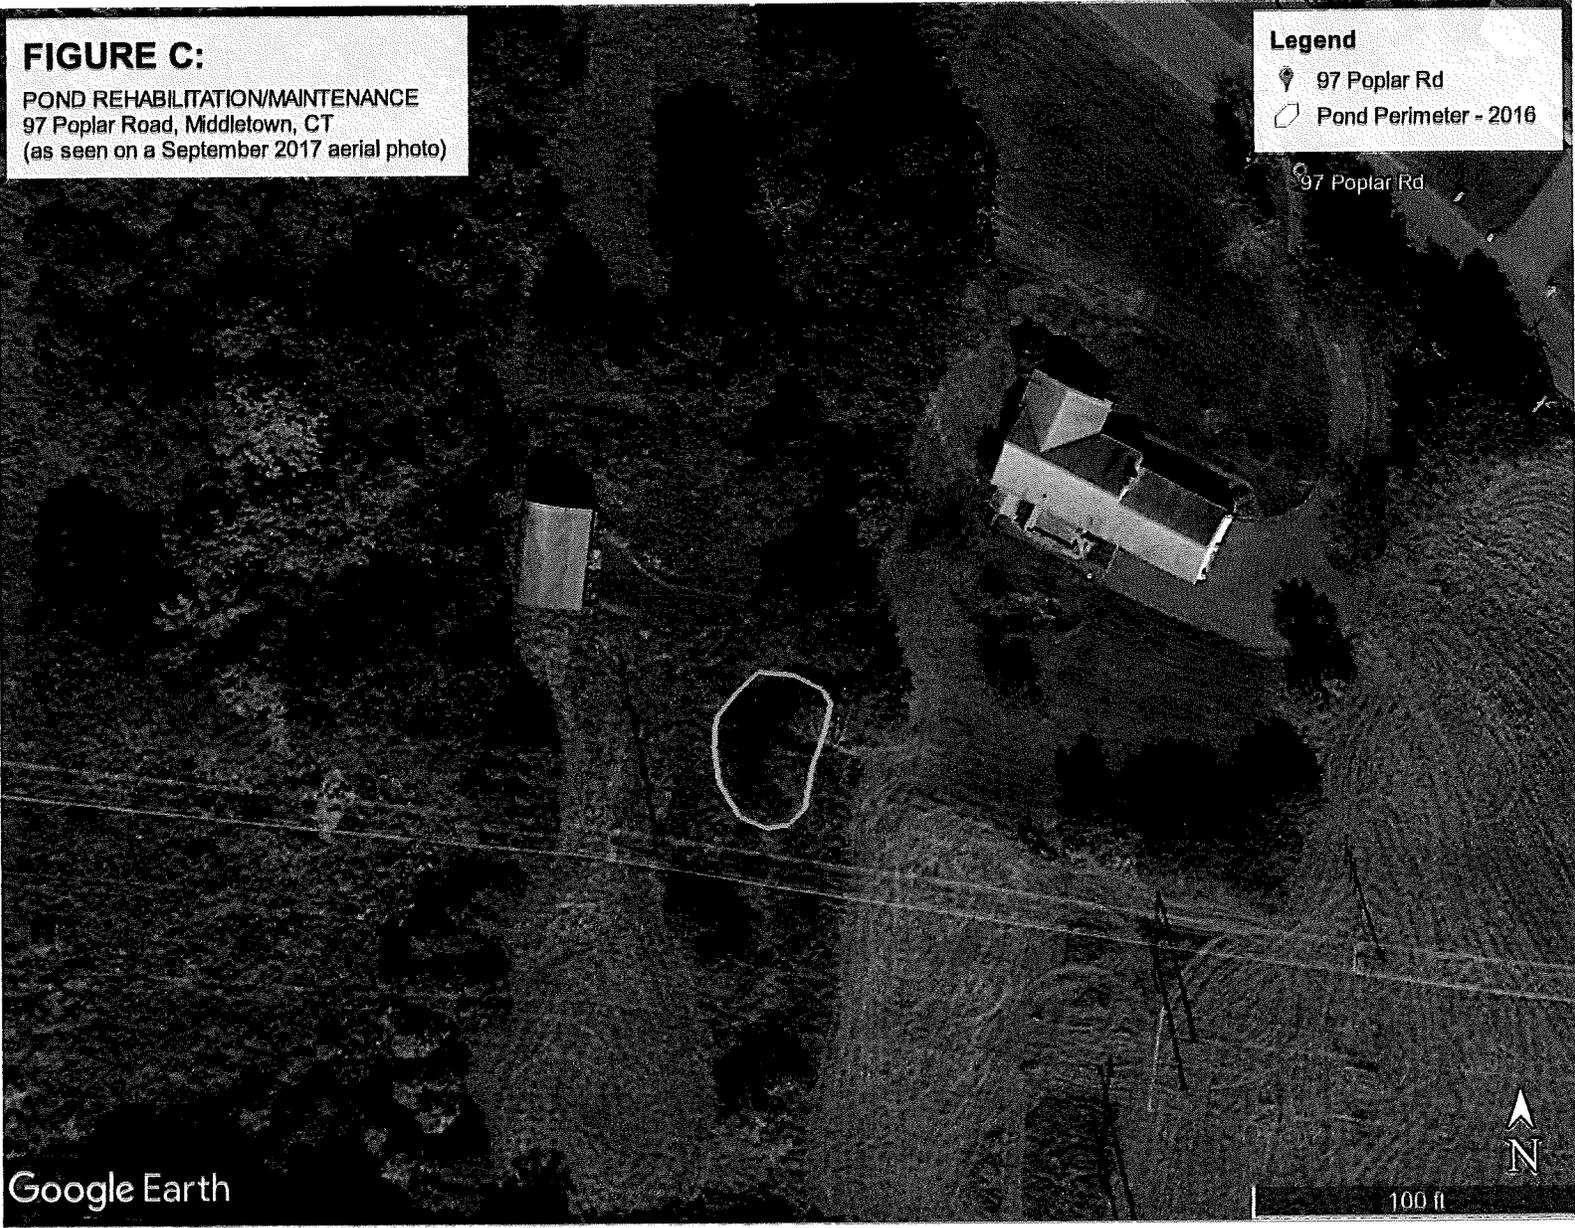
FIGURE C:

The finer sediment below the more recent deposits would indicate that this pond has been slowly filling for the past 3 to 4 decades. This natural accretion of sediment and organic matter typical of small waterbodies. The presence of mature willows and silky dogwood shrubs within the “pond” proper (see Photo 1, attached), especially closer to the inlet, would also indicate that accelerated accretion has taken place over the past decade. For instance, a September 2017 aerial photograph, taken before any substantial work upgradient associated with second phase of the residential development, shows the pond to be completely vegetated with emergent vegetation and shrubs, with no evidence of open water (see Figure C, attached).

POND REHABILITATION/MAINTENANCE
97 Poplar Road, Middletown, CT
(as seen on a September 2017 aerial photo)

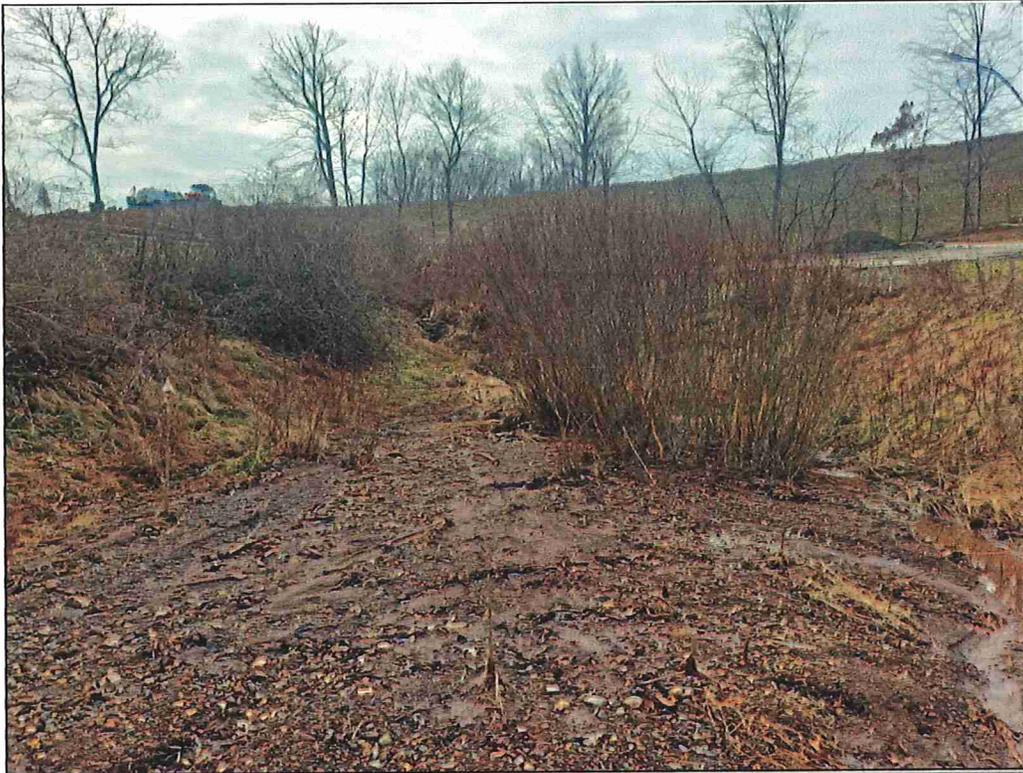
Photo 1: Central and southern portion of "pond"; facing southerly

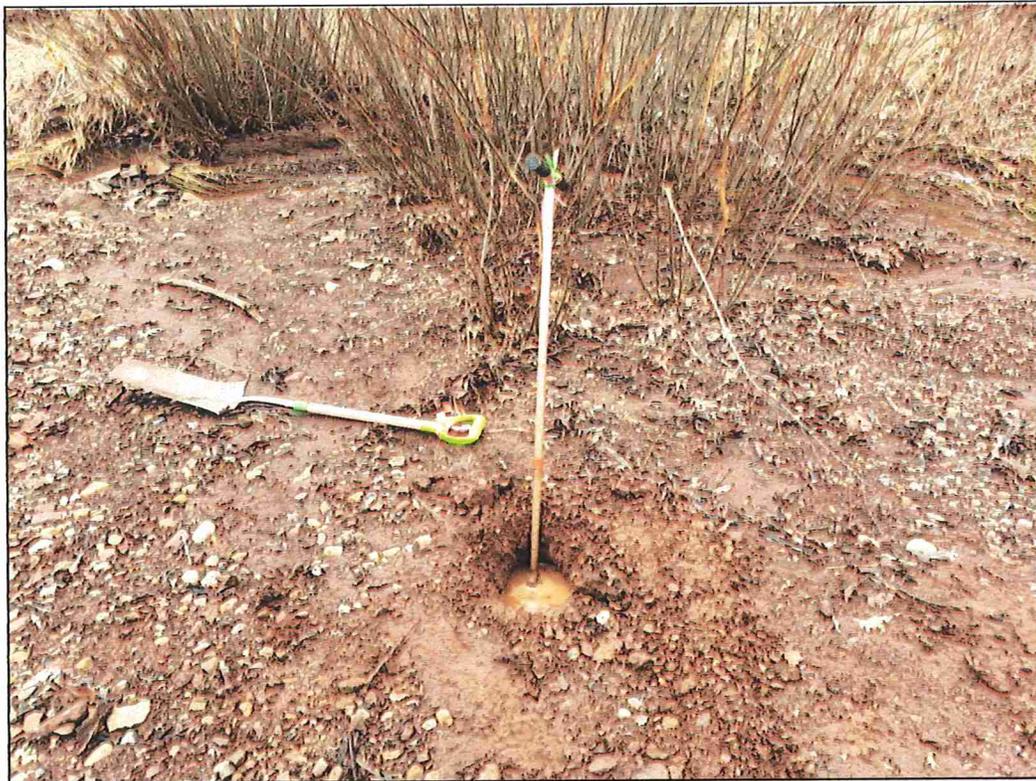
Exploration with a soil auger within the aforementioned shallow channel revealed two or three inches of coarse sediment (i.e., sand and gravel). However, finer sediment with incorporated organic matter was observed below the “channel bed.” These finer and waterlogged sediments extended at least 42 inches below the surface, the length of our soil auger (see Photo 4, attached). At the southern end of the pond, just below the eroded inlet channel, 8 to 10 inches of coarse sediment, including pea size gravel, was noted, again above finer sediment (see Photo 2, attached). The texture of this sediment is similar to what was observed in the eroded channel upgradient of the “pond.” This would indicate that it is of relatively recent origin, and was likely deposited here when the intermittent stream channel eroded during a significant storm event, or series of storm events.

Photo 2: Exploratory soil pit, southern portion of "pond"; facing southerly

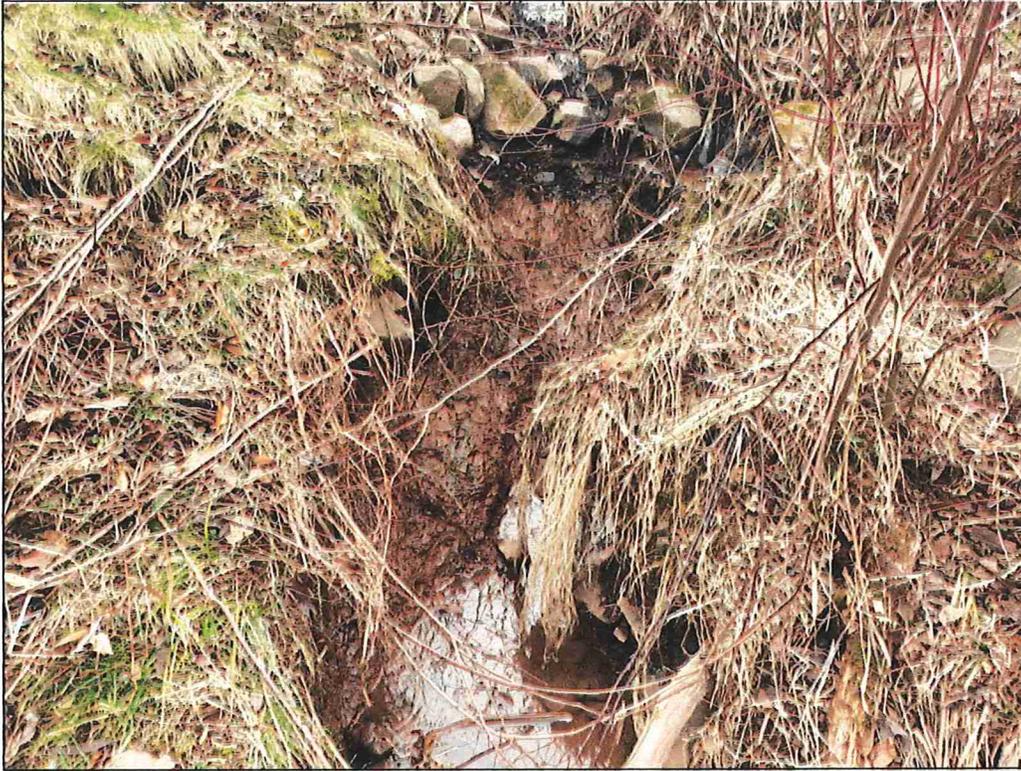
During the site visit we noted that the temporary bridge structure used by Eversource to cross the wetland/watercourse corridor upgradient of pond, may be in fact accelerating the velocities of flows to the downgradient segment of the stream. All of the severe channel erosion that has resulted in the recent deposition of sediment to the pond is downgradient of the temporary bridge.

Photo 3: One of the eroded portion of the intermittent stream feeding the “pond”; facing southerly

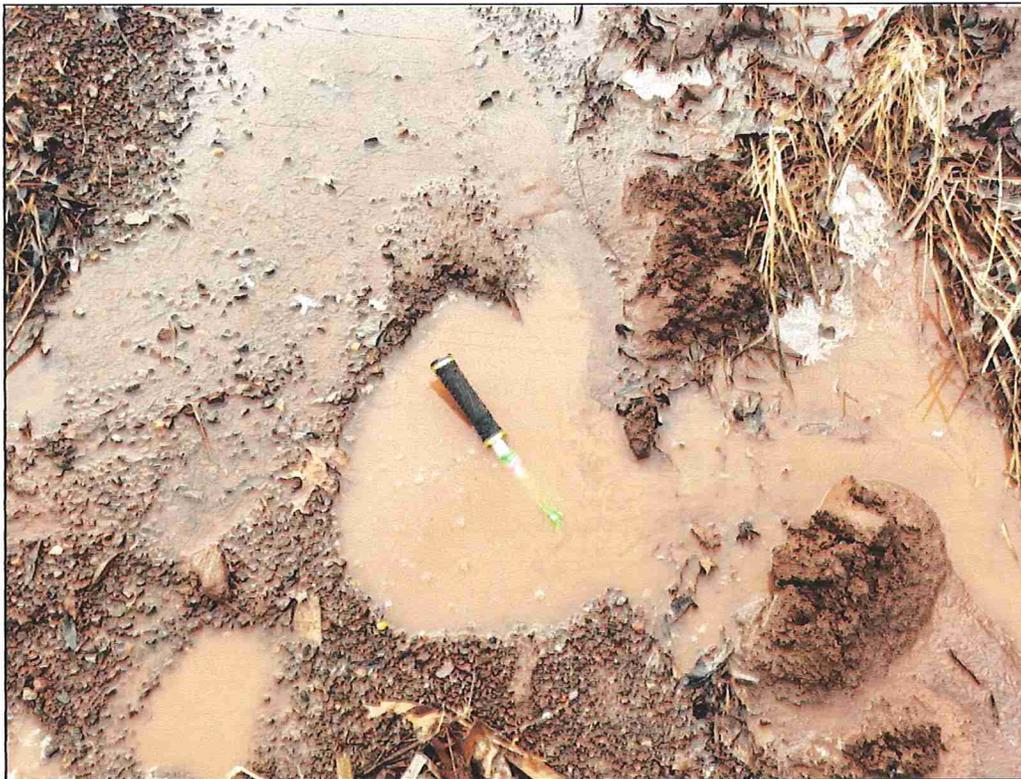
Photo 4: Exploratory soil pit along the existing flow path through the “pond;” auger buried to handle, indicating at least 42 inches of accreted sediment and organics

1. Removal of accumulated (i.e., accreted) sediment during the dry low flow season, typically July through September.
2. Leaving an aquatic shelf on the east side of the pond, closer to its outlet. This would extend 3 to 4 feet from the pond edge, be 6 to 12 inches below the inlet invert elevation of the pipes, and allow for marsh and meadow type vegetation to be established.

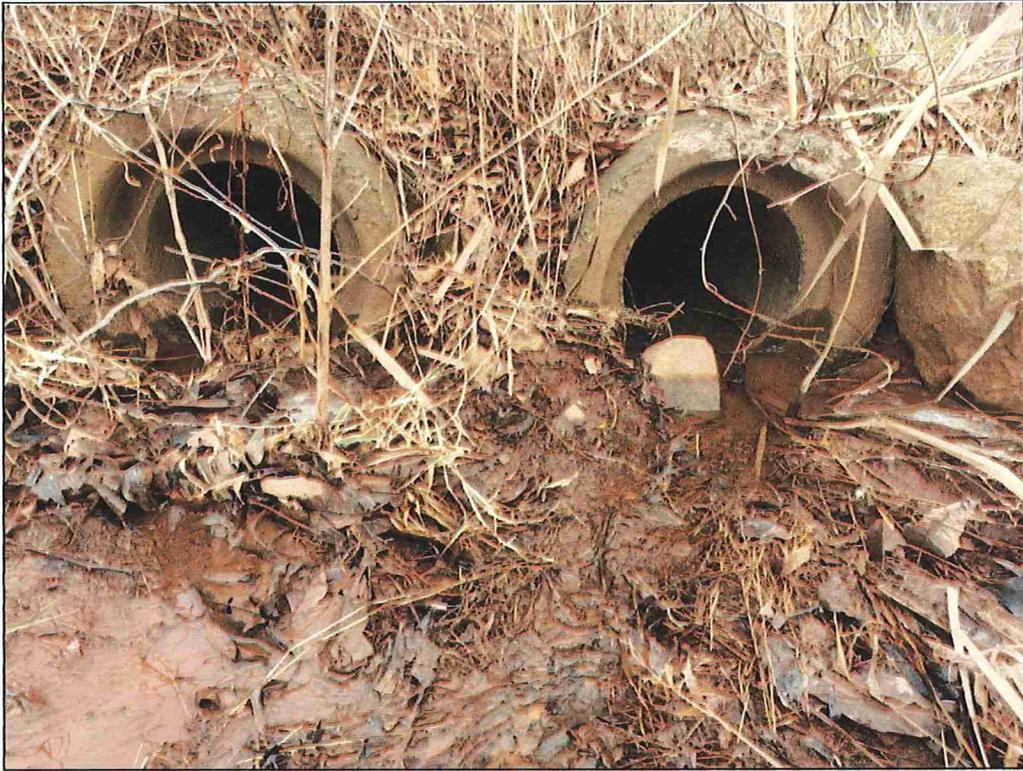
Photo 5: Twin outlet pipes through the "pond" embankment (berm); facing northerly
