**The Downtown Housing Analysis of Impediments
and Architectural Feasibility Study**

**339 MAIN STREET
Middletown, CT**

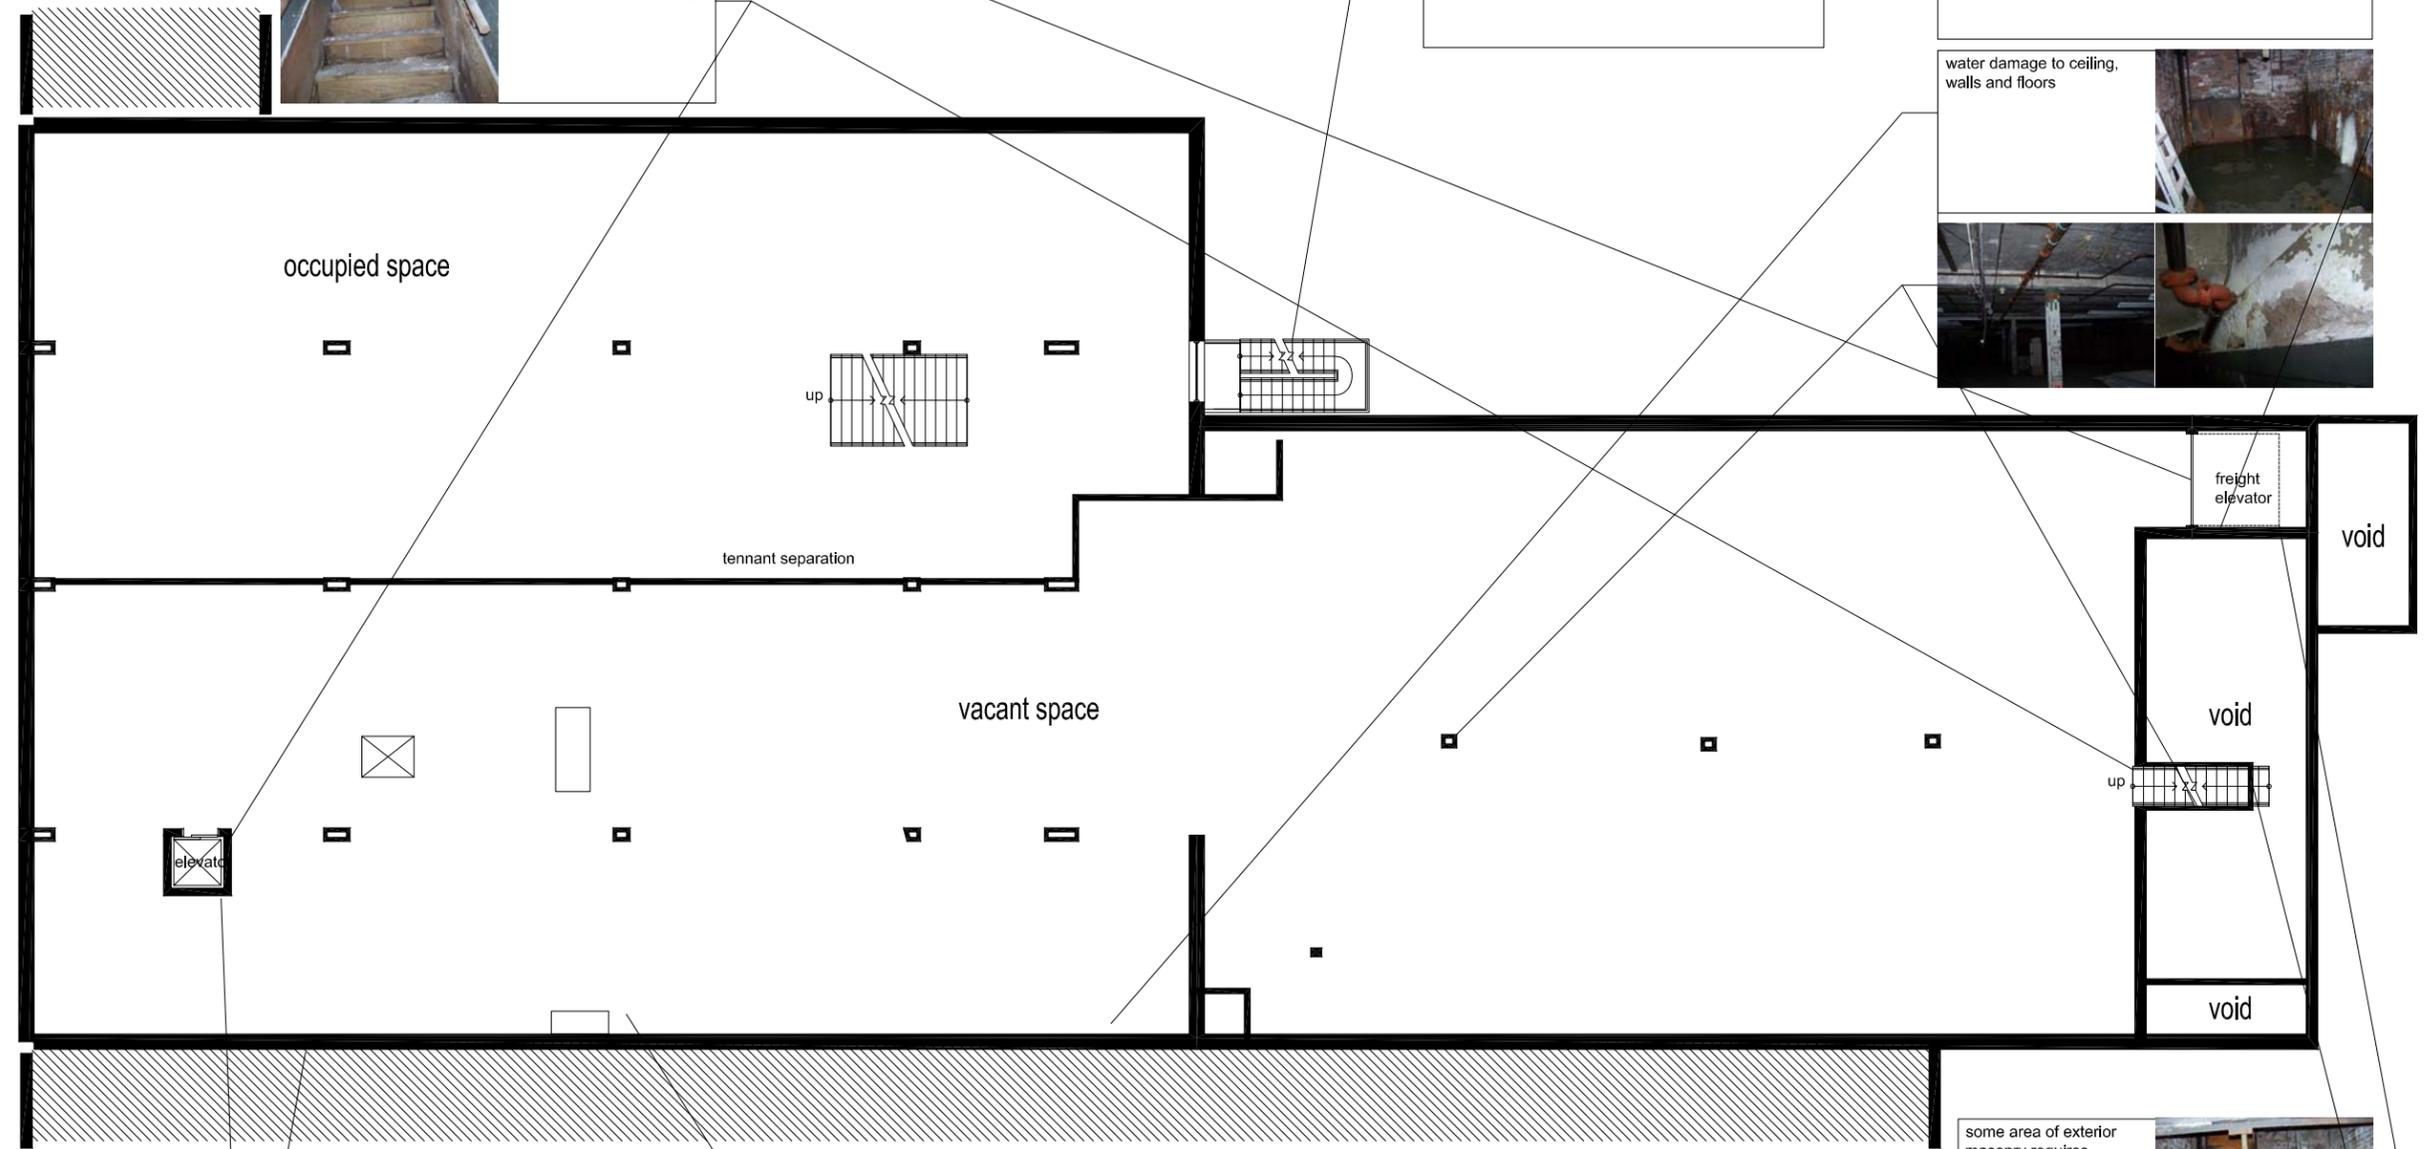
Freight elevator does not have any fire-rating opening protectives on any floor

Vertical exit enclosure - fire rating of walls, ceiling and doors is not retain.

No thermal or moisture barrier was observed

there is no handicap access from first floor (mercantile portion of the floor) to either: basement, mezzanine, upper floors or mezzanine

There is no bathrooms in basement

water damage to ceiling, walls and floors

some area of exterior masonry requires repointing

The only access stair has low overhead clearance the stair is too narrow

The fire separation of the elevator shaft was not determined. Opening protective of the shaft does not comply with code. There was no HC signs. Controls are not in compliance with Code. The car compliance was not determined.

Code classifies use of this floor as M - Mercantile occupancy. Fire wall separating from other buildings should be 3 hour rated

there is some limited existing HVAC equipment this area has no ventilation

there is musty smell indicating presence of mould there is a high level of dampness

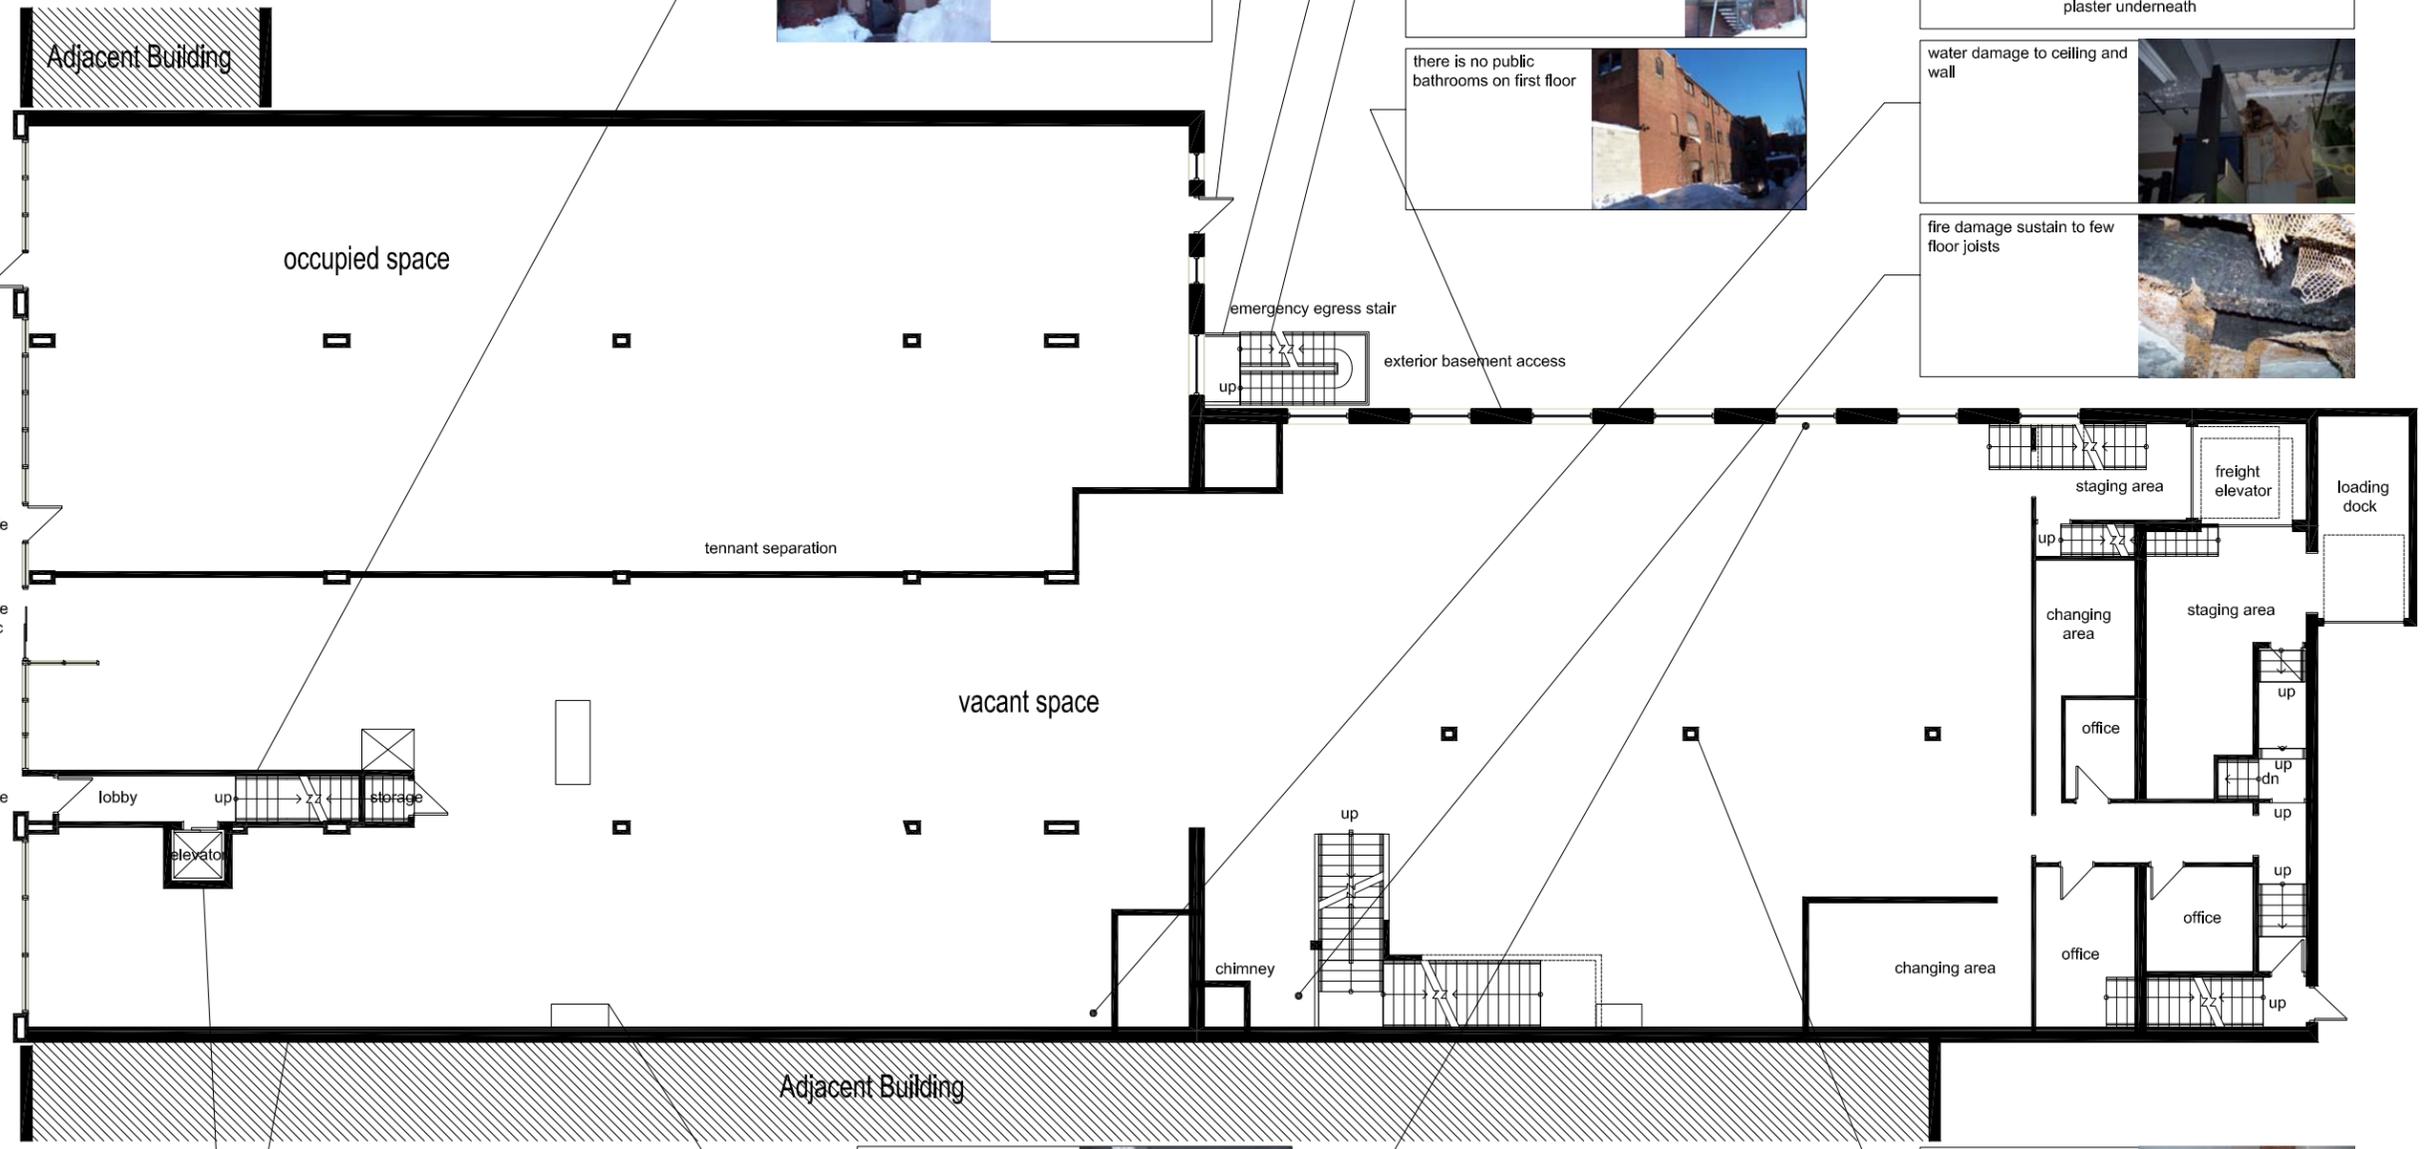
there is no handicap access from first floor (mercantile portion of the floor) to either: basement, mezzanine, upper floors or mezzanine

there is no public bathrooms on first floor

Exterior envelope: masonry walls, windows, doors and roof do not comply with current energy code requirements.

Exterior masonry wallshave some water and ice damage.

Vertical exit enclosure - fire rating of walls, ceiling and doors is not retain. Storage underneath stairs does not have 2 hour fire separation from stair enclosure.

existing hardwood floor is covered with carpet. The floor is not even and wet

existing wood windows may have lead paint

there is musty smell on the back of the building indicating presence of mould

The fire separation of the elevator shaft was not determined. Opening protective of the shaft does not comply with code. There was no HC signs. Controls are not in compliance with Code. The car compliance was not determined.

fire separation of occupancies M - Mercantile of the first floor and R-3 residential occupancy of second floor is not required

Code classifies use of this floor as M - Mercantile occupancy. Fire wall separating from other buildings should be 3 hour rated

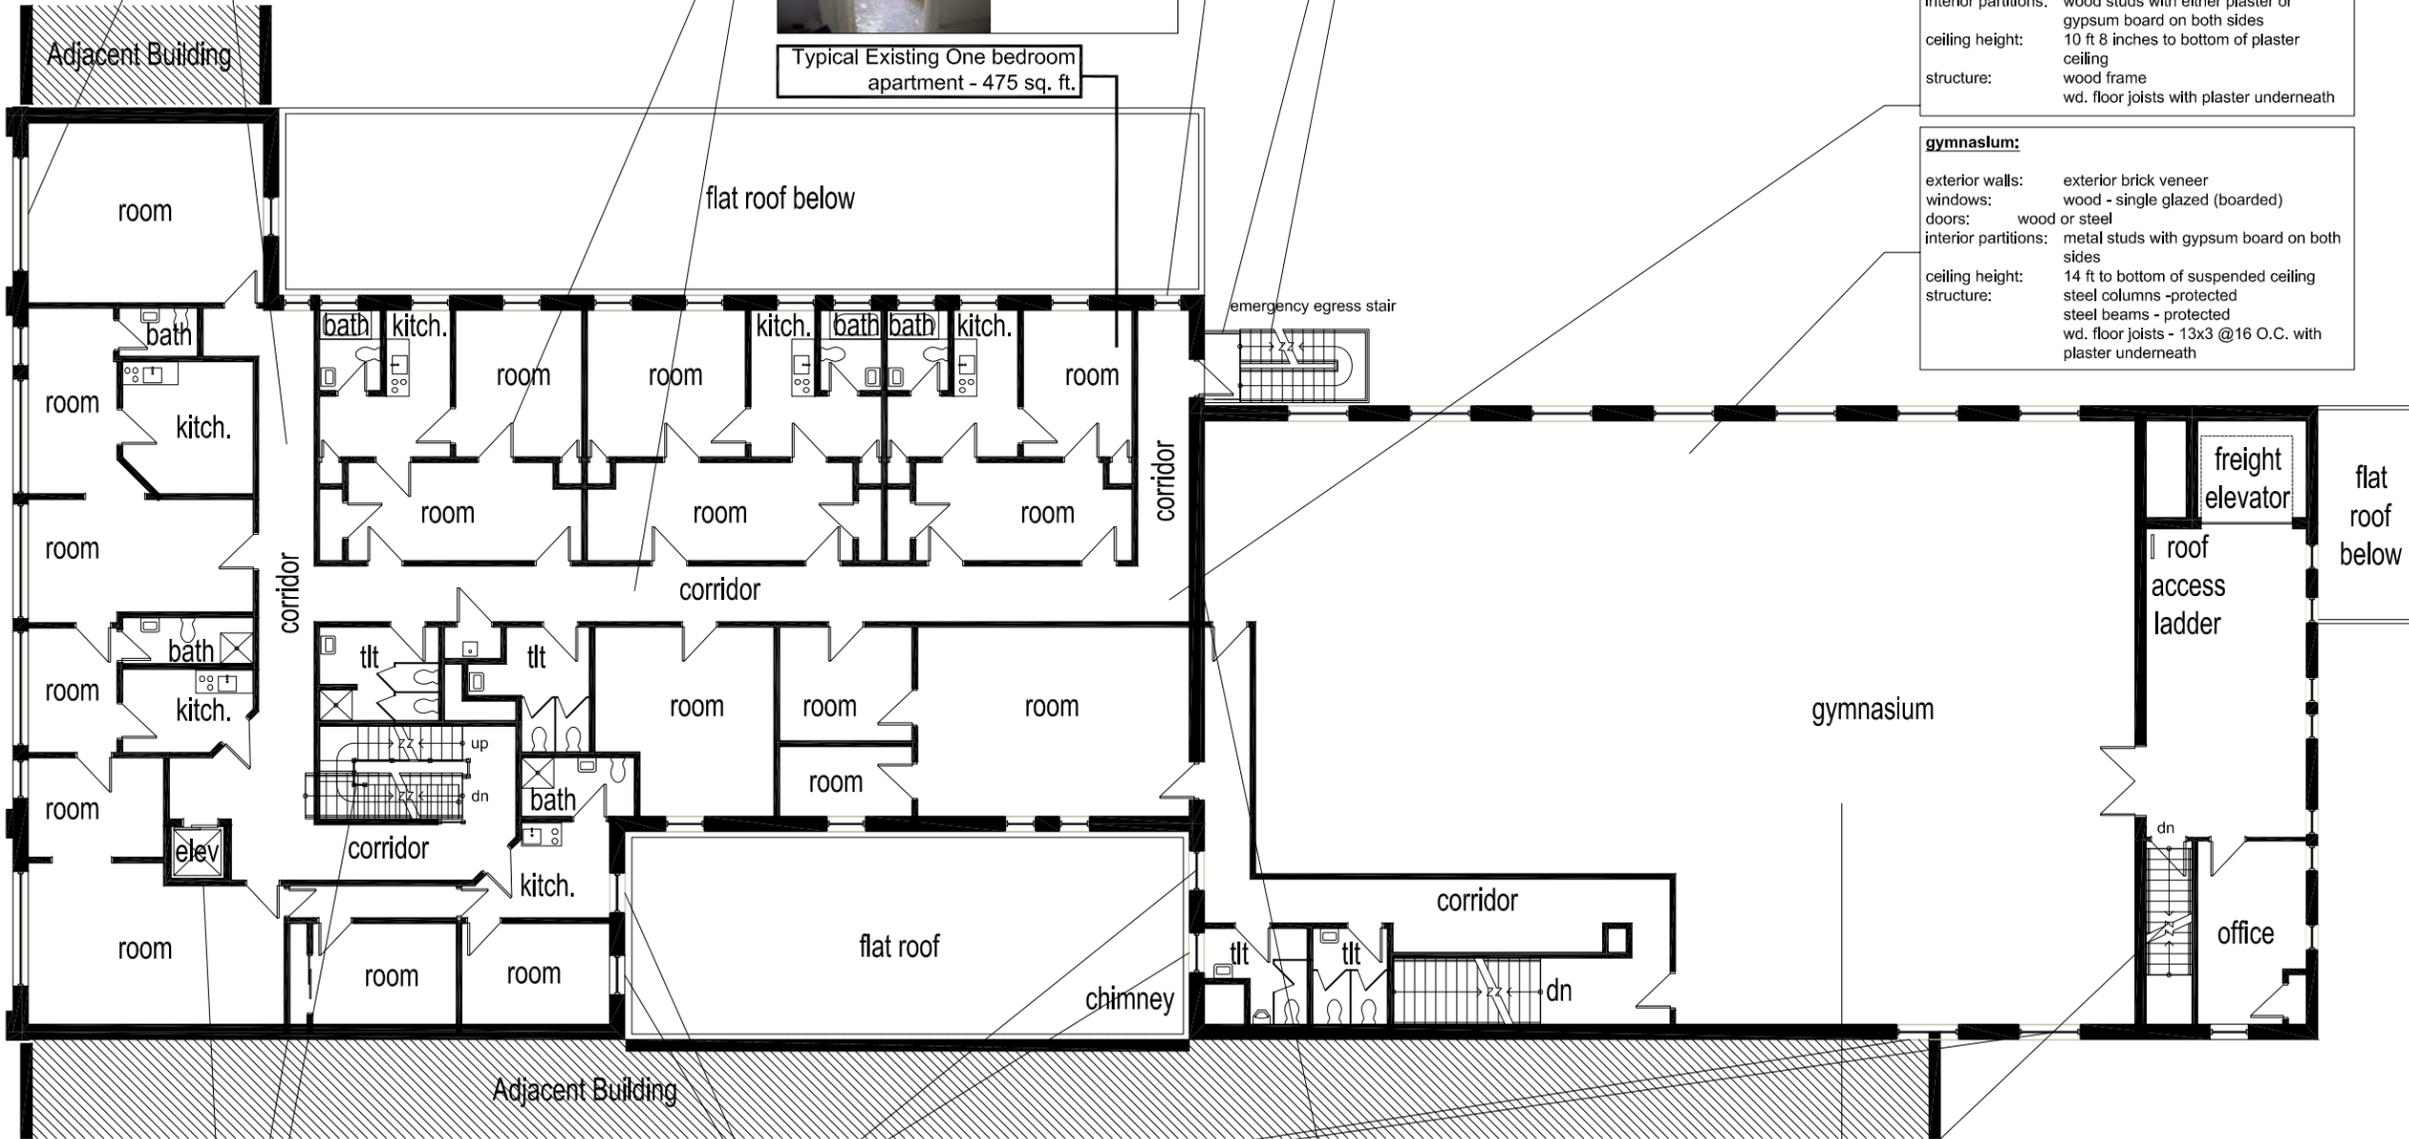
- Existing windows in the Main Street elevation have window sill at 16" above floor, but the glass panels are not safety glass, as required by code.
- All corridor walls and doors are not in compliant with Code's requirement of a half an hour rating.
- Most of doors are less than 3 ft in width. All doors have knobs and do not comply with ADA.
- Dead-end corridor is 27 feet long -max. allowed by Code is 25 feet.

- Existing windows are single glass panels
- All appliances are not code compliant
- Typical Existing One bedroom apartment - 475 sq. ft.

- There is no handicap access to this floor.
- Existing exterior steel emergency egress stair connect two upper floors to the ground level. The threshold is more 8 inches required by Code. The guardrail is 32 inches high - Code requires 36 inches. The raisers are 8 inches - Code requires 7 inches.

- The fire separation of the elevator shaft was not determined. Opening protective of the shaft does not comply with code. No HC signs. Controls are not in compliance with Code. The car compliance was not determined.
- Fire separation of occupancies M - Mercantile of the first floor and R-3 residential occupancy of second floor is not required
- Code classifies use of this floor as R-3 - Residential occupancy. Fire wall separating from other buildings should be 3 hour rated

- Six existing windows are not fire rated as required by Code.
- Existing stair is not located within 2 hour rated enclosure. Raisers are 7 3/4 inches - Code requires 7 inches. Existing guard rail at 32 inches. Overhead clearance on run to the third floor is 6 feet 3 inches.
- None of spaces have any ventilation.

- Existing wood windows may have lead paint. There is musty smell on the back of the building indicating presence of mould. Some floor finishes indicate the asbestos contents.

- Existing stair is do not have landing on the top of stair. Existing stair do not have area of refuge.

- some area of exterior masonry requires repointing
- most of windows are boarded and in poor condition

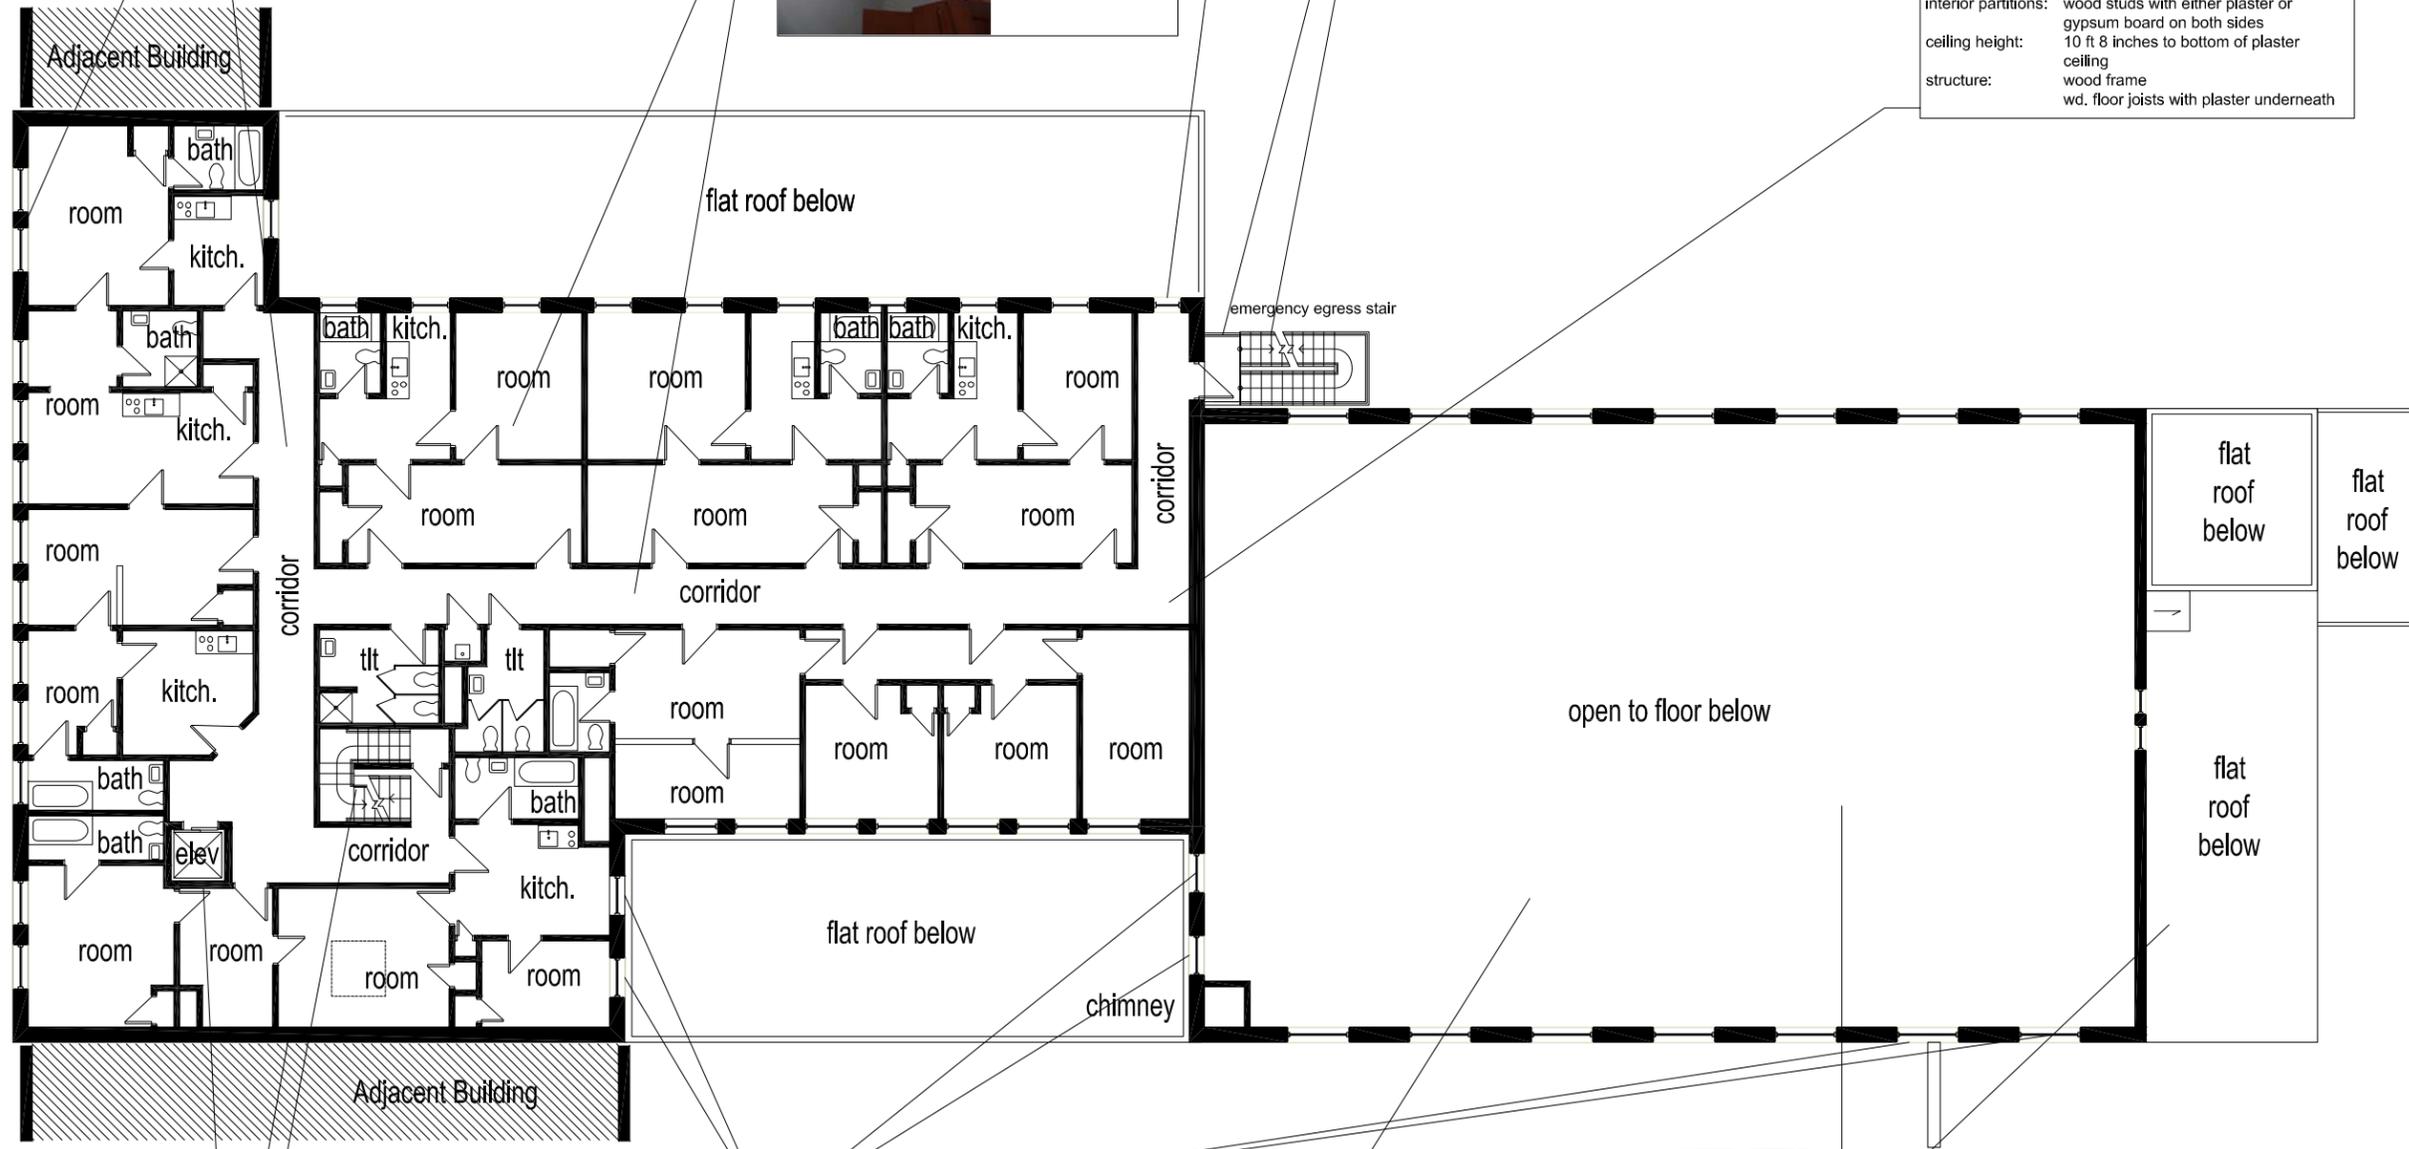
- Existing windows in the Main Street elevation have window sill at 16" above floor, but the glass panels are not safety glass, as required by code.
- All corridor walls and doors are not in compliant with Code's requirement of a half an hour rating.
- Most of doors are less than 3 ft in width. All doors have knobs and do not comply with ADA.
- Dead-end corridor is 27 feet long -max. allowed by Code is 25 feet.

Existing windows are single glass panels

All appliances are not code compliant

There is no handicap access to this floor.

Existing exterior steel emergency egress stair connect two upper floors to the ground level. The threshold is more than 8 inches required by Code. The guardrail is 32 inches high - Code requires 36 inches. The raisers are 8 inches - Code requires 7 inches.

The fire separation of the elevator shaft was not determined. Opening protective of the shaft does not comply with code. No HC signs. Controls are not in compliance with Code. The car compliance was not determined.

Code classifies use of this floor as R-3 - Residential occupancy. Fire wall separating from other buildings should be 3 hour rated

Ten existing windows located less than 10 feet above adjacent room are not fire rated as required by Code

Existing stair is not located within 2 hour rated enclosure. Raisers are 7 3/4 inches - Code requires 7 inches. Existing guard rail at 32 inches. Overhead clearance on run to the third floor is 6 feet 3 inches.

None of spaces have any ventilation.

Existing wood windows may have lead paint. There is musty smell on the back of the building indicating presence of mould. Some floor finishes indicate the asbestos contents.

Existing stair is do not have landing on the top of stair. Existing stair do not have area of refuge.

some area of exterior masonry requires repointing most of windows are boarded and in poor condition

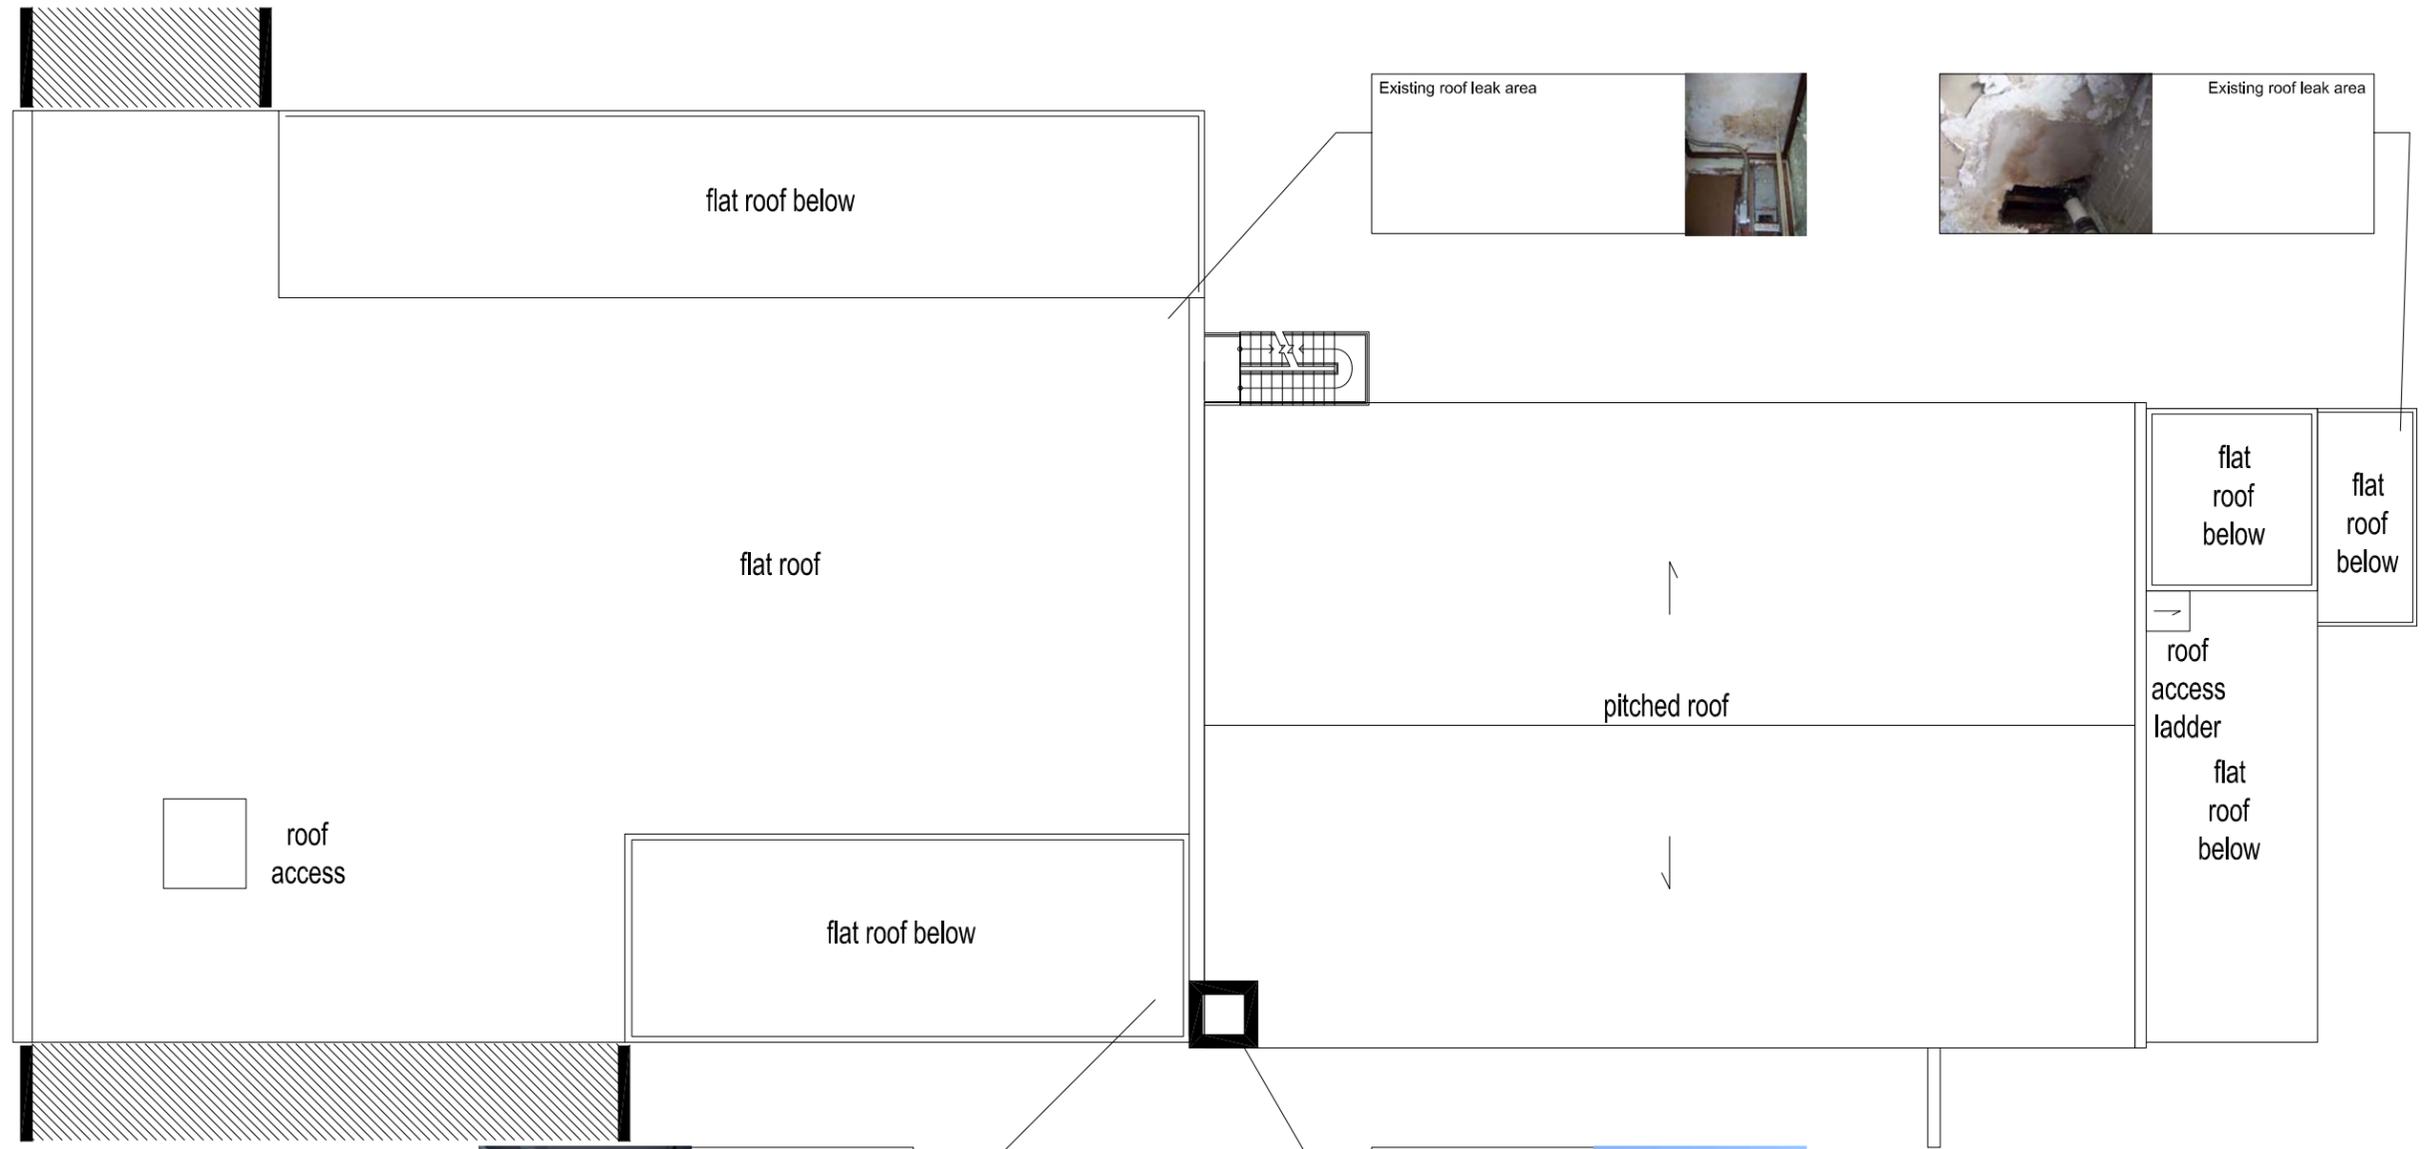
ROOF PLAN

The building has three types of roofs: pitched (above gymnasium), flat wood structure and metal deck on steel beams (over the newest loading dock addition). The evaluation sheet of the roof plan shows the locations of the roof leakage. There is a number of malfunctioning gutters, downspouts and water leaders. All roofs have to be inspected for the structural soundness and condition of roofing systems. None of the roof systems have any thermal insulation materials.
