The Downtown Housing Analysis of Impediments and Architectural Feasibility Study

360 MAIN STREET
Middletown, CT

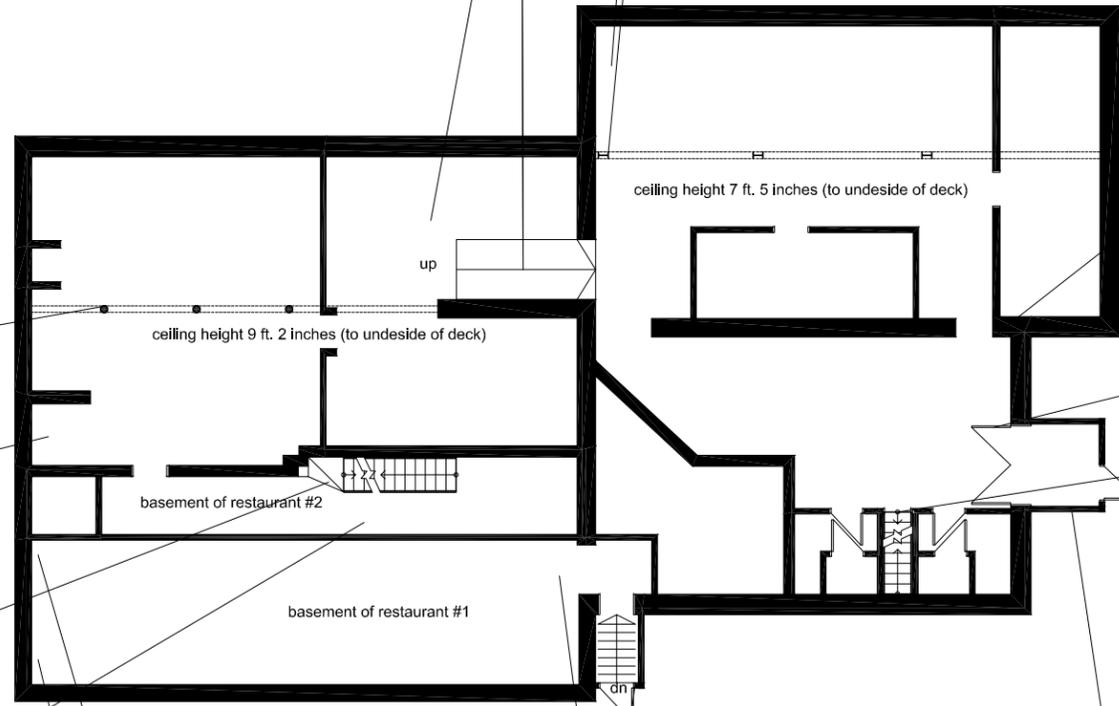
The cast iron column near the foundation wall facing Main Street. The columns support solid wood beam.

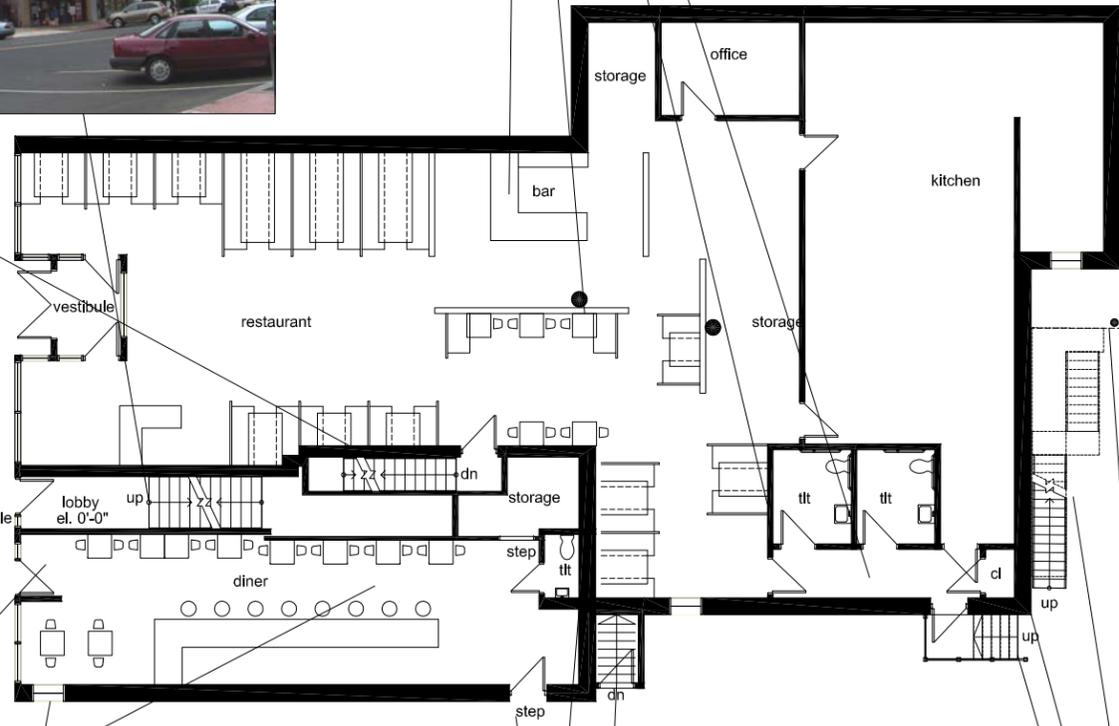
The existing paved yard is being flooded due to damaged or non-existing drainage system

existing downspout is damaged

existing exterior emergency egress stair not compliant with current code

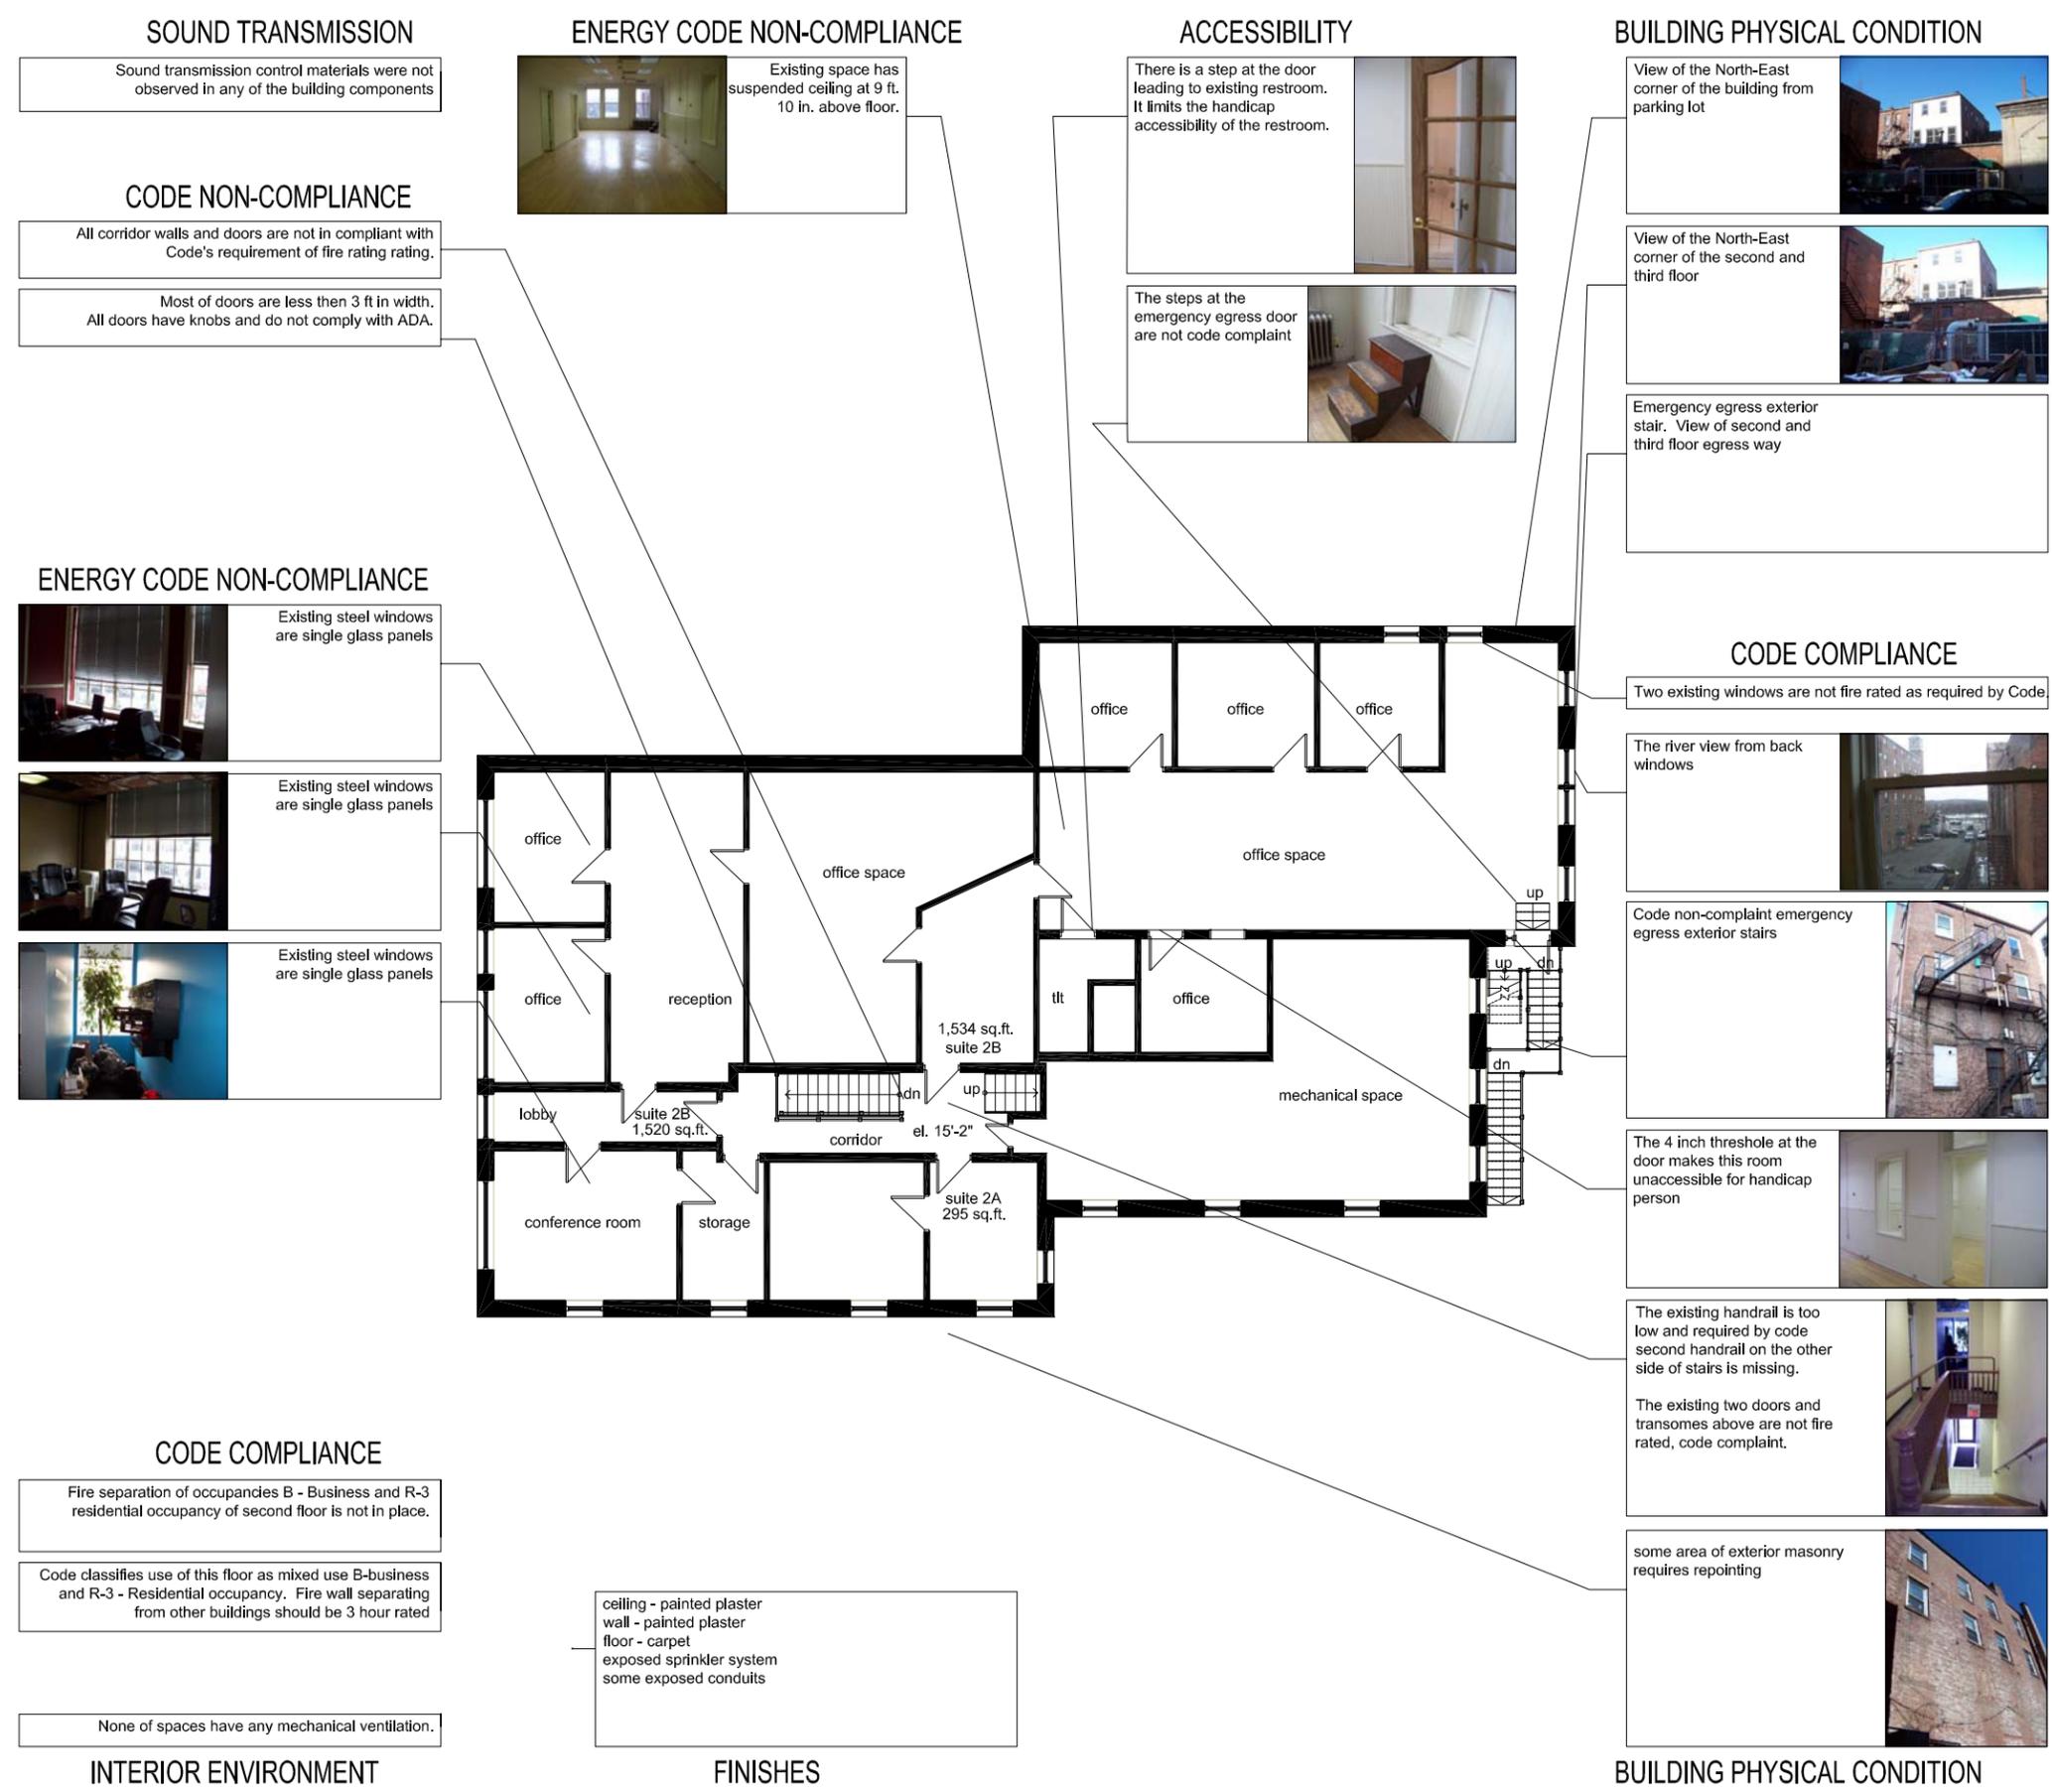
CODE NON-COMPLIANCE
 All corridor walls and doors are not in compliant with Code's requirement of fire rating rating.

Most of doors are less then 3 ft in width. All doors have knobs and do not comply with ADA.

ACCESSIBILITY
 There is a step at the door leading to existing restroom. It limits the handicap accessibility of the restroom.

The steps at the emergency egress door are not code compliant

ENERGY CODE NON-COMPLIANCE
 Existing steel windows are single glass panels

CODE COMPLIANCE
 Two existing windows are not fire rated as required by Code.

The existing handrail is too low and required by code second handrail on the other side of stairs is missing.

The existing two doors and transoms above are not fire rated, code complaint.
 some area of exterior masonry requires repointing

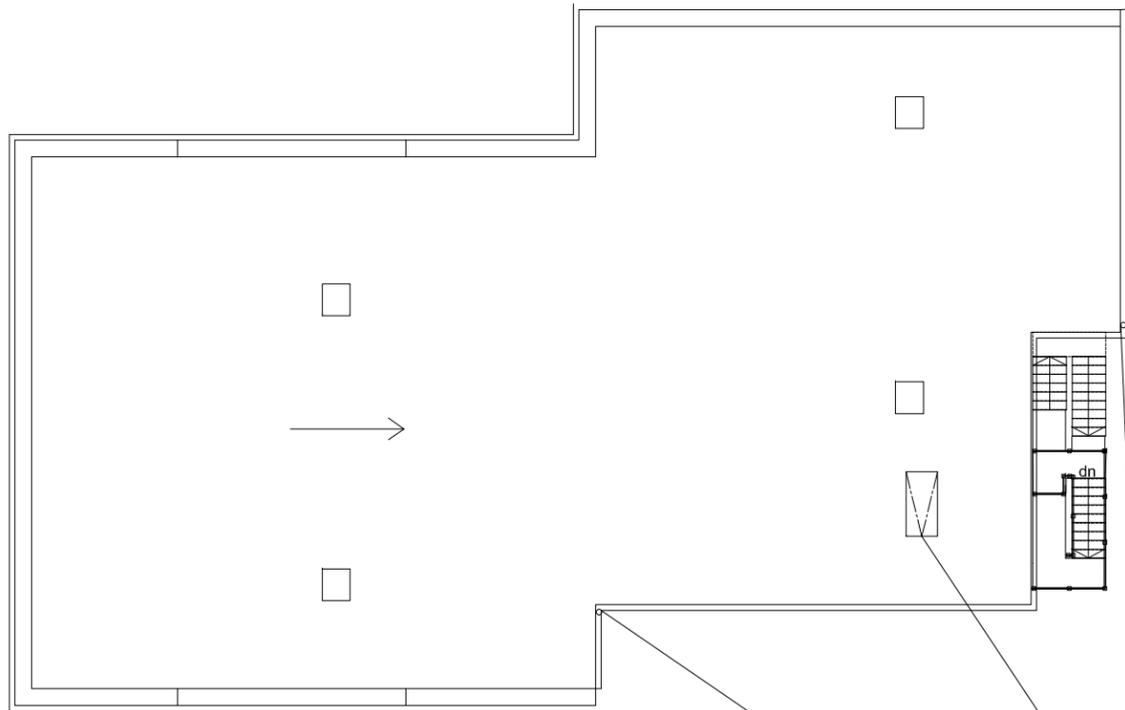
The existing damaged downspout

The existing roof access hatch is located in apartment 3C.

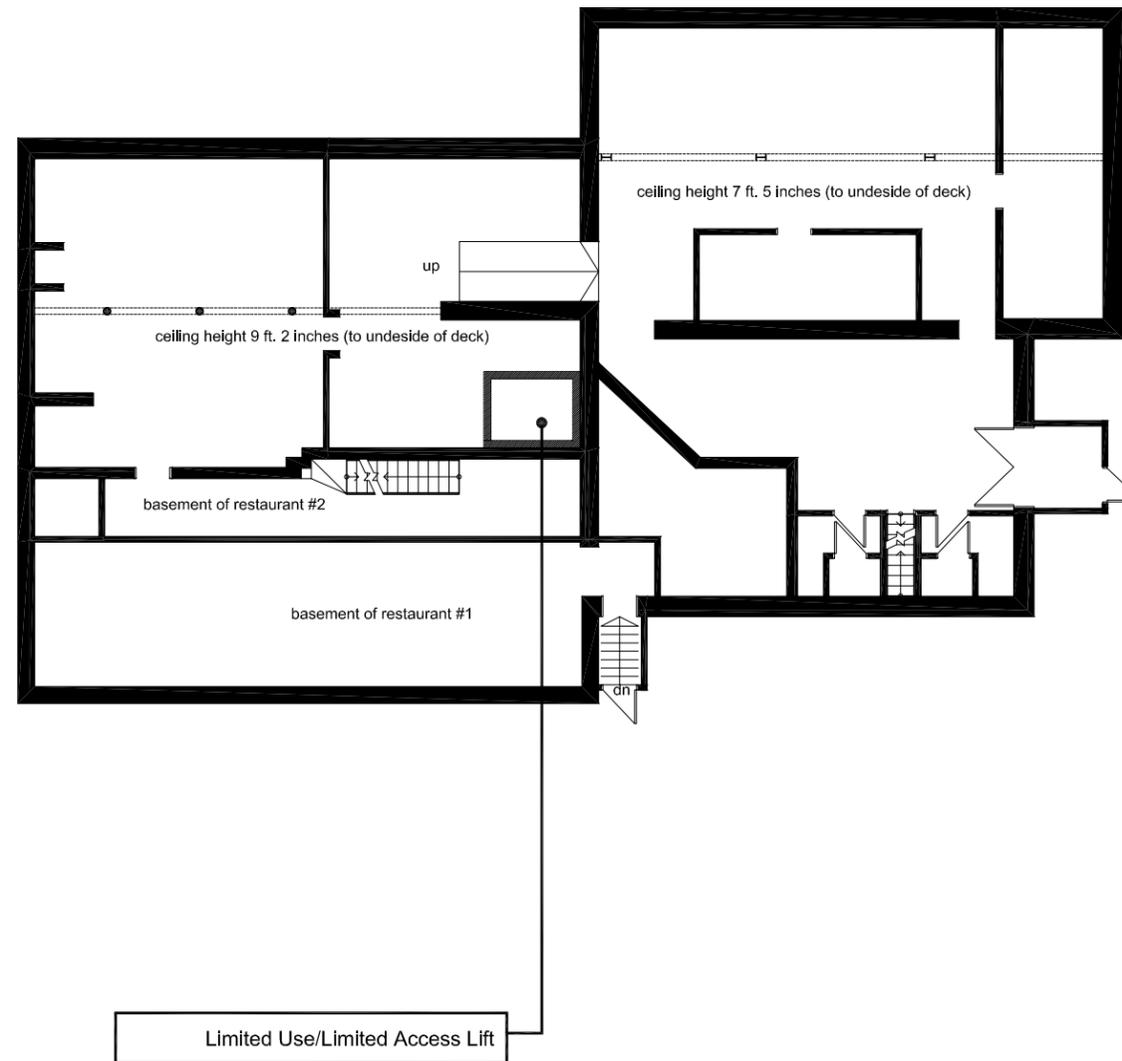
PROPOSE REHABILITATION OF THE UPPER FLOORS FOR
 HANDICAP ACCESSIBILITY
BASEMENT

New corridor providing access to Limited Use/Limited Access Lift
