**Evaluation of Athletic  
Fields & Parks**  
Middletown, Connecticut  
April 8, 2015

**Prepared for:**  
City of Middletown  
245 DeKoven Drive  
Middletown, Connecticut 06457

MMI #2708-09-3

**Prepared by:**  
MILONE & MACBROOM, INC.  
99 Realty Drive  
Cheshire, Connecticut 06410  
(203) 271-1773  
[www.miloneandmacbroom.com](http://www.miloneandmacbroom.com)

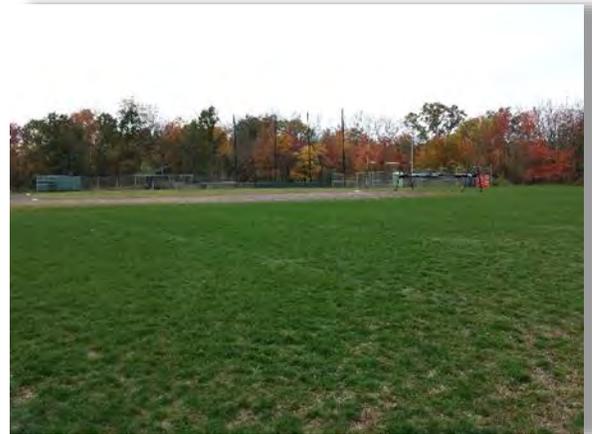
Keigwin Middle School is located on Spruce Street just north of the Middletown High School. The athletic field parcel is located across the street from the school building. The site is a large open lawn area with a baseball diamond located between two striped football practice areas. The site is used primarily for school gym activities and middle school football practice. The baseball diamond appeared to have no recent use. There is no vehicular access although the paved pedestrian walk could accommodate emergency vehicles. Paved access crosses Spruce Street as well as East Swamp Brook and continues along the western edge of the open lawn area.

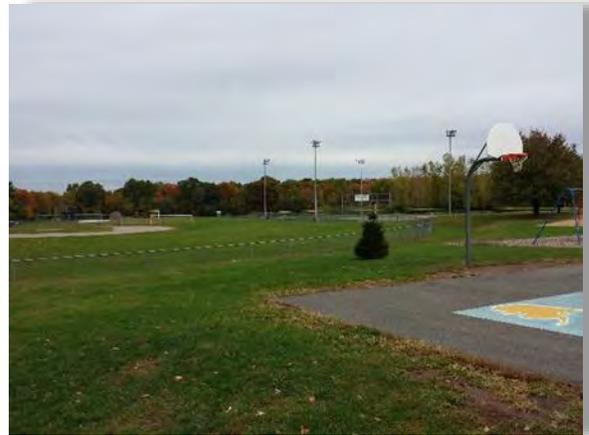
**Moody School**

Moody School is located on Country Club Road, east of the I-91 corridor. The site contains multiple athletic facilities including one Little League field, two softball fields, one soccer field, and two basketball

courts. The soccer field and larger softball field, named Ray Jacobs Field, have lighting. The athletic facilities are located at the rear of the school and are terraced south to north with steep slopes in between a number of the fields. Parking is a paved lot at the southwest corner of the school. Pedestrian access is along the western edge of the fields with a paved spur between the soccer and softball fields to the north. The site has a permanent restroom and storage building located at the north end. There is a connection to a trail at the north end, which connects to the adjacent Smith Park parcel.

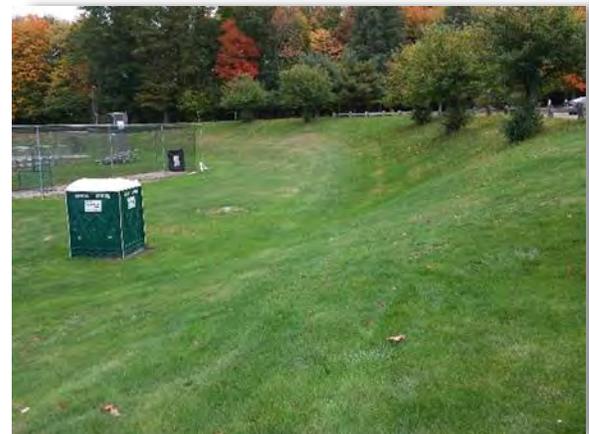
**Snow School**

Snow School is located on Wadsworth Street, southwest of Wesleyan University. The athletic facilities are located at the front of the school along Wadsworth Street and include three softball fields and a multipurpose overlay field. One of the softball fields appears to be unused. The site has other site amenities including a batting cage and four bullpens. Parking is located on an upper terrace just south of the fields. Pedestrian access is limited due to the steep slope between the fields and parking. There are presently no sidewalks from the parking to the fields and no accessible connections between the fields.

Improvements to Snow School aim primarily to improve accessibility and turf conditions. Sidewalks are proposed to connect the existing parking areas to the fields providing accessible routes and a direct route with a proposed set of stairs located near field No. 2. Painted crosswalks will aid in directing pedestrian routes and connect existing and proposed sidewalks. Field improvements will include turf and infield renovations to fields No. 1 and No. 2. Due to the lack of use of field No. 3, it is proposed to be removed and the area restored to open space to provide additional multiuse field space. The multiuse field is slated for turf restoration, and a perimeter fence will be installed along Wadsworth Street to keep errant balls from entering the road. Other site improvements include a restroom and storage building located between fields No. 1 and No. 2, new portable bleachers and pads, and restoration of the bullpens and batting cage stone dust surfaces. Proposed improvements for Snow School total \$710,000.

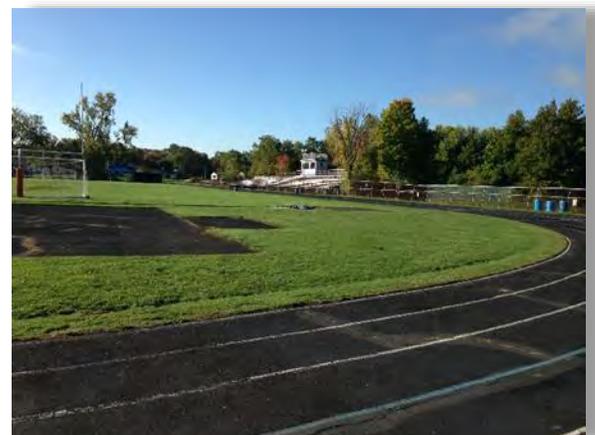
**Woodrow Wilson Middle School**

Woodrow Wilson Middle School is located on Hunting Hill Avenue. Pat Kidney Field abuts the property to the west. The athletic facilities are located across the street to the west and include a multiuse field surrounded by a six-lane track with grandstand bleacher seating. The site also contains a restroom/concession building and a storage building and shed. There are no public parking facilities for the athletic complex. Paved pedestrian access is provided to the track, field, and bleachers.

Due to the numerous unsafe conditions, including fall hazards from the grandstands and large cracks in the track surface, coupled with the nonstandard track and severe lack of parking, it was decided that a global view should be taken of both the Woodrow Wilson site and Pat Kidney Park to determine if a safer, more efficient and functional park could be established. While each of these sites is summarized and estimated individually, it is the intent that both projects would be completed in concert to achieve optimal results for the community. A signature city park can be implemented that greatly enhances safety, accessibility, field availability, and the city's athletic programs.

Complete removal of the existing grandstands, bleachers, press box, track, multiuse field, concession building, field lighting, and ancillary site items is recommended. Once cleared, the site will have installed a six-lane nonequal quadrant track suitable to hold competitive scholastic track meets, a synthetic multiuse field, new grandstand bleachers and press box, concession building with restrooms and storage, and paved parking to accommodate 13 parking spaces including six handicap-accessible spaces. Redesigning the track and field will push the grandstand improvements downslope into the area

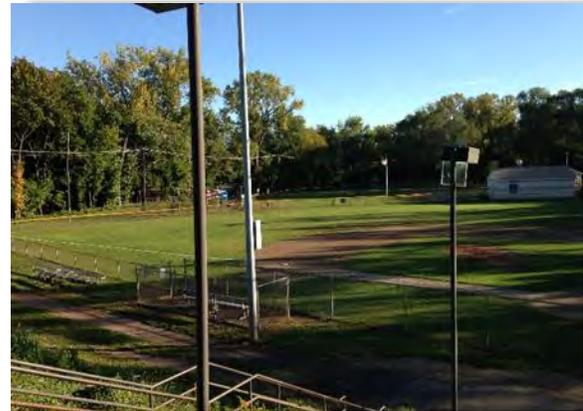
Hubbard Park is a 3.5-acre site located between Main Street and East Main Street just north of Route 17. The park is a Little League complex consisting of two baseball fields. The west field adjacent to Main Street has lights. The site has additional amenities including press boxes, concession/restroom building, and batting cages. Primary site access is from the southeast corner of the site into a paved parking lot of approximately 35 spaces. Paved pedestrian access is limited to the west field. Gravel surfacing surrounds the concession building and provides limited access to the east field. There is a set of concrete stairs connecting the site to Main Street.

Proposed improvements to Hubbard Park include the conversion of both baseball fields to synthetic turf, installing field lighting for field No. 2, paved walks to provide accessible routes to the fields and concession building, striping of the parking lot including accessible spaces, and repair of the stair access from Main Street. Proposed improvements for Hubbard Park total \$2,340,000.

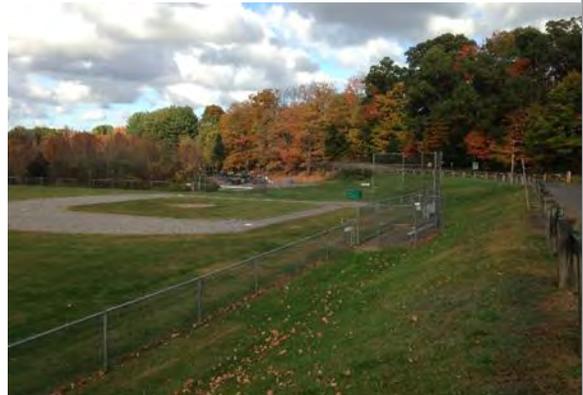
Smith Park is an 80-acre site located on Country Club Road, east of the I-91 corridor. The park has one Little League baseball field and one soccer field as well as a playground, a pavilion, horseshoe pits, shuffleboard courts, and walking/hiking trails. Paved parking is provided at two locations. The first is located near the baseball field at the park's entrance, and the second parking area is located at the upper portion of the site at the soccer field. Pedestrian access is limited to perimeter walking paths and wooded trails. The site has no permanent restroom facilities.

Recommended improvements at Smith Park include renovations to the Little League field's turf and infield and turf renovations to the soccer field. Sidewalk connections will be installed to provide accessible routes to amenities at both fields. Additional improvements include formally striping parking spaces within the upper parking lot, including two accessible spaces, and replacement of the portable bleachers on site. Due to security concerns, an access gate with remote control through a smartphone will be installed to limit access to the upper soccer field and parking lot. Proposed improvements for Smith Park total \$115,000.

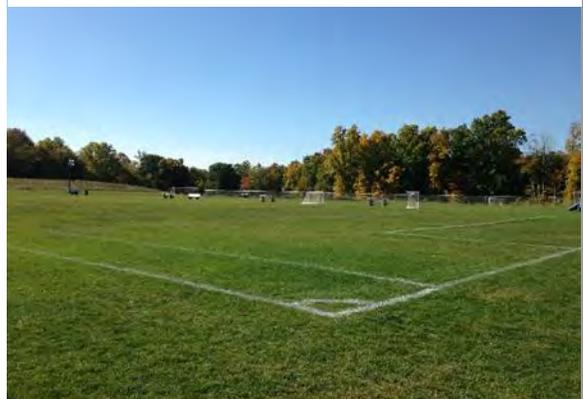
The Country Club Road Soccer Complex is a 40-acre site located off Country Club Road, east of the I-91 corridor. The complex consists of two full-size soccer fields utilized for competitive play and two undersized fields used for practice and open play. One of the competitive fields has lights. Access to the complex is up a steep, paved drive from the northeast. The parking lot is a reclaimed asphalt surface. There is a paved bituminous concrete walk between the two full-size fields. The site has no permanent restroom facilities.

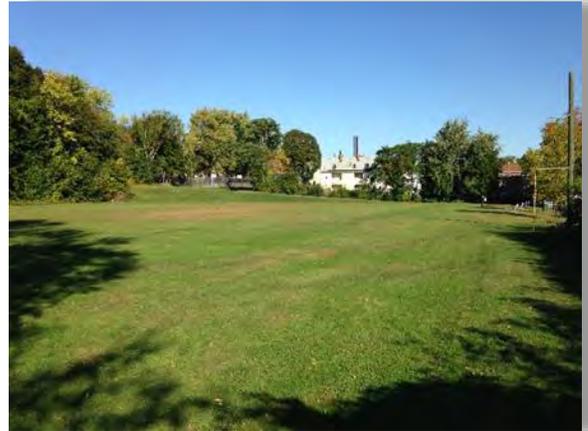
**McCarthy Park**

McCarthy Park is a 2.5-acre site located on Hotchkiss Street. The park consists of an open lawn area, one basketball court, one tennis court, and a swing set. The courts are located side by side. There is no parking area provided. Pedestrian access is provided from Hotchkiss Street along a paved walk to the basketball and tennis courts.

Recommended improvements at McCarthy Park are limited to the removal of the basketball and tennis courts toward the rear of the site due to underuse, misuse, and safety concerns. This work will be completed by city staff and is not included in the overall master plan budget.

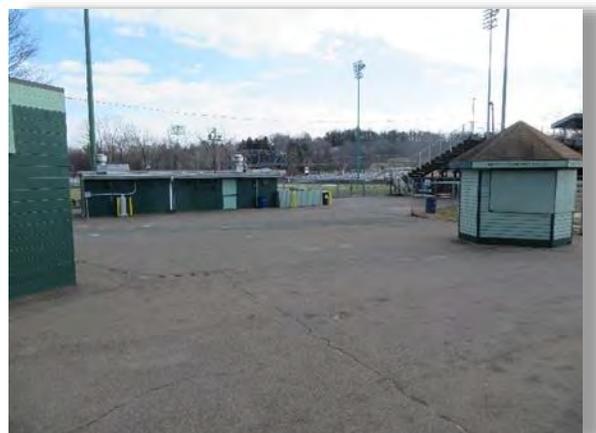
**Palmer Field Entrance**

Palmer Field is a 7-acre site located on Bernie O'Rourke Drive. The complex is a multiuse baseball, soccer, and football stadium with football and soccer as an overlay field within the baseball outfield. Stadium seating is provided for the baseball diamond and along the east side of the football/soccer field. The complex also contains the Middletown Sports Hall of Fame as well as concession and restroom buildings. Paved parking is provided to the west

of the stadium with an additional unpaved area further to the west. There is also an unpaved parking area to the east of the stadium. Paved pedestrian access is provided to the stadium's bleachers, Hall of Fame, and concession and restroom buildings.

Further improvements to the site include the removal of the grandstand's wood bleacher seats and replacement with aluminum seating. Proposed improvements for Palmer Field total \$570,000.

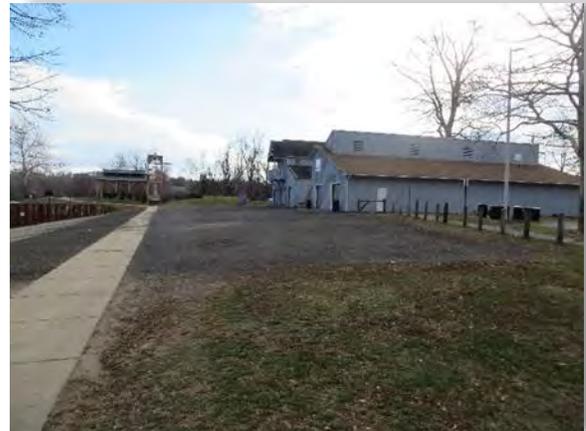
Harbor Park - Boathouses

Harbor Park is a 2-acre linear site located on Harbor Drive along the banks of the Connecticut River. The park consists of a paved riverwalk along the west bank of the river with site amenities including a restaurant, boat launch, restrooms, picnic pavilions, and a gazebo. Paved parking is provided in multiple lots primarily on the southeastern half of the park. Paved pedestrian routes connect the park facilities.

Improvements at Harbor Park are limited to the area between the restaurant and boat ramp. The gravel and millings area between the boathouses and ramp is proposed to be replaced with bituminous concrete to reduce maintenance and migration of loose surface materials. The existing concrete walk that traverses along the top of the boat ramp will be replaced and enlarged to a 5-foot width. The concrete paver area surrounding the open-air pavilion will be replaced with concrete and enlarged slightly. The pavilion itself will remain. Curbing and landscaping enhancements will better define hardscape areas and improve the aesthetic as more and more public events take place within this area of the park. Proposed improvements for Harbor Park total \$585,000.

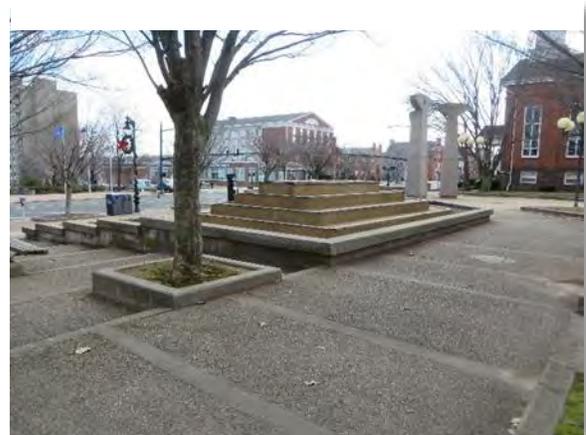
Spear Park is a 2-acre site located at the corner of Main Street and William Street. The park is an urban space containing a terraced, paved plaza with fountain, sculptures, tree grove, and adjacent open lawn area. The paved plaza abuts the Main Street commercial corridor on the east. Public housing abuts the lawn area to the west. The parcel is owned by the Housing Authority.

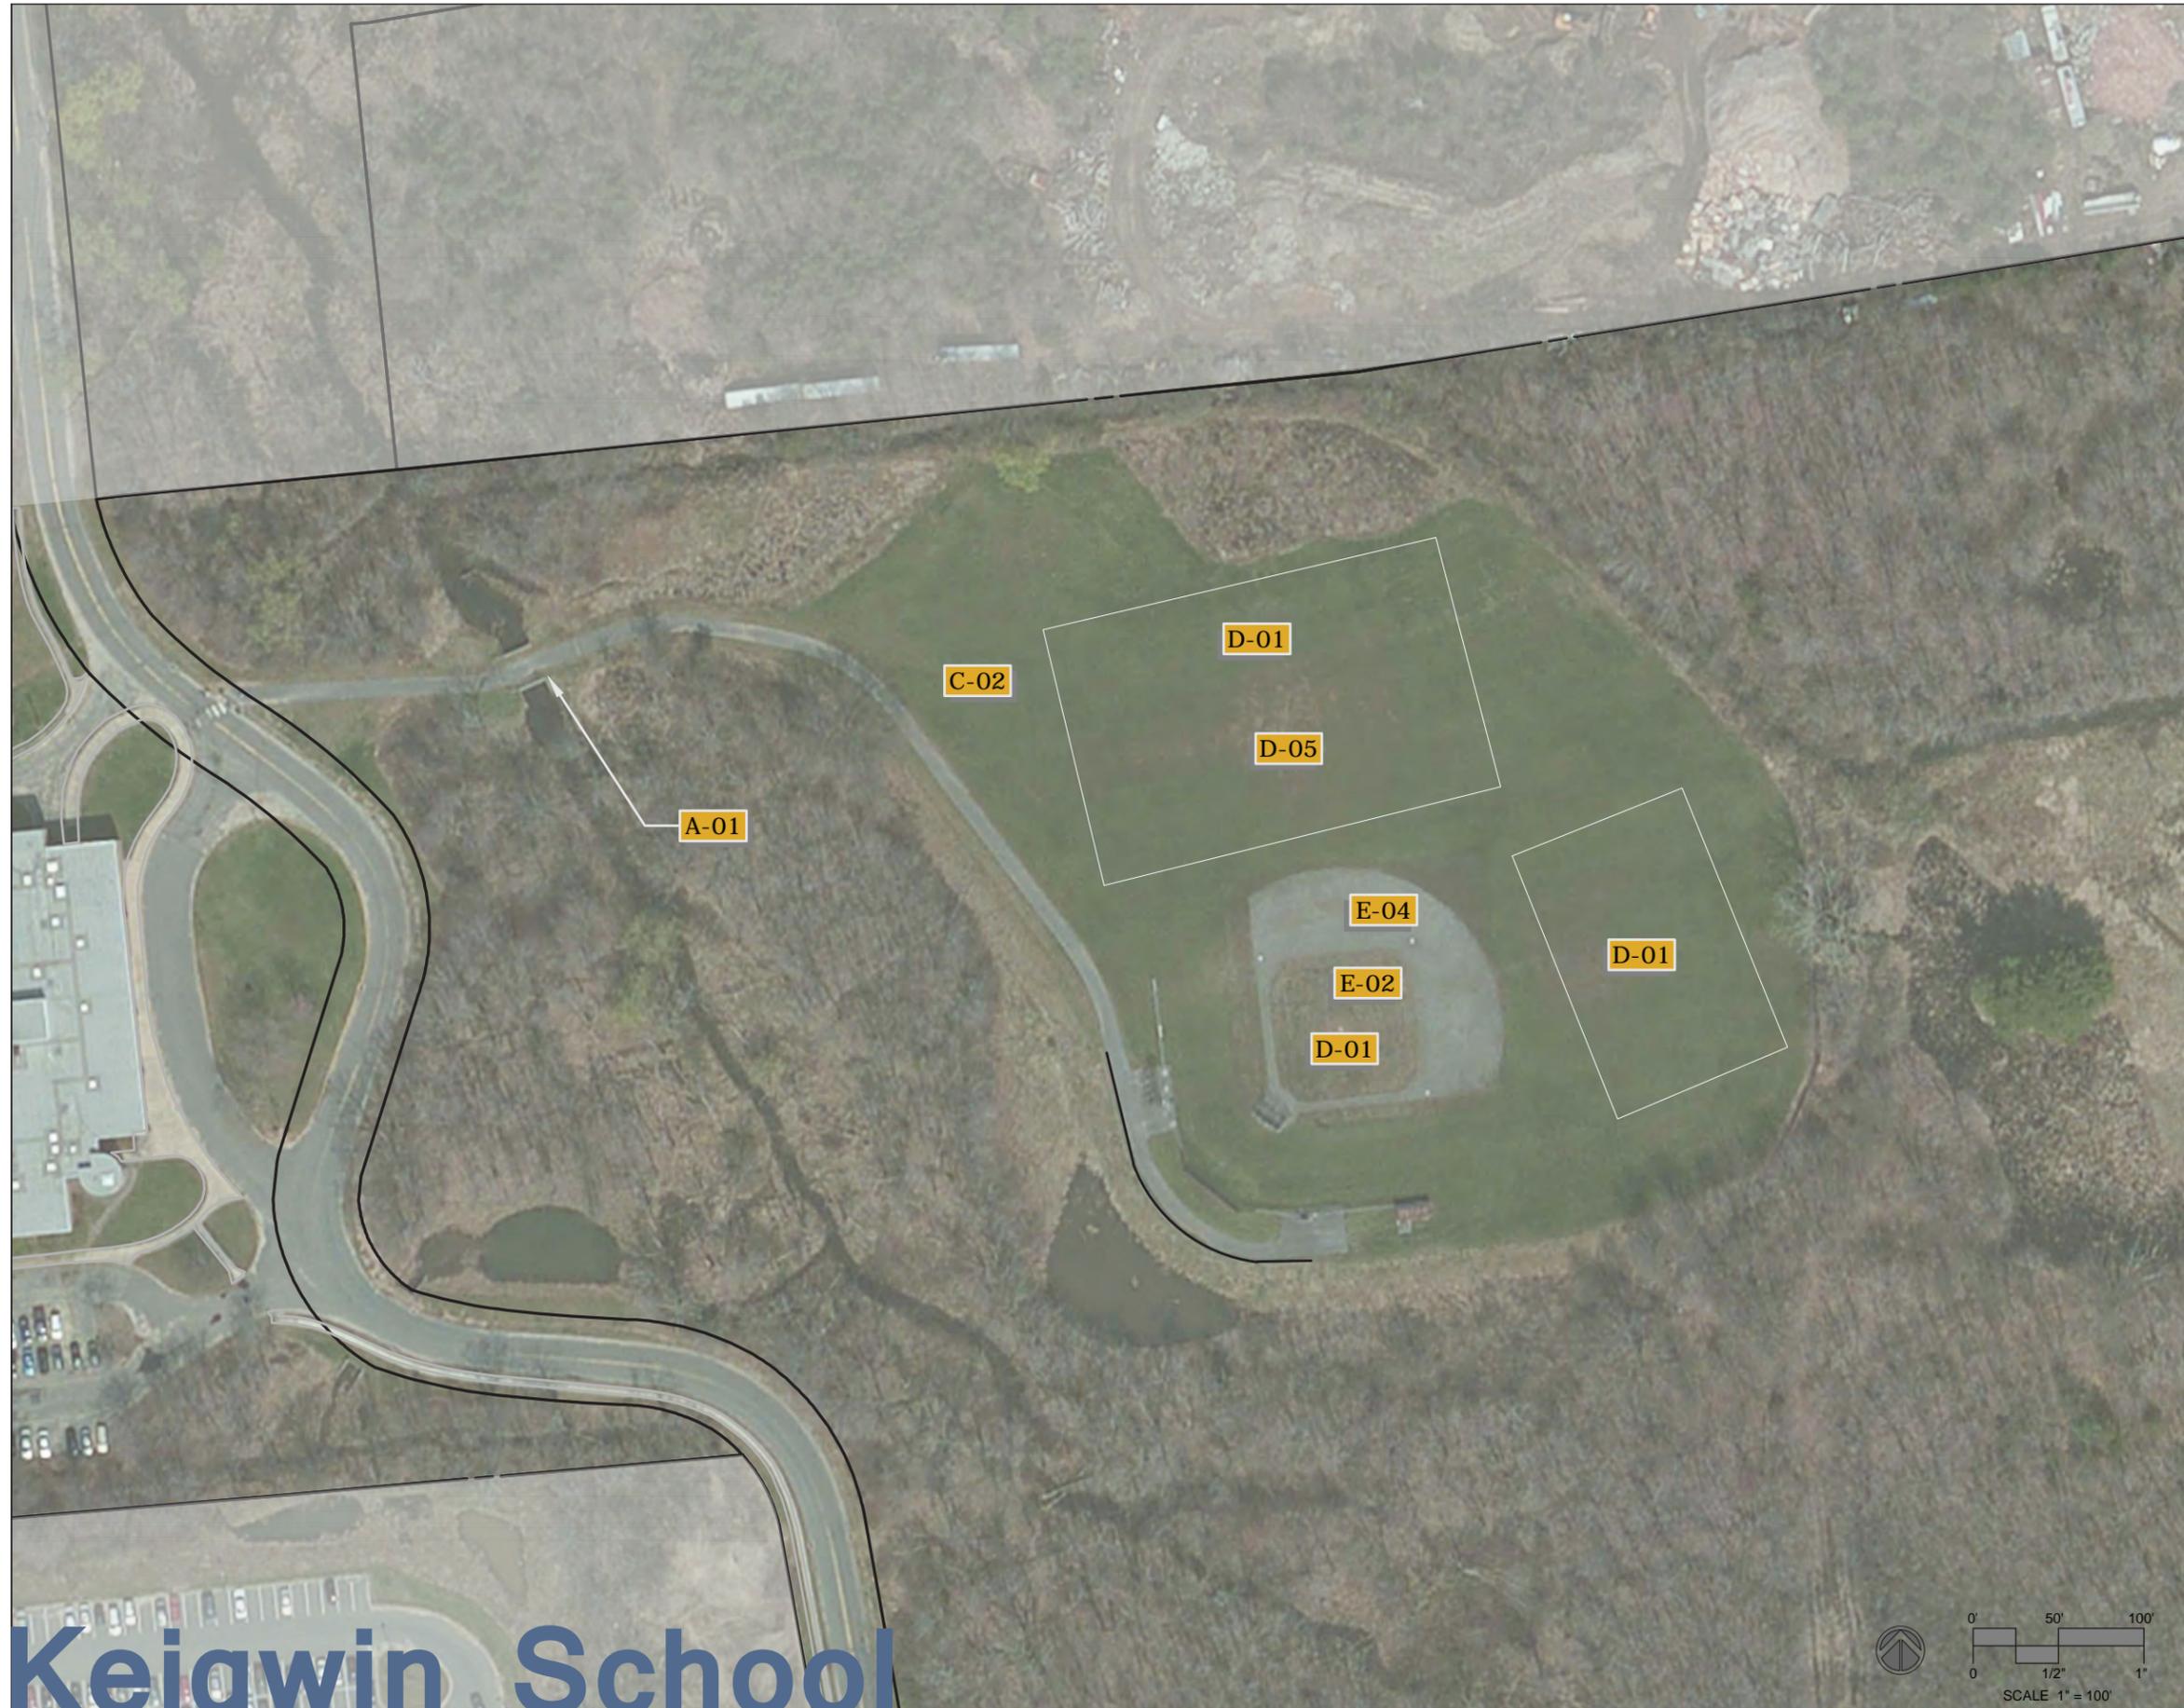
**Keigwin School**

Baseball field appears unused and is in very poor condition.

Heavy use on football practice overlay fields are resulting in compaction, weed growth, worn turf, and bare soil areas.

If facility is used for spectator attended events issues with damaged and lack of perimeter fencing near culvert and stormwater basin should be addressed.

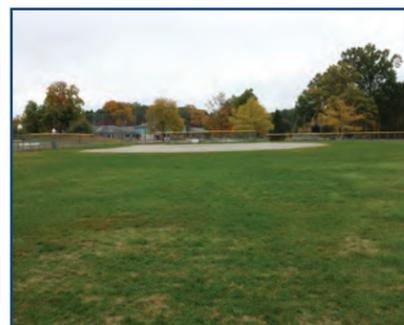
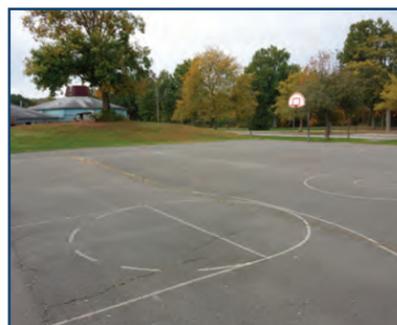
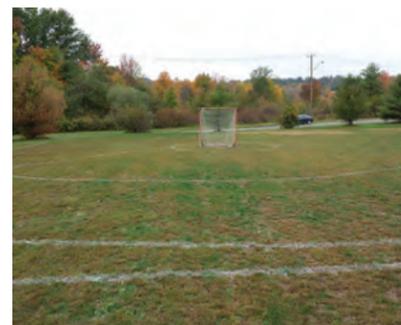
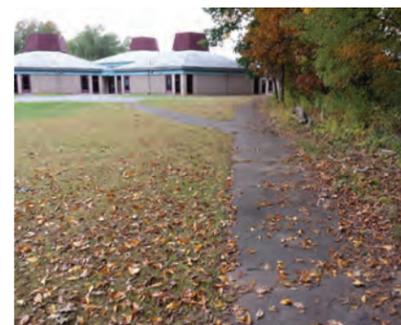
# Lawrence School

<b>General Site</b>	School site with recreational facilities flanking the school on north and south sides
<b>Vehicular Circulation</b>	Paved parking at north side of school
<b>Pedestrian Circulation</b>	Sidewalk from adjacent neighborhood, Paved access to facilities along eastern perimeter
<b>Accessibility</b>	Parking spaces provided, Limited access to softball field and multi-use field, Connections to basketball courts and playgrounds provided
<b>Athletic Facilities:</b>	
<b>Softball</b>	Fair Condition, Low spouts in infield, Weedy and compacted turf, Uneven playing surface in outfield
<b>Multi-Use</b>	Fair/Poor Condition, Turf worn, weedy, and compacted, Uneven playing surface in areas, Striped for Lacrosse at time of evaluation
<b>Basketball</b>	Fair Condition, Some surface cracks, Hoops need nets

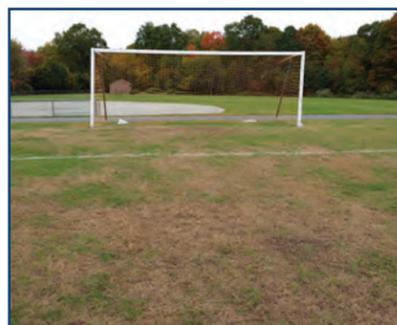
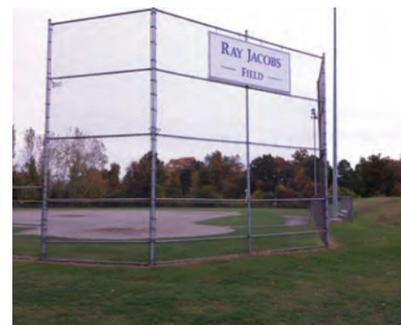
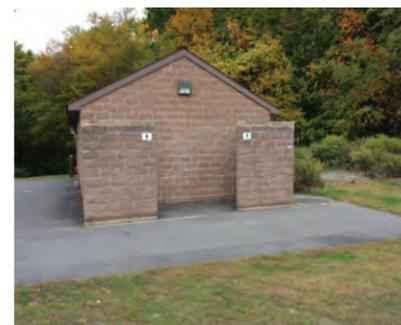
# Moody School

<b>General Site</b>	School site with recreational facilities at rear of school, Significant grade change from south to north, Bordered by forested vegetation on 3 sides
<b>Vehicular Circulation</b>	Paved parking at south west corner of property
<b>Pedestrian Circulation</b>	Limited paved access, Terraced fields create challenge
<b>Accessibility</b>	Limited - 2 parking spaces provided, pedestrian limited to west side of park, No connections to any fields
<b>Athletic Facilities:</b>	
<b>Baseball</b>	Fair Condition, Turf weedy, Poorly defined turf edge at infield & outfield,
<b>Softball -1</b>	Good/Fair Condition, Turf weedy, Lip at turf edge of infield & outfield, Poorly defined turf edge at outfield, Weedy warning track surface
<b>Softball -2</b>	Fair Condition, Turf weedy , Lip at turf edge of infield & outfield, Weedy warning track surface
<b>Soccer</b>	Poor Condition, Turf badly worn from over use, Exposed irrigation heads, Uneven playing surface in areas

<b>Basketball</b>	Poor Condition, Large surface cracks throughout

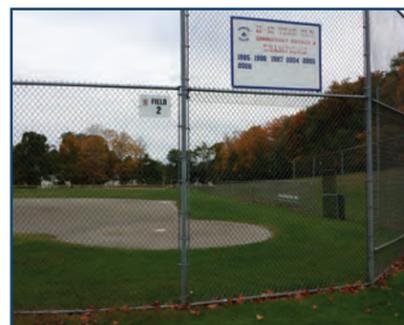
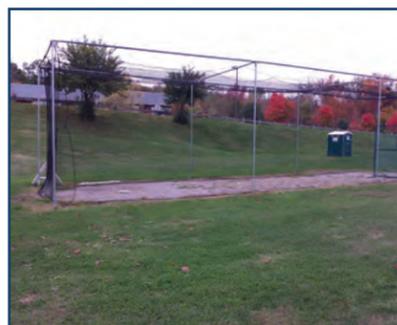
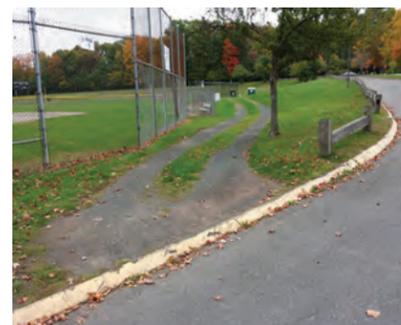
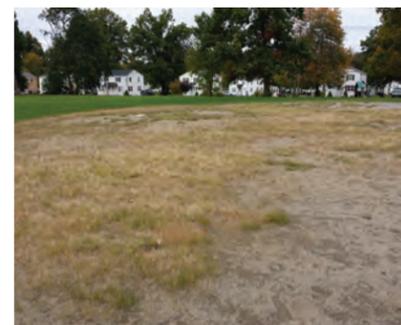
**Snow School**

<b>Softball -1</b>	Good/Fair Condition, Infield in good condition, Turf weedy, Outfield turf poor, Poorly defined turf edge at outfield
<b>Softball -2</b>	Fair Condition, Turf weedy, Poor turf edge of infield & outfield
<b>Softball -3</b>	Very Poor Condition, Appears unused
<b>Multi-Use</b>	Fair/Poor Condition, Turf worn, weedy, and compacted, Uneven playing surface in areas, Unstriped at time of evaluation

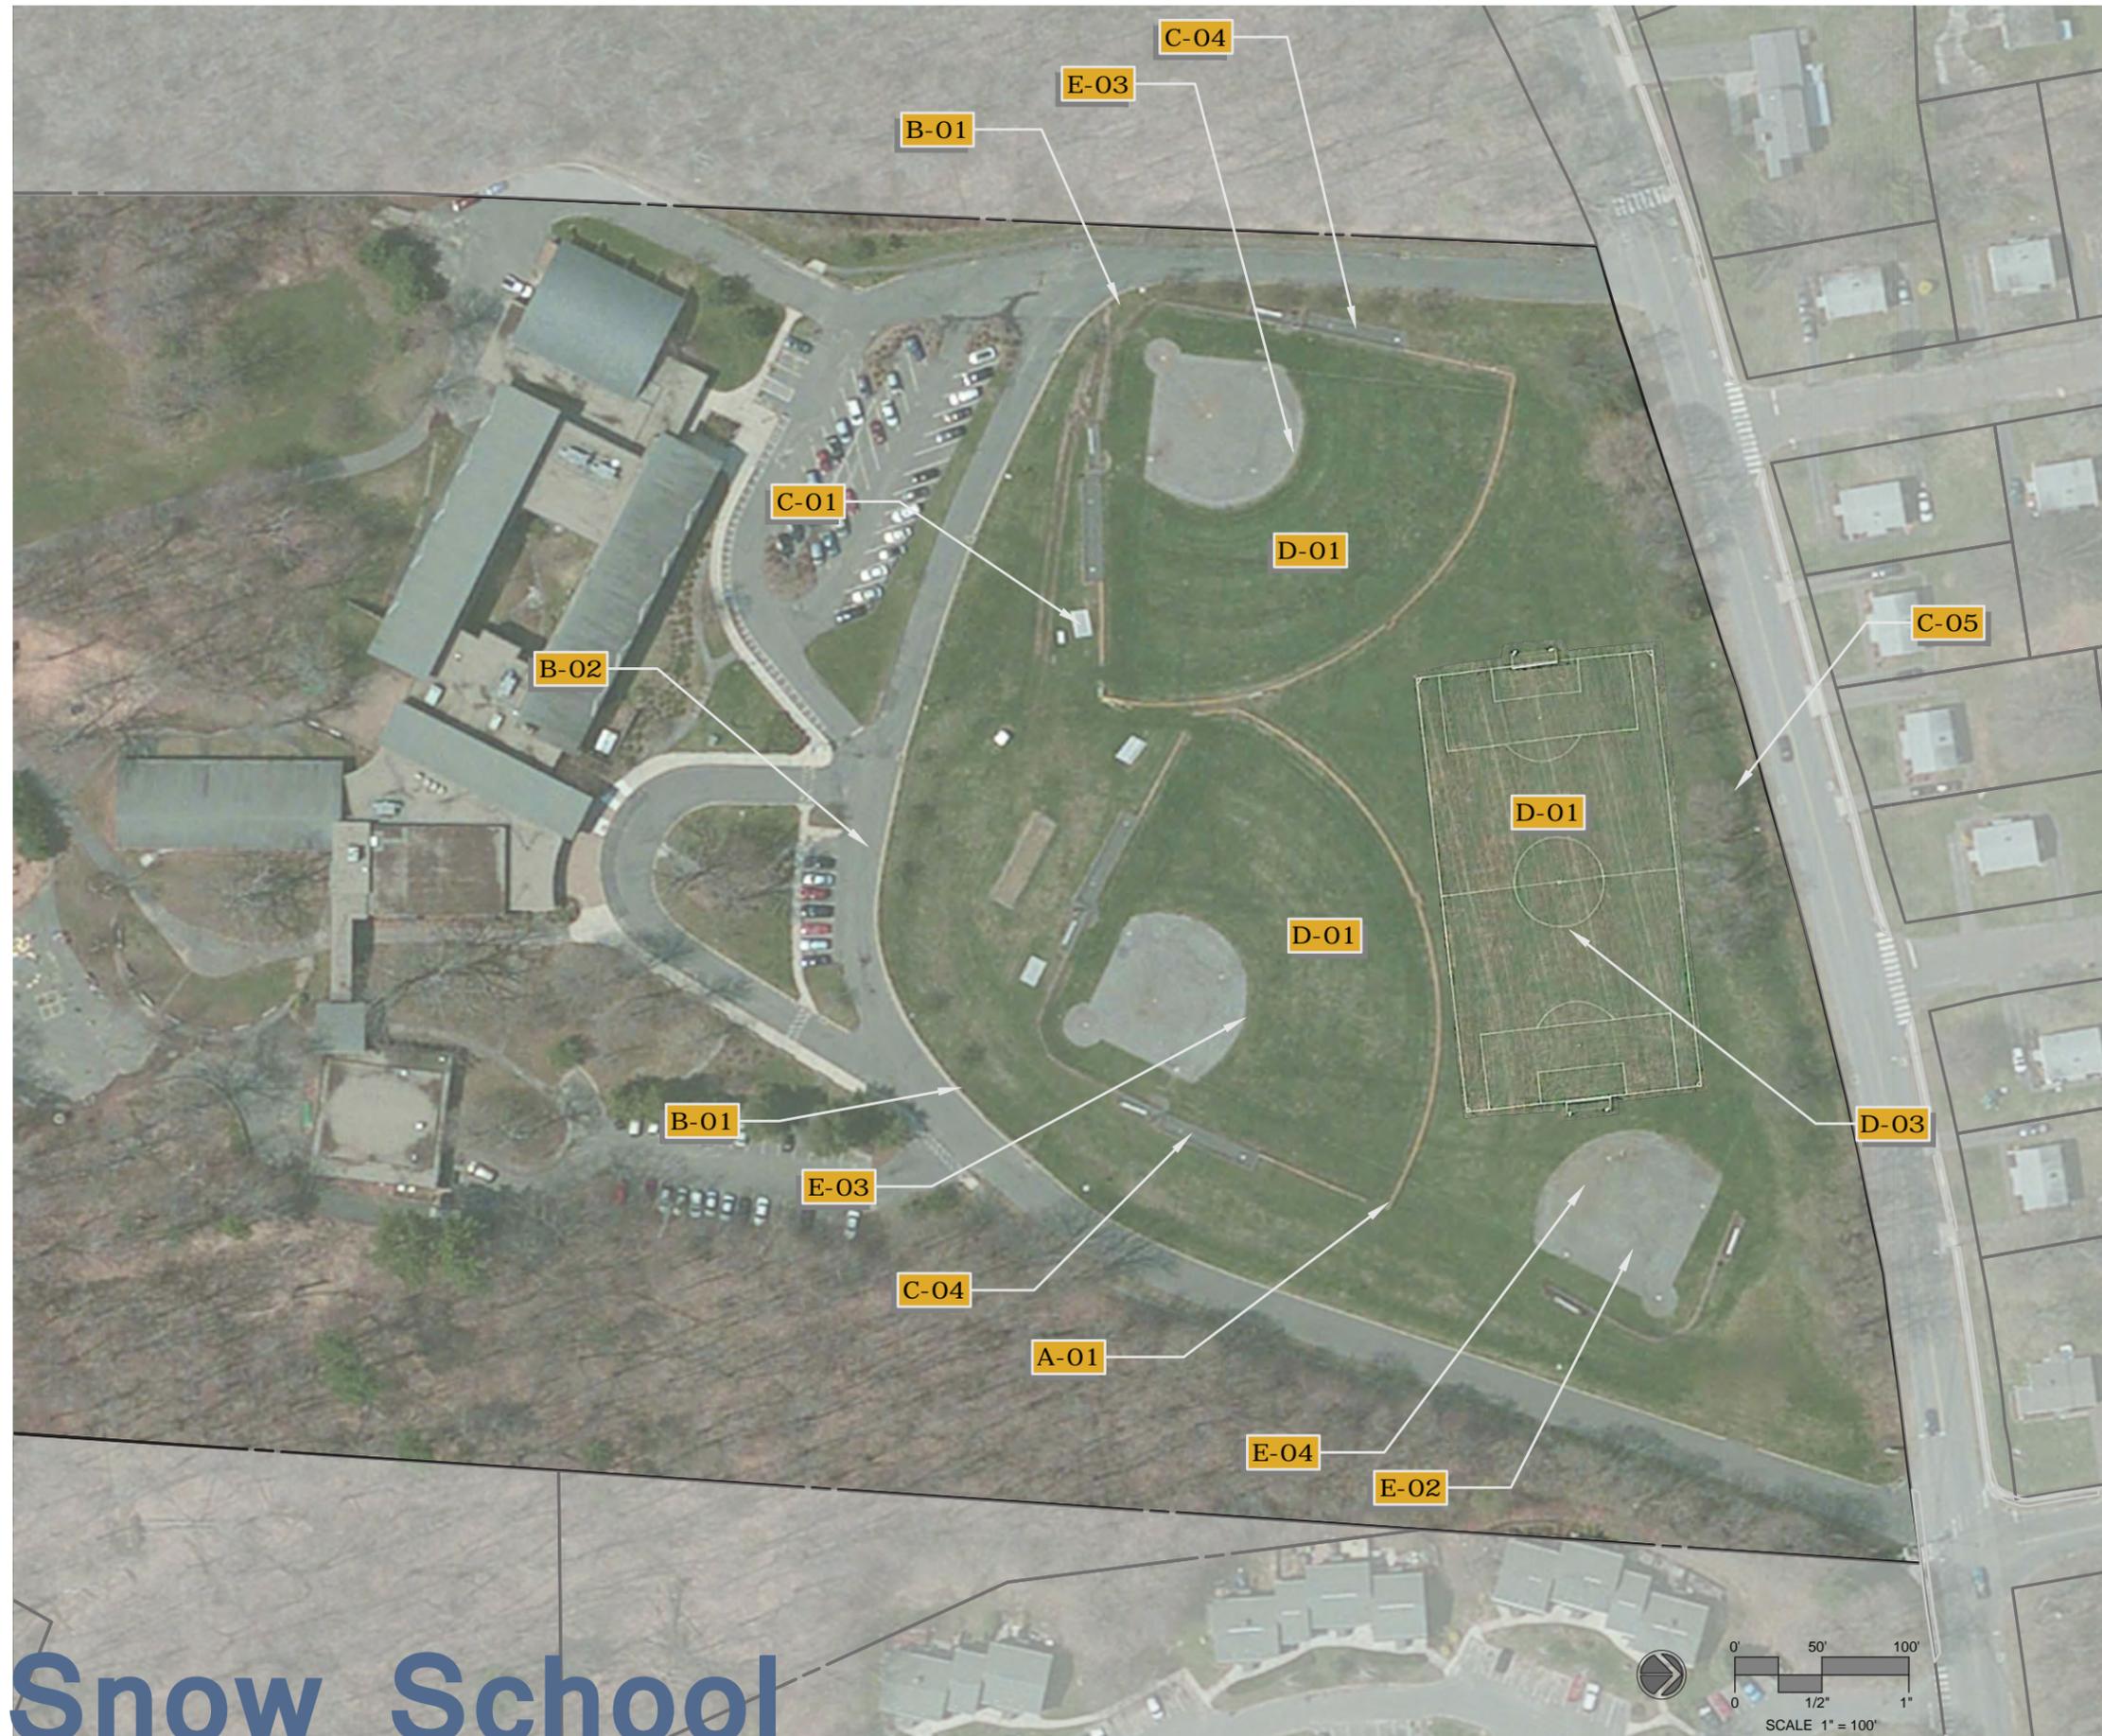
- Softball Field No. 3 appears unused and is in very poor condition.
- Overlay multipurpose field lacks adequate run-out area around perimeter.
- Steep slopes at south side of facility create access issues.
- Site bleachers are not compliant with safety code.

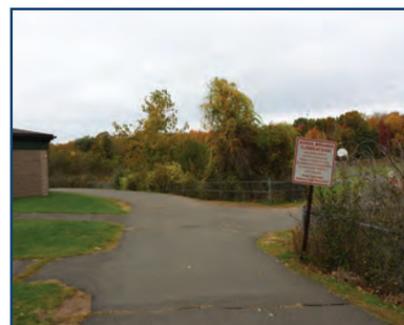
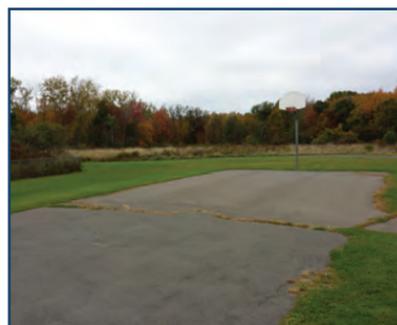
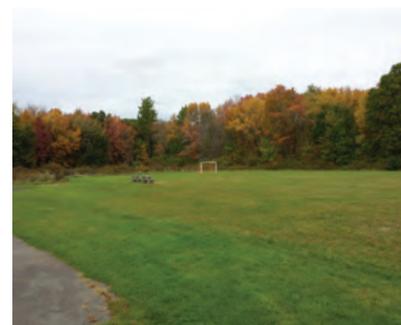
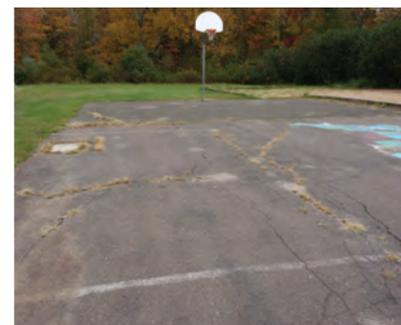
**Wesley School**

<b>General Site</b>	School site with recreational facilities on the east side of school
<b>Vehicular Circulation</b>	Paved parking at southeast side of school, Paved access around school
<b>Pedestrian Circulation</b>	Sidewalk connections to access road around school, Paved access into recreational facility area - poor condition, Lawn path to walking trails in adjacent property
<b>Accessibility</b>	Parking spaces provided, Limited access to soccer field, Connections to basketball courts and playgrounds provided - poor condition
<b>Athletic Facilities:</b>	
<b>Soccer</b>	Fair/Poor Condition, Turf worn, weedy, and compacted, Uneven playing surface in areas
<b>Basketball -1</b>	Fair Condition, Some surface cracks, Not striped or sized for sports play
<b>Basketball -2</b>	Poor Condition, Significant surface cracks, Not striped or sized for sports play, Should not be used

Improvements at Wesley School are limited to turf renovation of the youth soccer field, replacement of the bituminous concrete play area adjacent to the playground, and repaving of the bituminous access loop to the field. Proposed improvements for Wesley School total \$100,000.

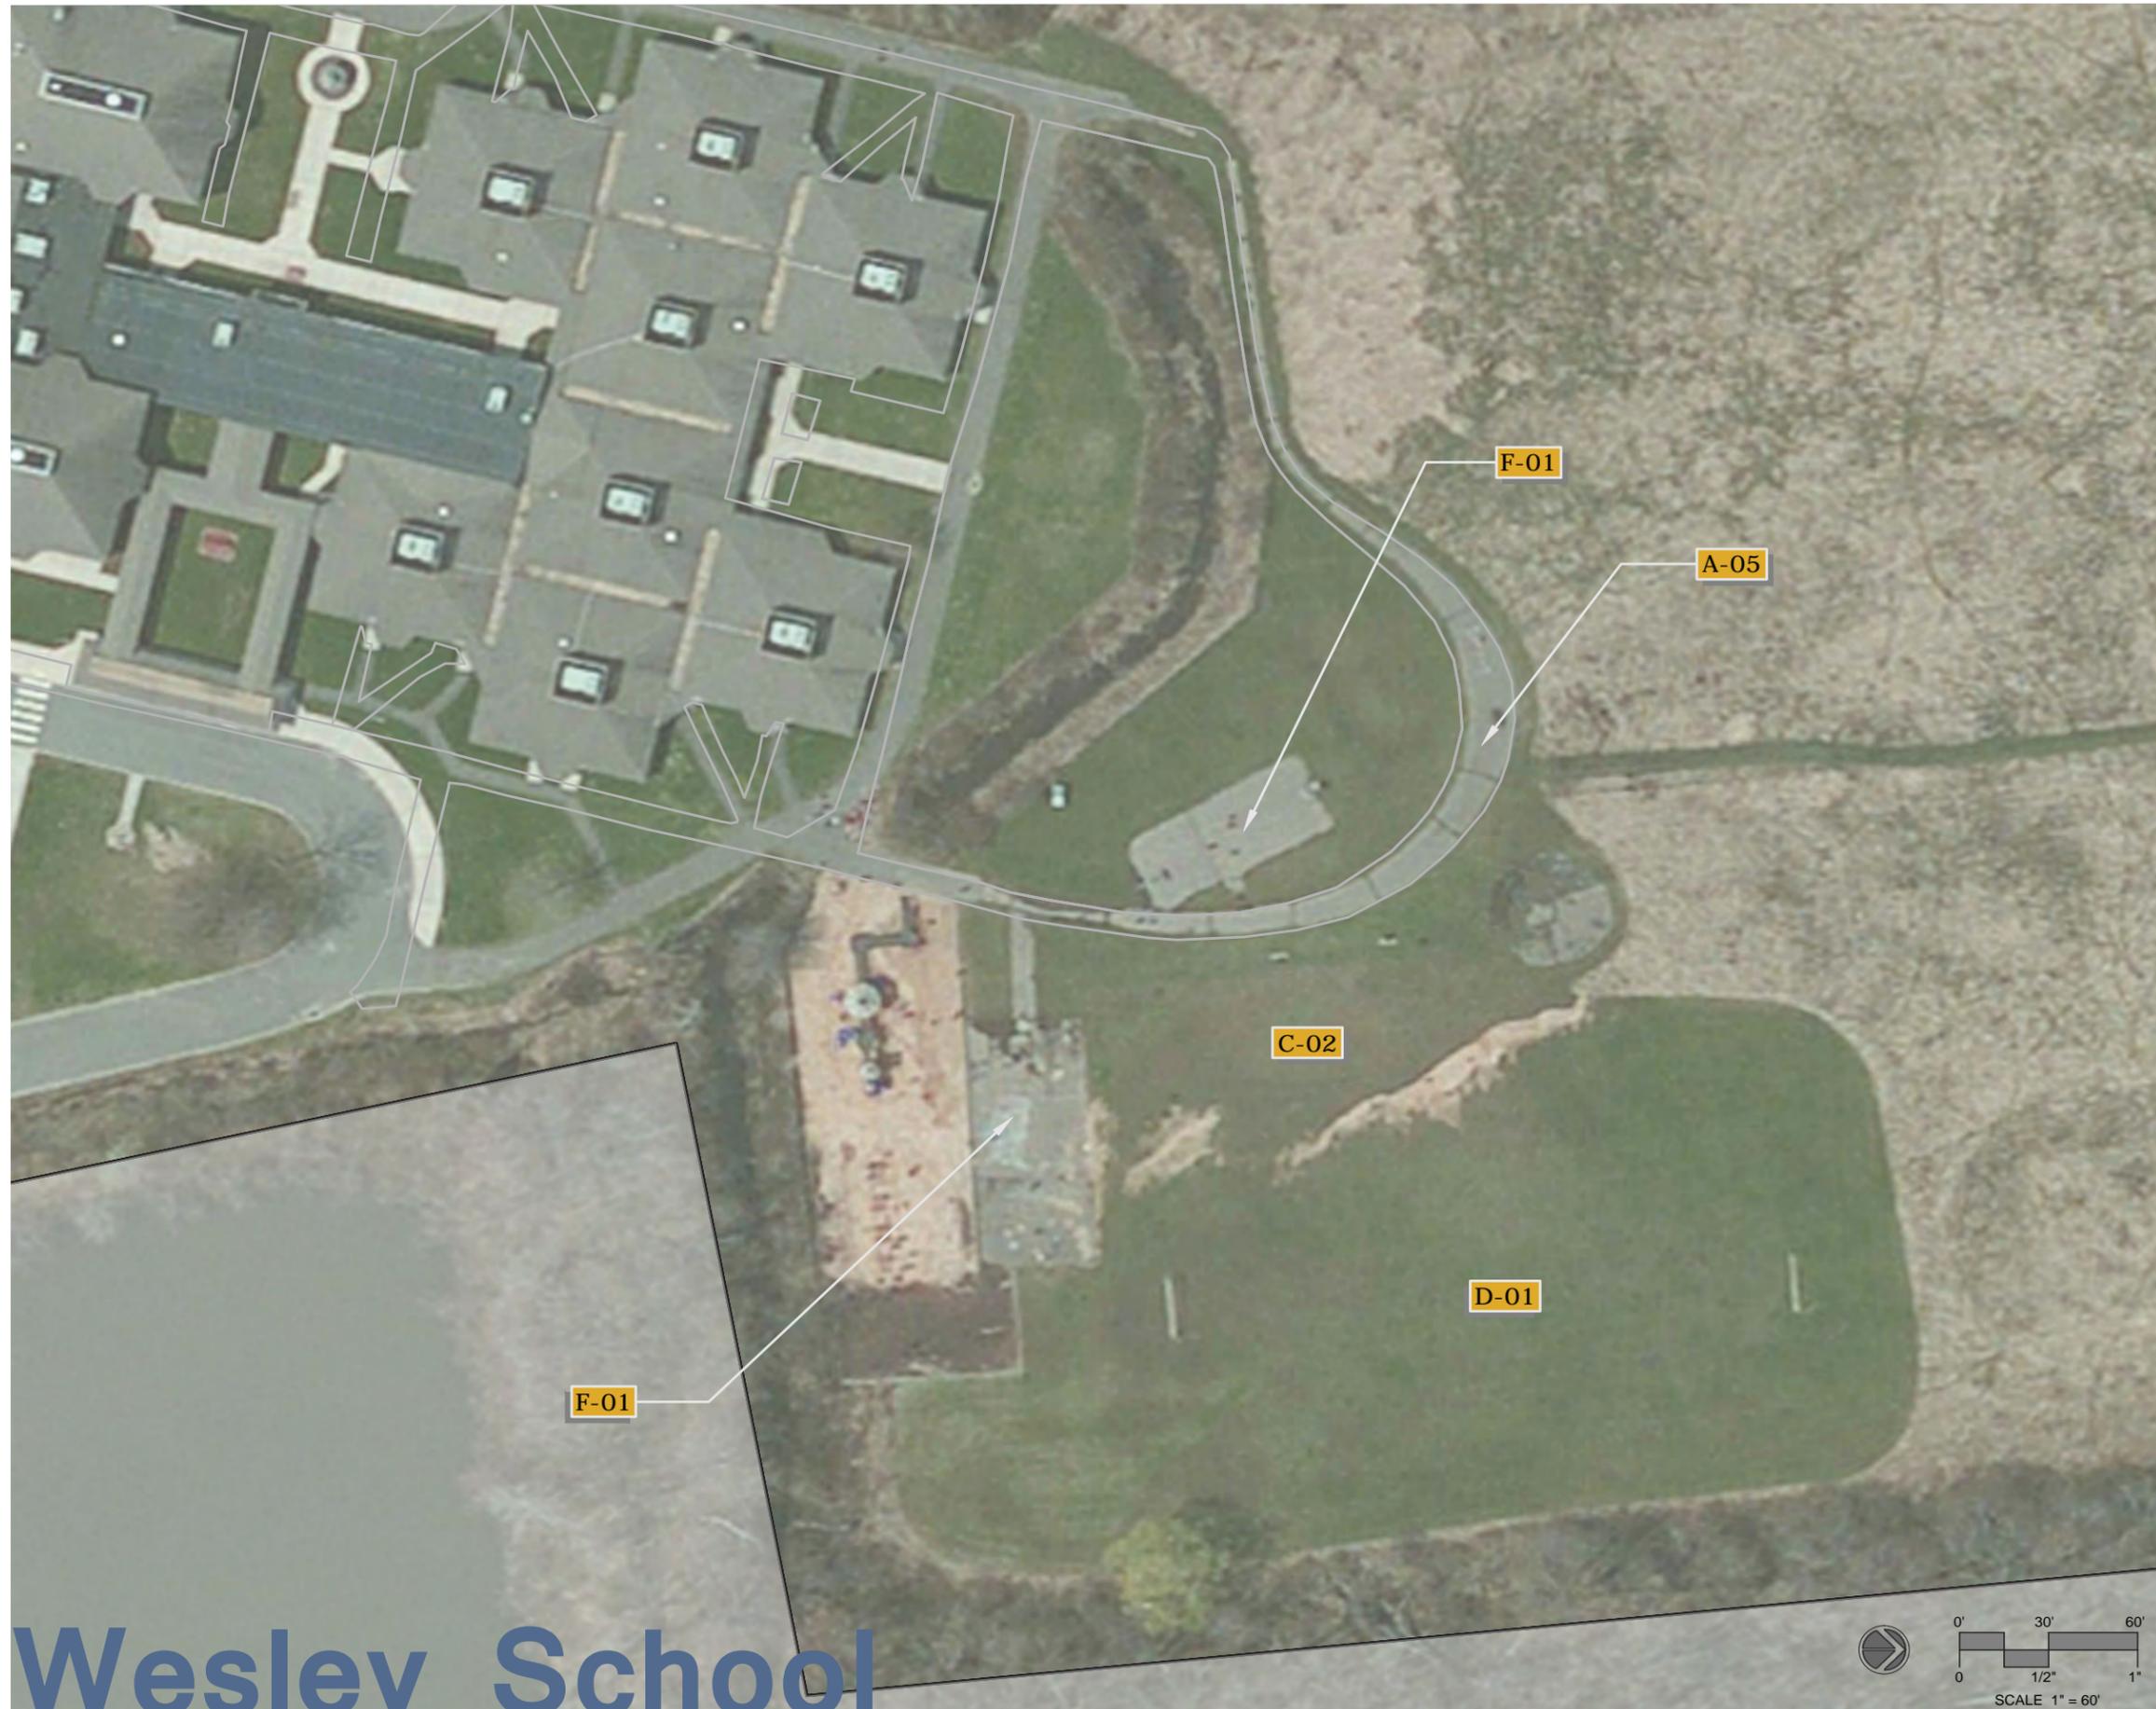
Basketball Courts are in very poor condition.  
 Court No.2 should not be used for play.
