**Evaluation of Athletic  
Fields & Parks**  
Middletown, Connecticut  
April 8, 2015

**Prepared for:**  
City of Middletown  
245 DeKoven Drive  
Middletown, Connecticut 06457

MMI #2708-09-3

**Prepared by:**  
MILONE & MACBROOM, INC.  
99 Realty Drive  
Cheshire, Connecticut 06410  
(203) 271-1773  
[www.miloneandmacbroom.com](http://www.miloneandmacbroom.com)

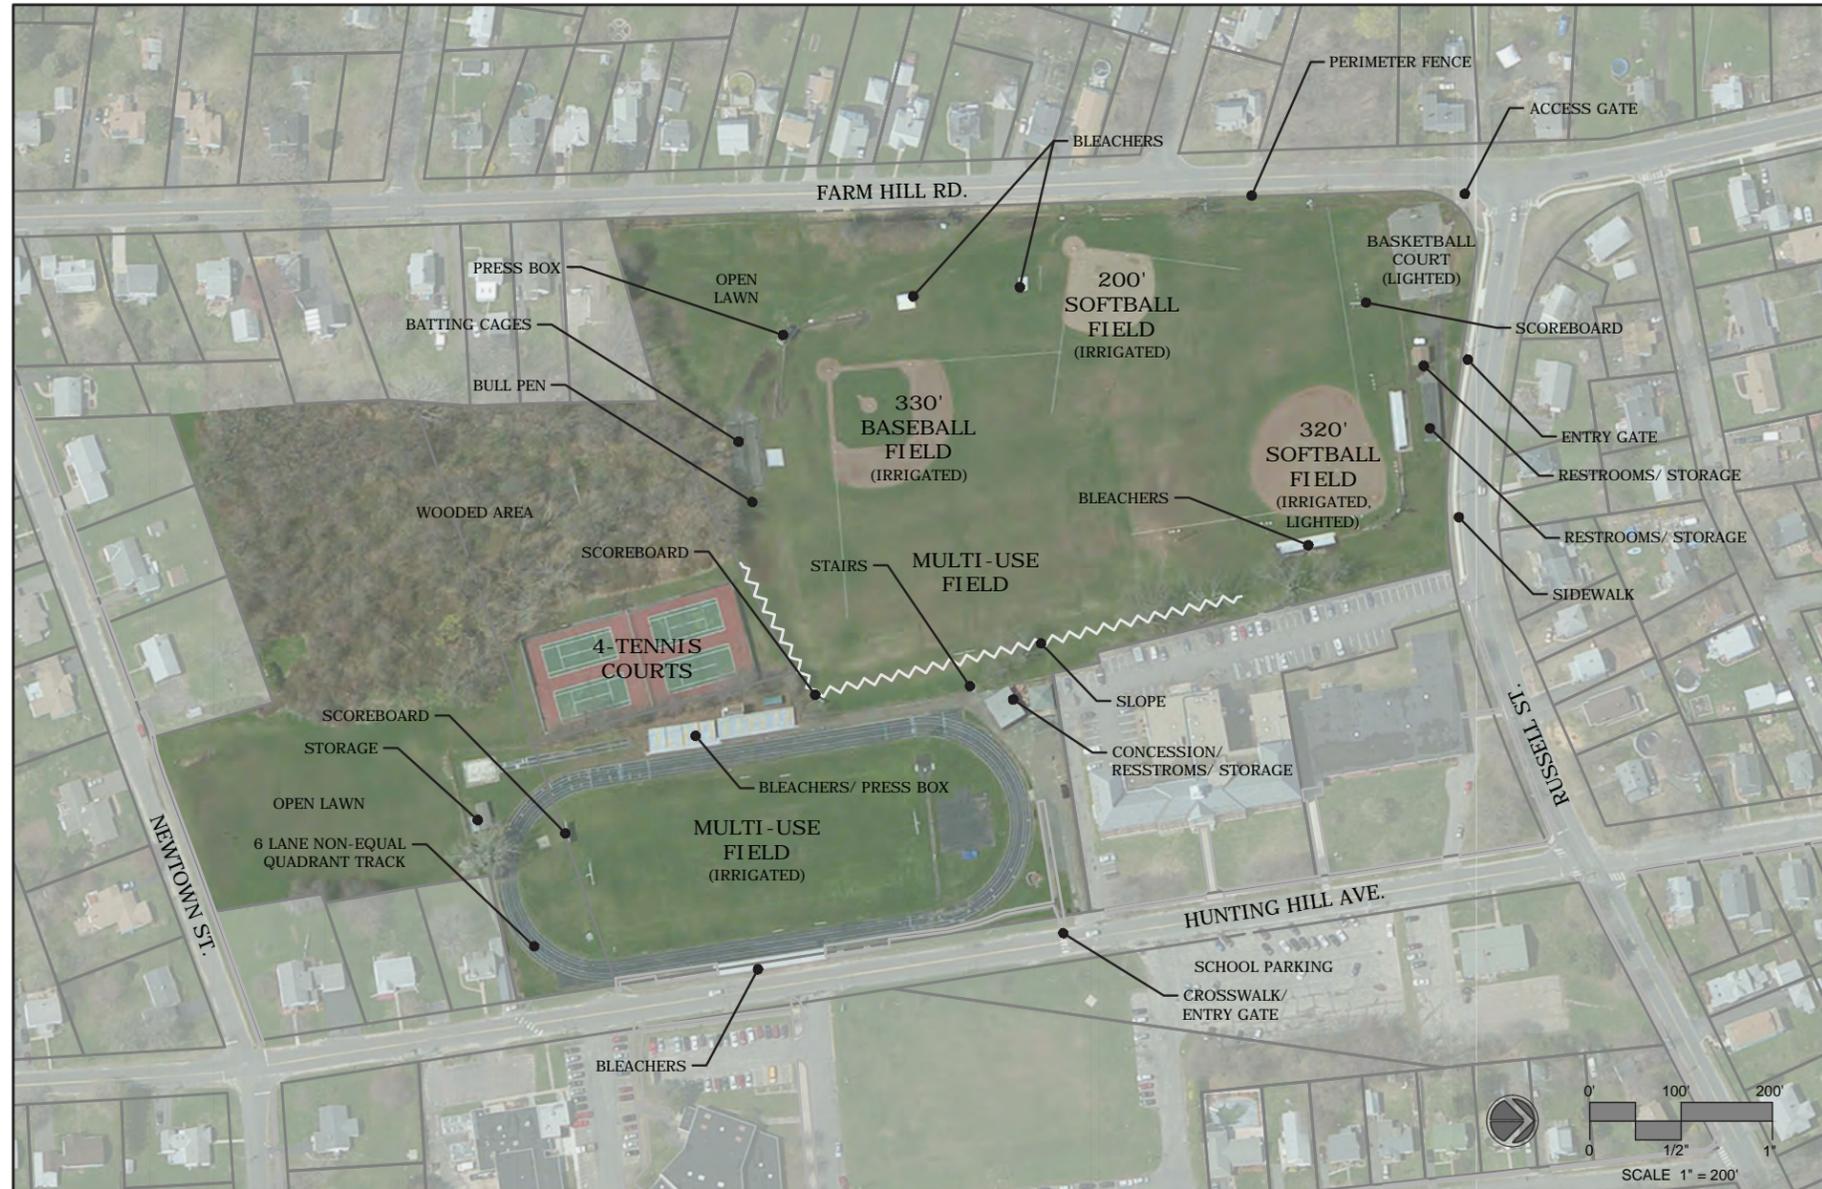
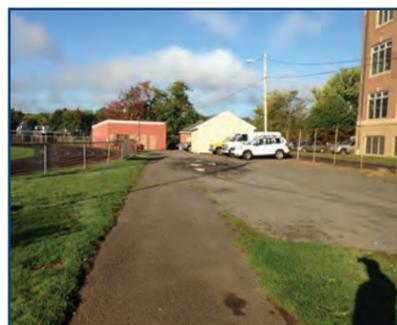
# Woodrow Wilson School

**Multi-use** Turf in good condition except for bare areas, drainage inadequate, bleachers in poor condition, fencing in poor condition.

**Track** Dangerous condition, holes in surface, large cracks, surface delaminating, drainage inadequate, fencing is poor condition. Field events in poor condition.

Due to the numerous unsafe conditions, including fall hazards from the grandstands and large cracks in the track surface, coupled with the nonstandard track and severe lack of parking, it was decided that a global view should be taken of both the Woodrow Wilson site and Pat Kidney Park to determine if a safer, more efficient and functional park could be established. While each of these sites is summarized and estimated individually, it is the intent that both projects would be completed in concert to achieve optimal results for the community. A signature city park can be implemented that greatly enhances safety, accessibility, field availability, and the city's athletic programs.

Complete removal of the existing grandstands, bleachers, press box, track, multiuse field, concession building, field lighting, and ancillary site items is recommended. Once cleared, the site will have installed a six-lane nonequal quadrant track suitable to hold competitive scholastic track meets, a synthetic multiuse field, new grandstand bleachers and press box, concession building with restrooms and storage, and paved parking to accommodate 13 parking spaces including six handicap-accessible spaces. Redesigning the track and field will push the grandstand improvements downslope into the area

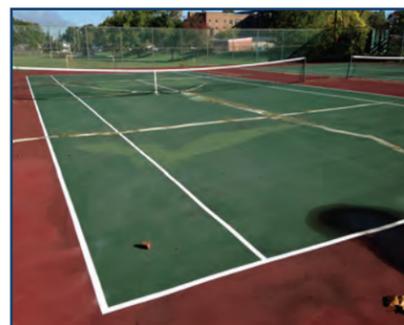
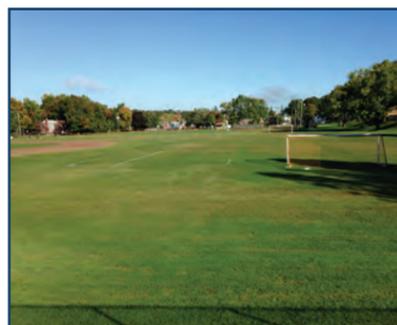
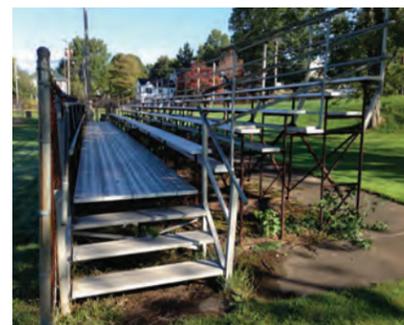
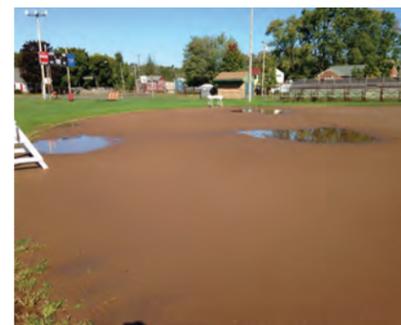
- Softball Field-2** Poor Condition, infield higher in elevation, weedy, turf in poor condition, poorly defined edge of infield & outfield, backstop in poor condition.

- Overlay Turf** Turf worn from use.
  - Basketball** Bituminous concrete surface old, no cracks, no court surfacing, old hoop foundations exposed.
  - Tennis** Poor Condition, Large surface cracks throughout, fencing needs repairs.

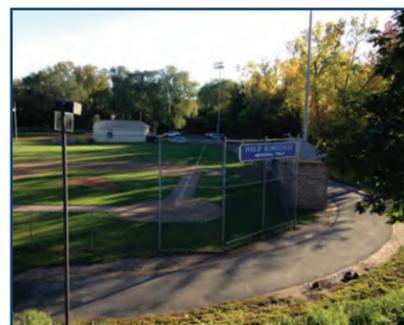
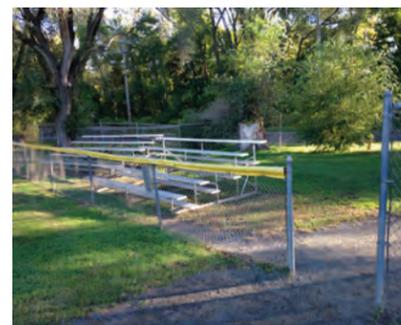
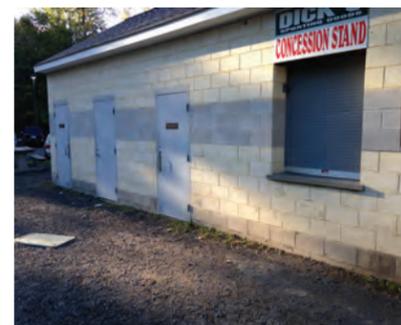
<b>Baseball Field -1</b>	Good condition, turf contains weedy areas, thin areas; mound in poor condition, infield elevation raised, fence needs minor repairs, no warning track. Bleachers not to code.
<b>Baseball Field-2</b>	Good condition, turf contains weedy areas, thin areas; mound in poor condition, infield elevation raised, fence needs minor repairs, fence topper in poor condition, no warning track. Bleachers not to code.

Proposed improvements to Hubbard Park include the conversion of both baseball fields to synthetic turf, installing field lighting for field No. 2, paved walks to provide accessible routes to the fields and concession building, striping of the parking lot including accessible spaces, and repair of the stair access from Main Street. Proposed improvements for Hubbard Park total \$2,340,000.

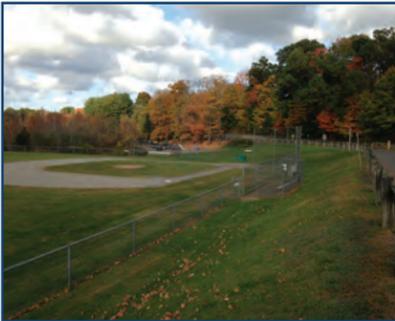
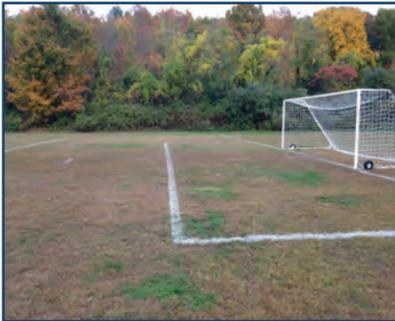
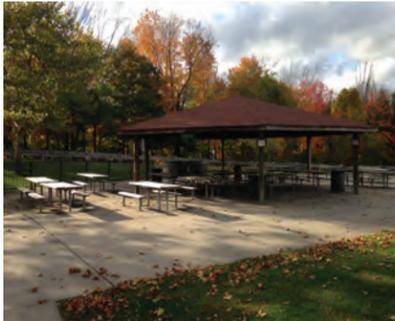
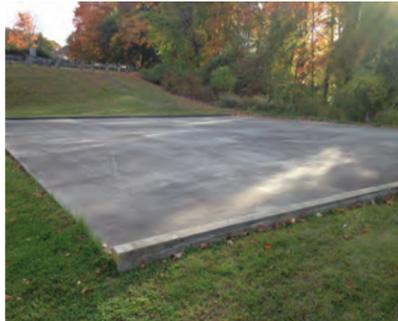
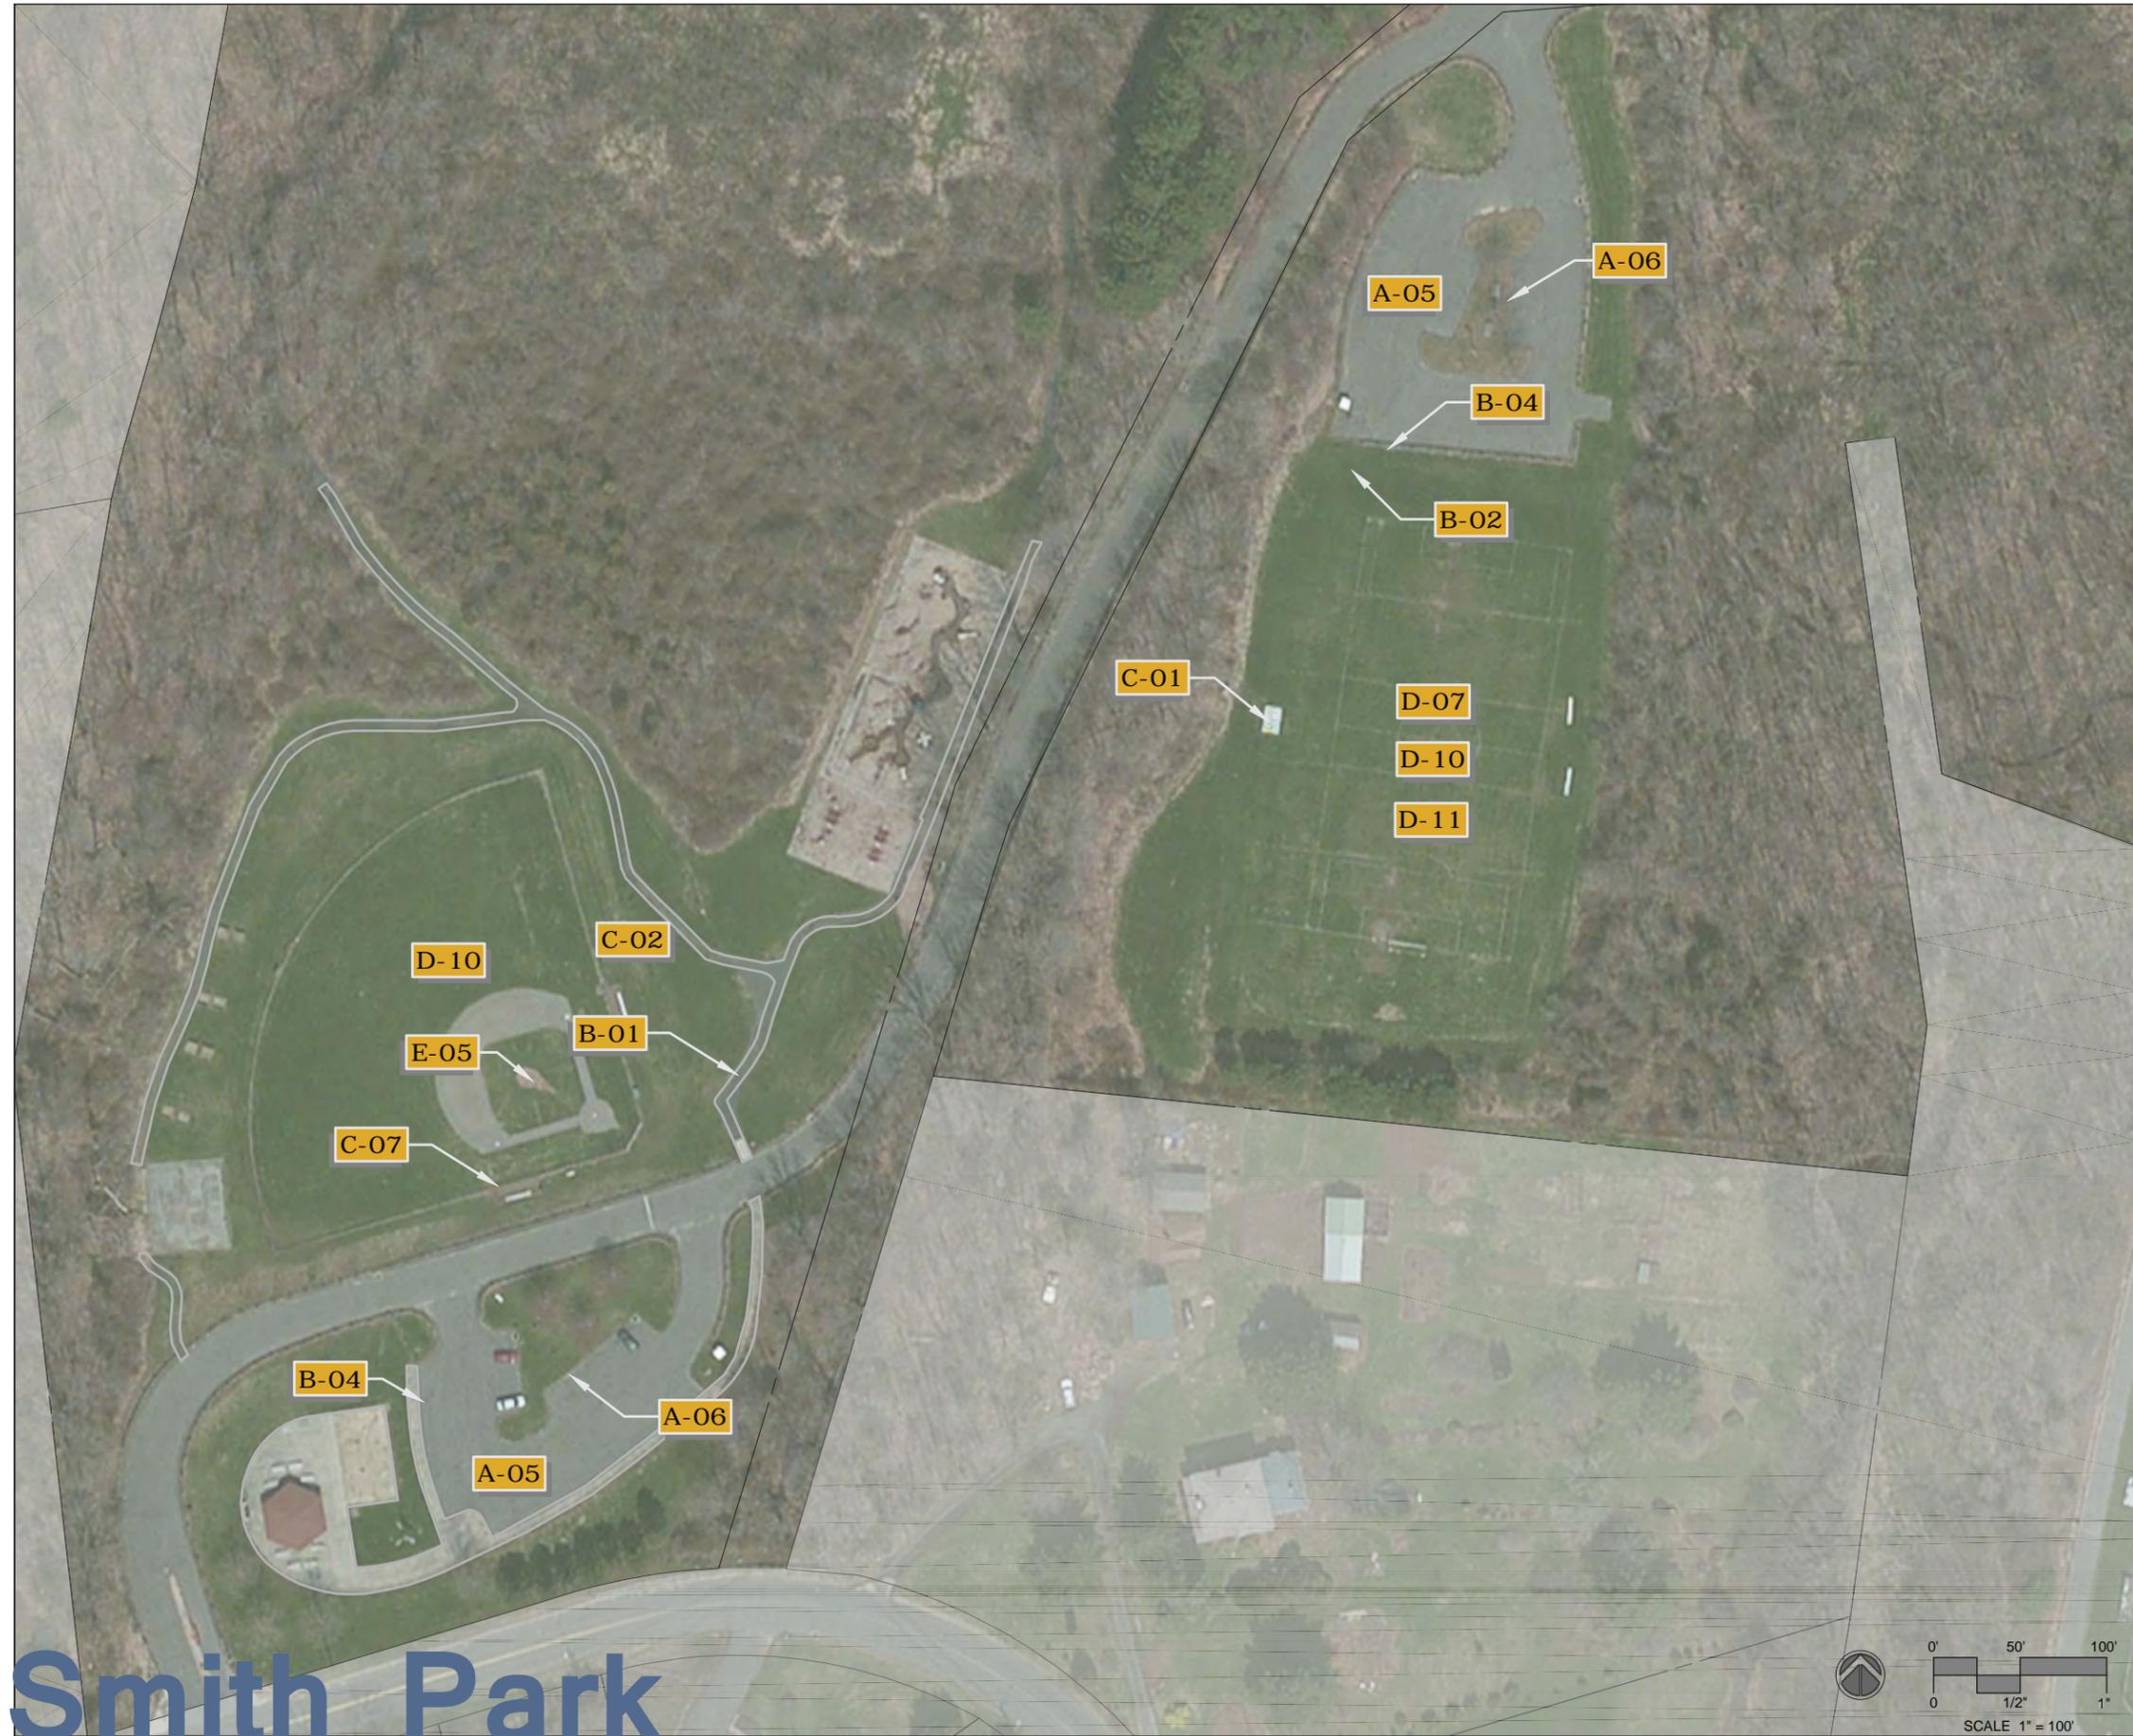
# Smith Park

<b>General Site</b>	Park site containing one little league size baseball field and one soccer field in an outlying location, both fields are irrigated. The park also contains two areas of play equipment, a pavilion, horseshoe pits, shuffle board courts, and a trail system.
<b>Vehicular Circulation</b>	There are two paved parking areas one along the street serving the baseball field and the other park amenities and one area serving the outlying soccer field.
<b>Pedestrian Circulation</b>	No paved access, to athletic facilities. No spectator seating at baseball field.
<b>Accessibility</b>	Limited - 2 parking spaces provided, pedestrian limited to west side of park, No connections to any fields
<b>Athletic Facilities:</b>	
<b>Baseball Field</b>	Fair Condition, infield turf thin, outfield turf weedy poorly defined turf edge at infield & outfield, mound requires reconstruction, fencing needs minor repairs. No warning track or fence topper.

<b>Soccer</b>	Poor Condition, turf generally in poor condition worn badly in areas from use, bleachers not to code.

Recommended improvements at Smith Park include renovations to the Little League field's turf and infield and turf renovations to the soccer field. Sidewalk connections will be installed to provide accessible routes to amenities at both fields. Additional improvements include formally striping parking spaces within the upper parking lot, including two accessible spaces, and replacement of the portable bleachers on site. Due to security concerns, an access gate with remote control through a smartphone will be installed to limit access to the upper soccer field and parking lot. Proposed improvements for Smith Park total \$115,000.

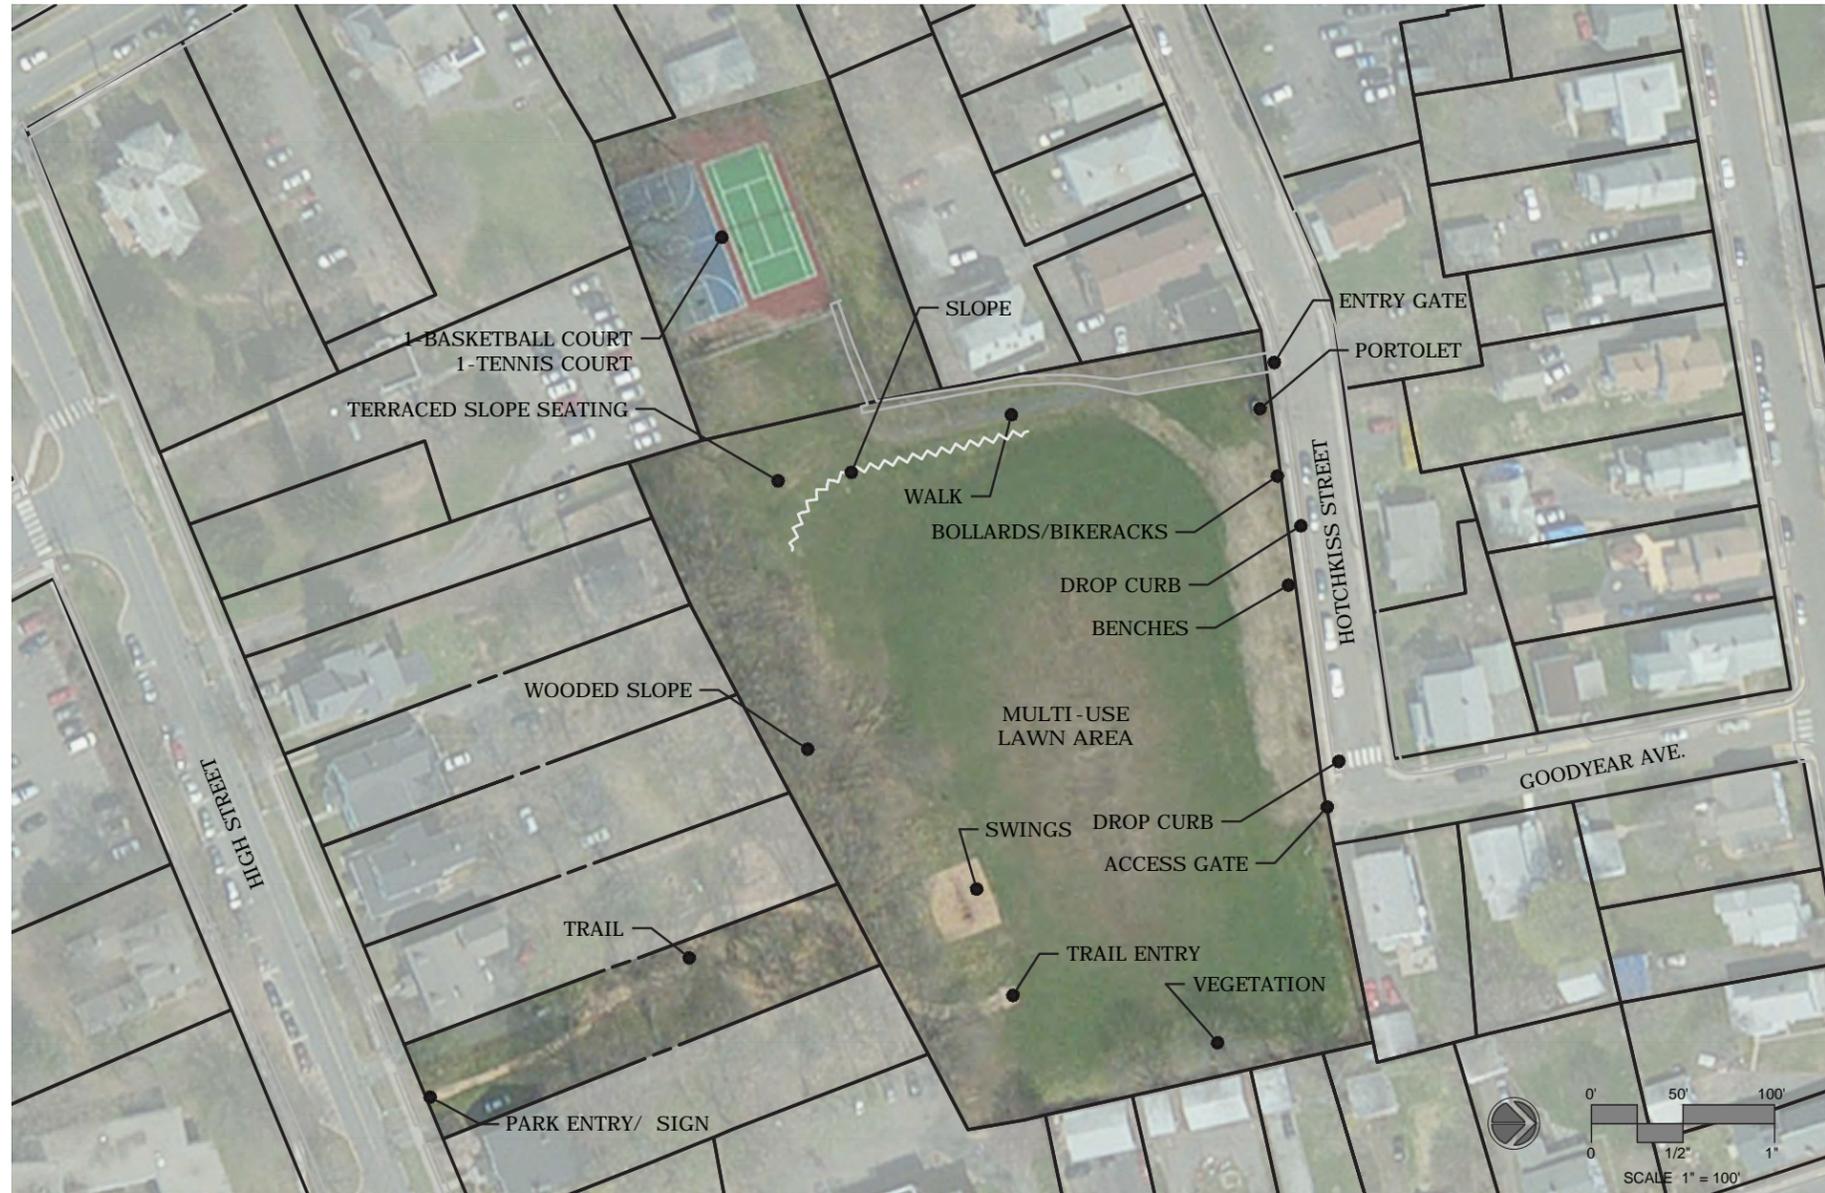
# McCarthy Park

**Multi-Use** Poor Condition, Turf worn, weedy, and compacted, Bare soil areas, Uneven playing surface in areas

**Basketball** Surface in fair condition, areas of vandalism, cracking and birdbaths, fencing in fair/poor condition.

**Tennis** Surface in fair condition, areas of vandalism, cracking and birdbaths, fencing in fair/poor condition.

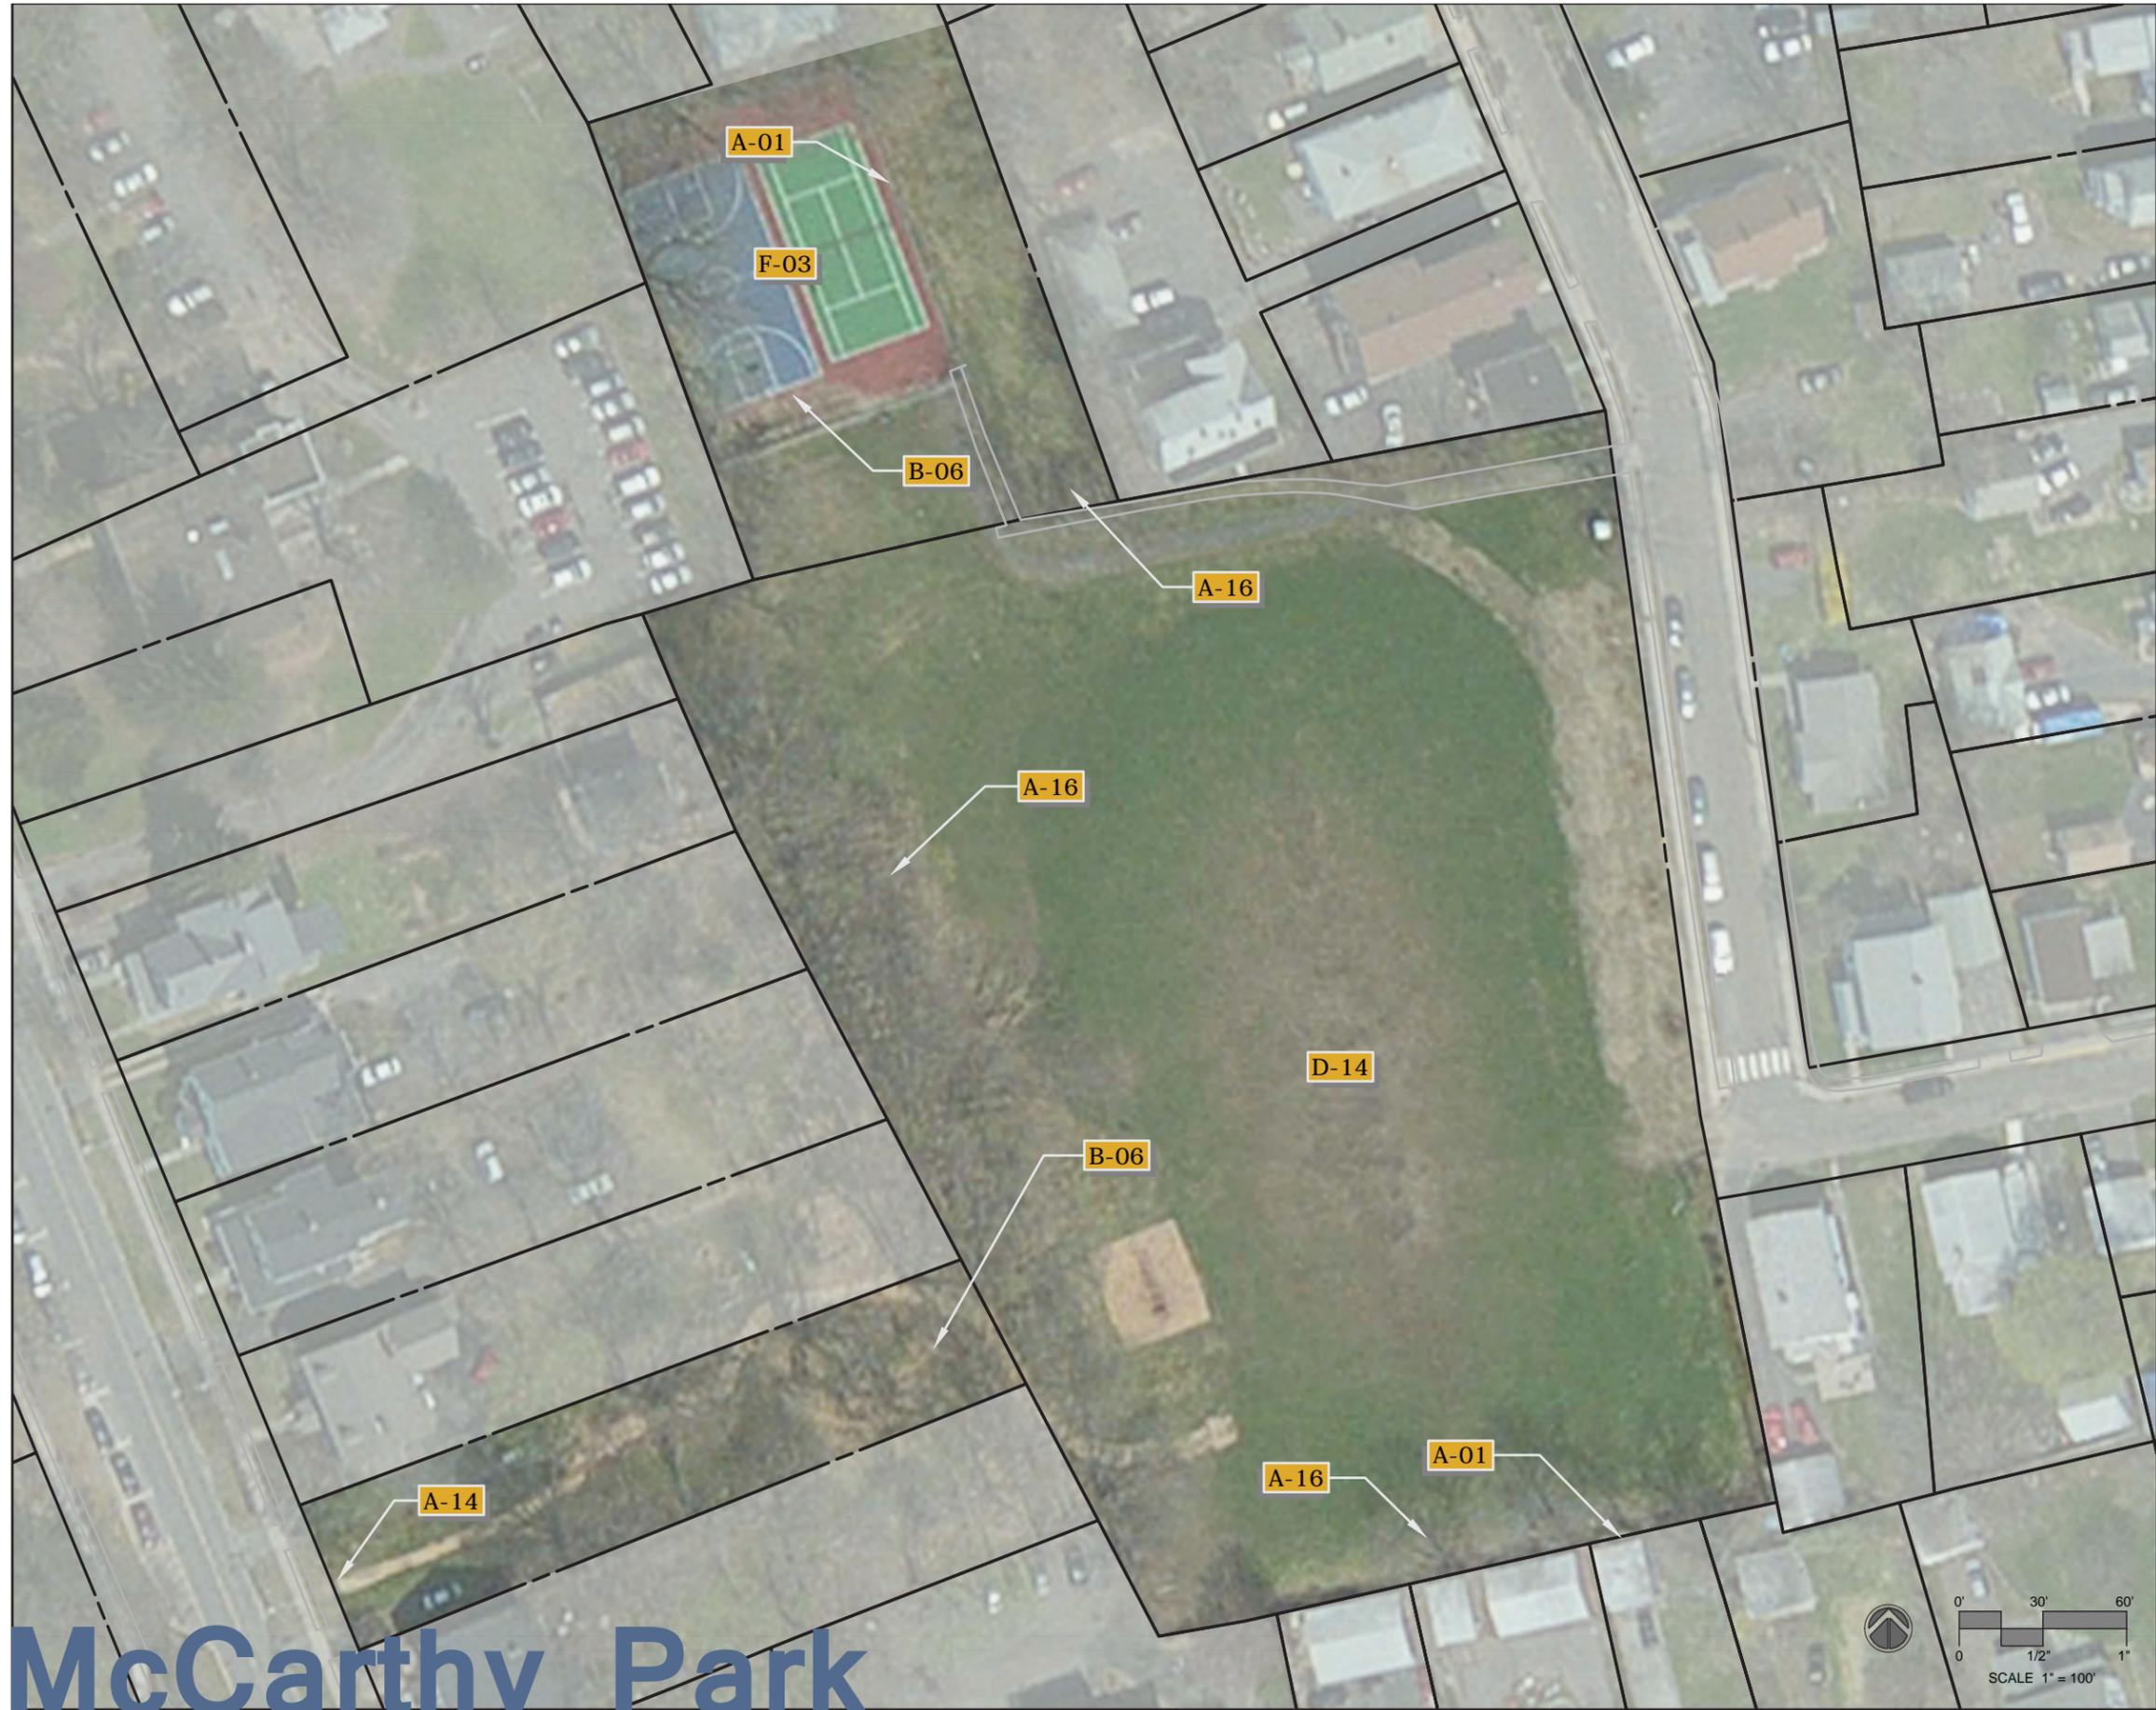
<u>GENERAL SITE DESCRIPTION</u>	
<u>SYMBOL</u>	<u>DESCRIPTION</u>
A-01	Repair Fence
A-14	Park Entry Undefined
A-16	Vegetation Overgrown
<u>ACCESSIBILITY DESCRIPTION</u>	
<u>SYMBOL</u>	<u>DESCRIPTION</u>
B-06	Area of Poor Visibility
<u>FIELD TURF DESCRIPTION</u>	
<u>SYMBOL</u>	<u>DESCRIPTION</u>
D-14	Field Reconstruction Required
<u>SPORT COURT DESCRIPTION</u>	
<u>SYMBOL</u>	<u>DESCRIPTION</u>
F-03	Surface Needs Repairs

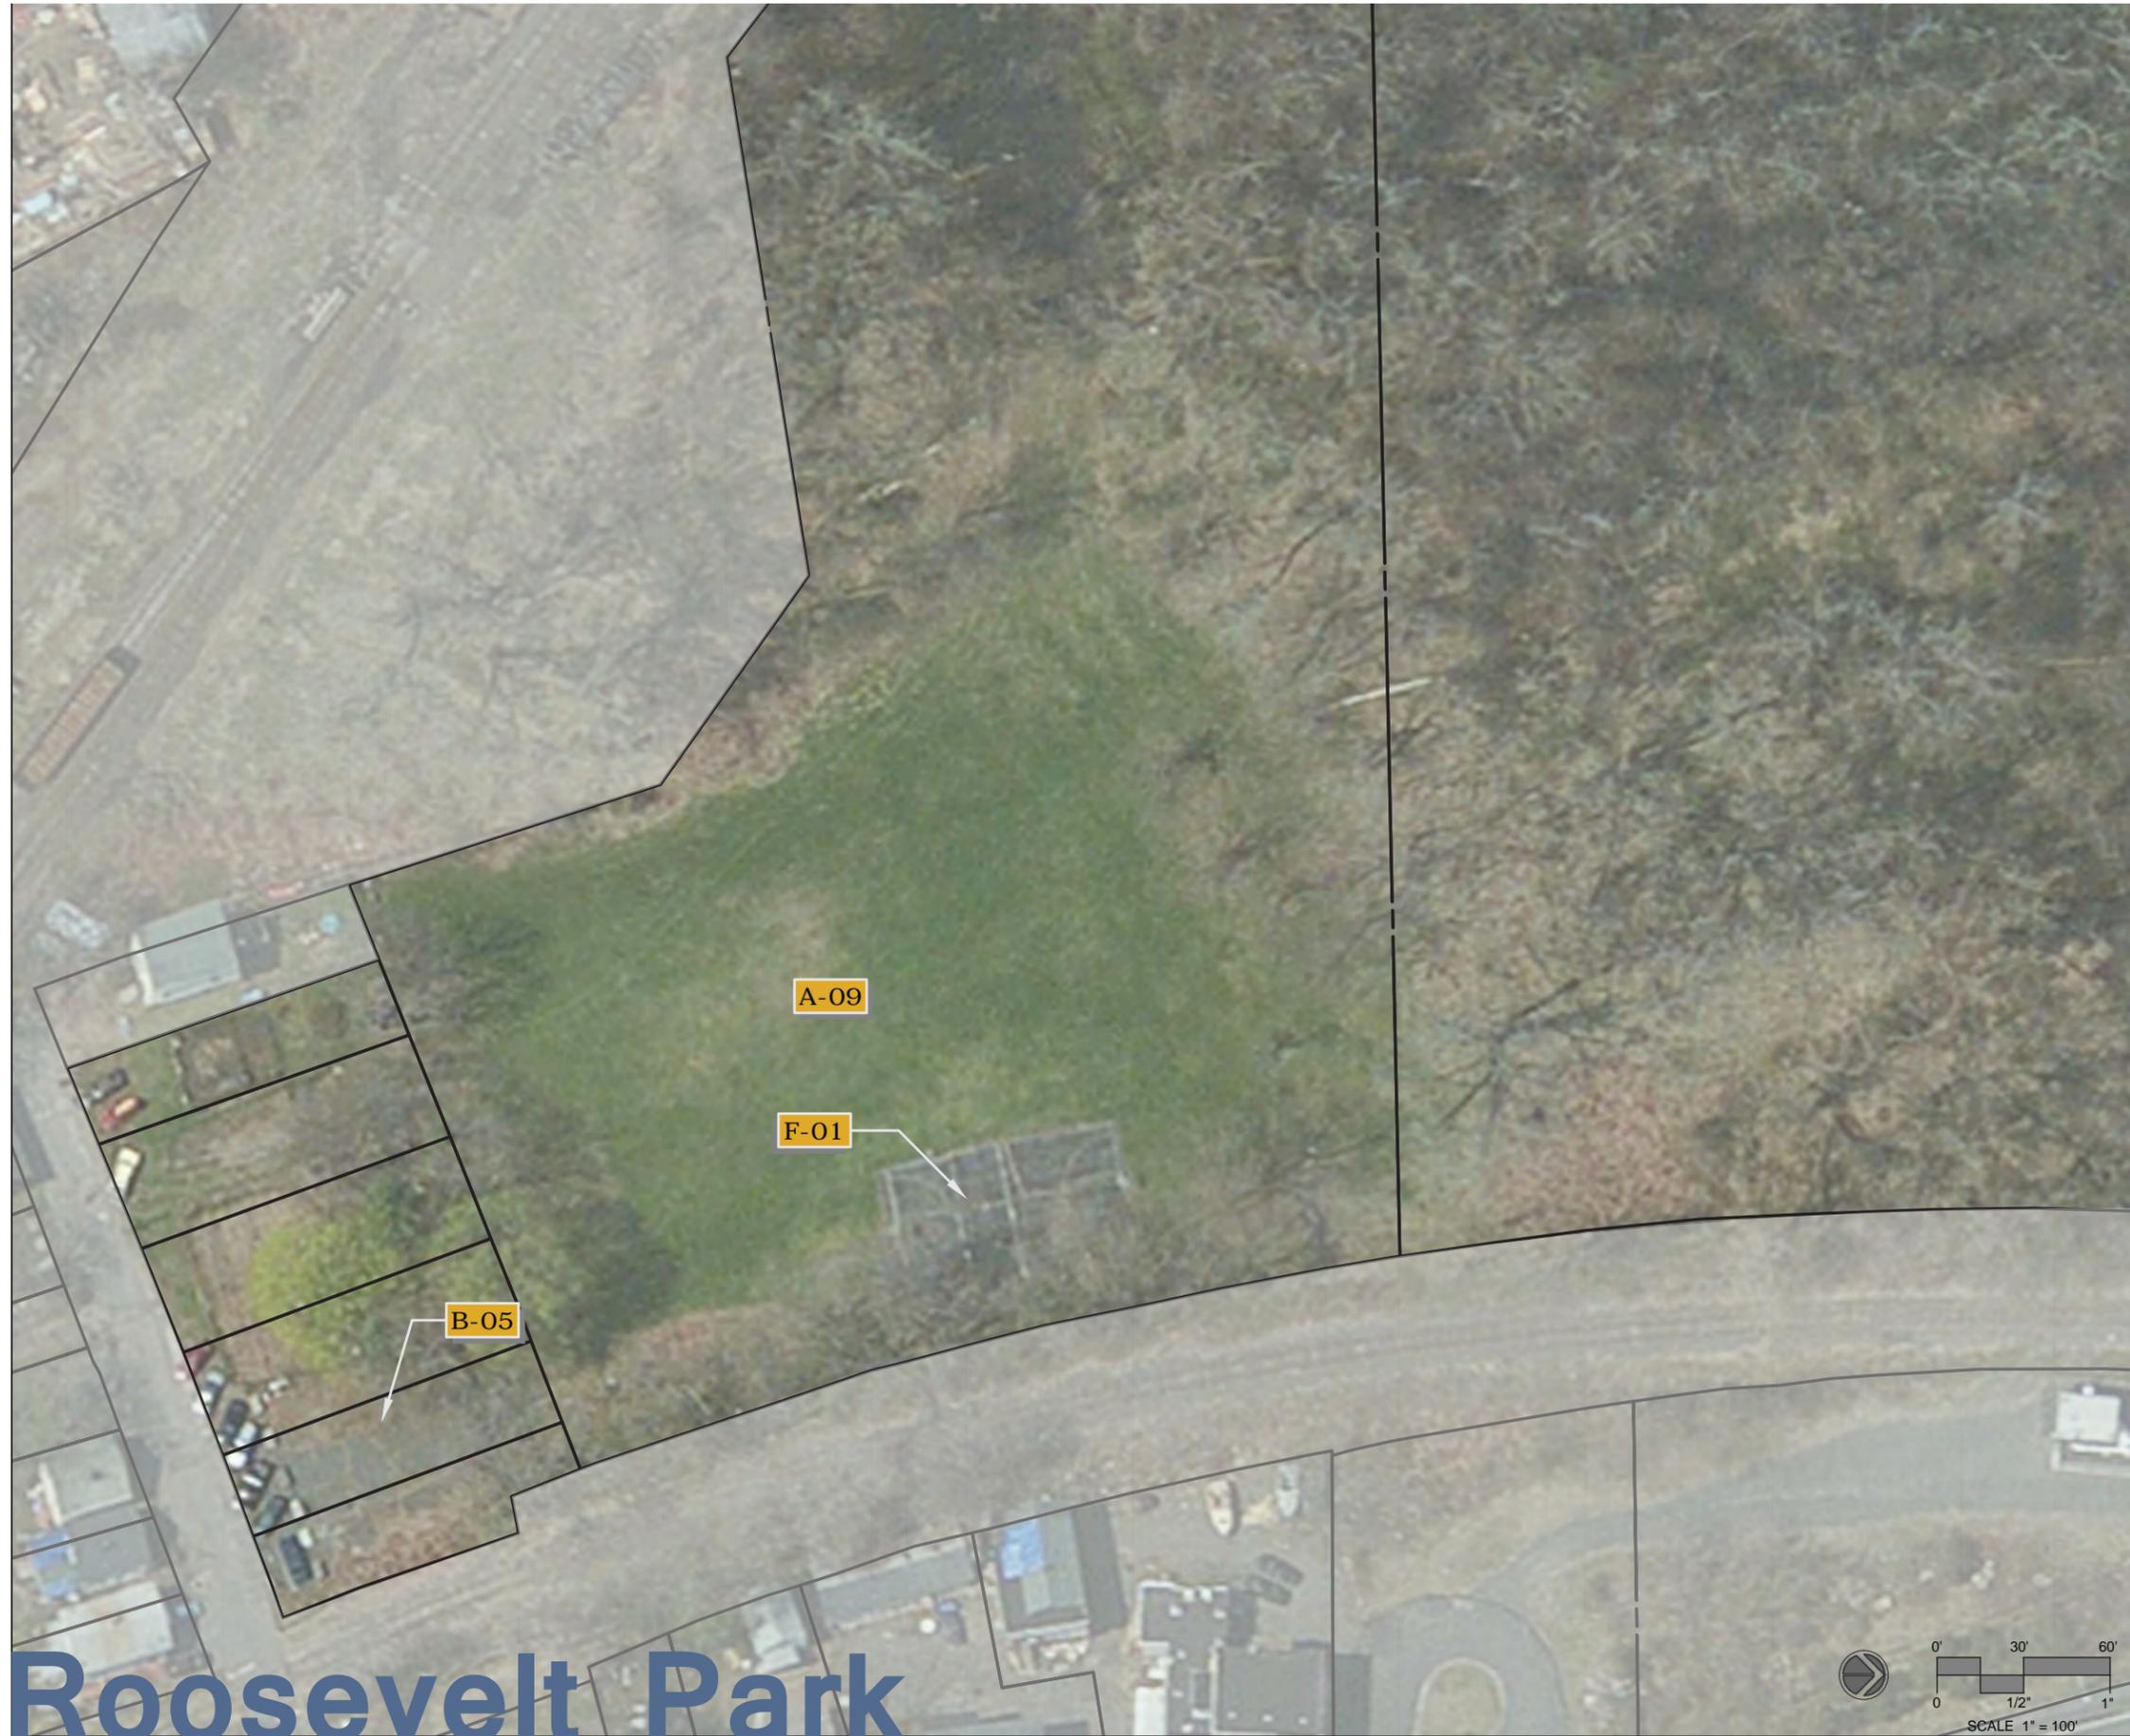
# Roosevelt Park

<u>SYMBOL</u>	<u>GENERAL SITE DESCRIPTION</u>
A-09	Athletic Field will Need to be Constructed
<u>SYMBOL</u>	<u>ACCESSIBILITY DESCRIPTION</u>
B-05	No Site Parking
<u>SYMBOL</u>	<u>SPORT COURT DESCRIPTION</u>
F-01	Playing Surface in Poor Condition

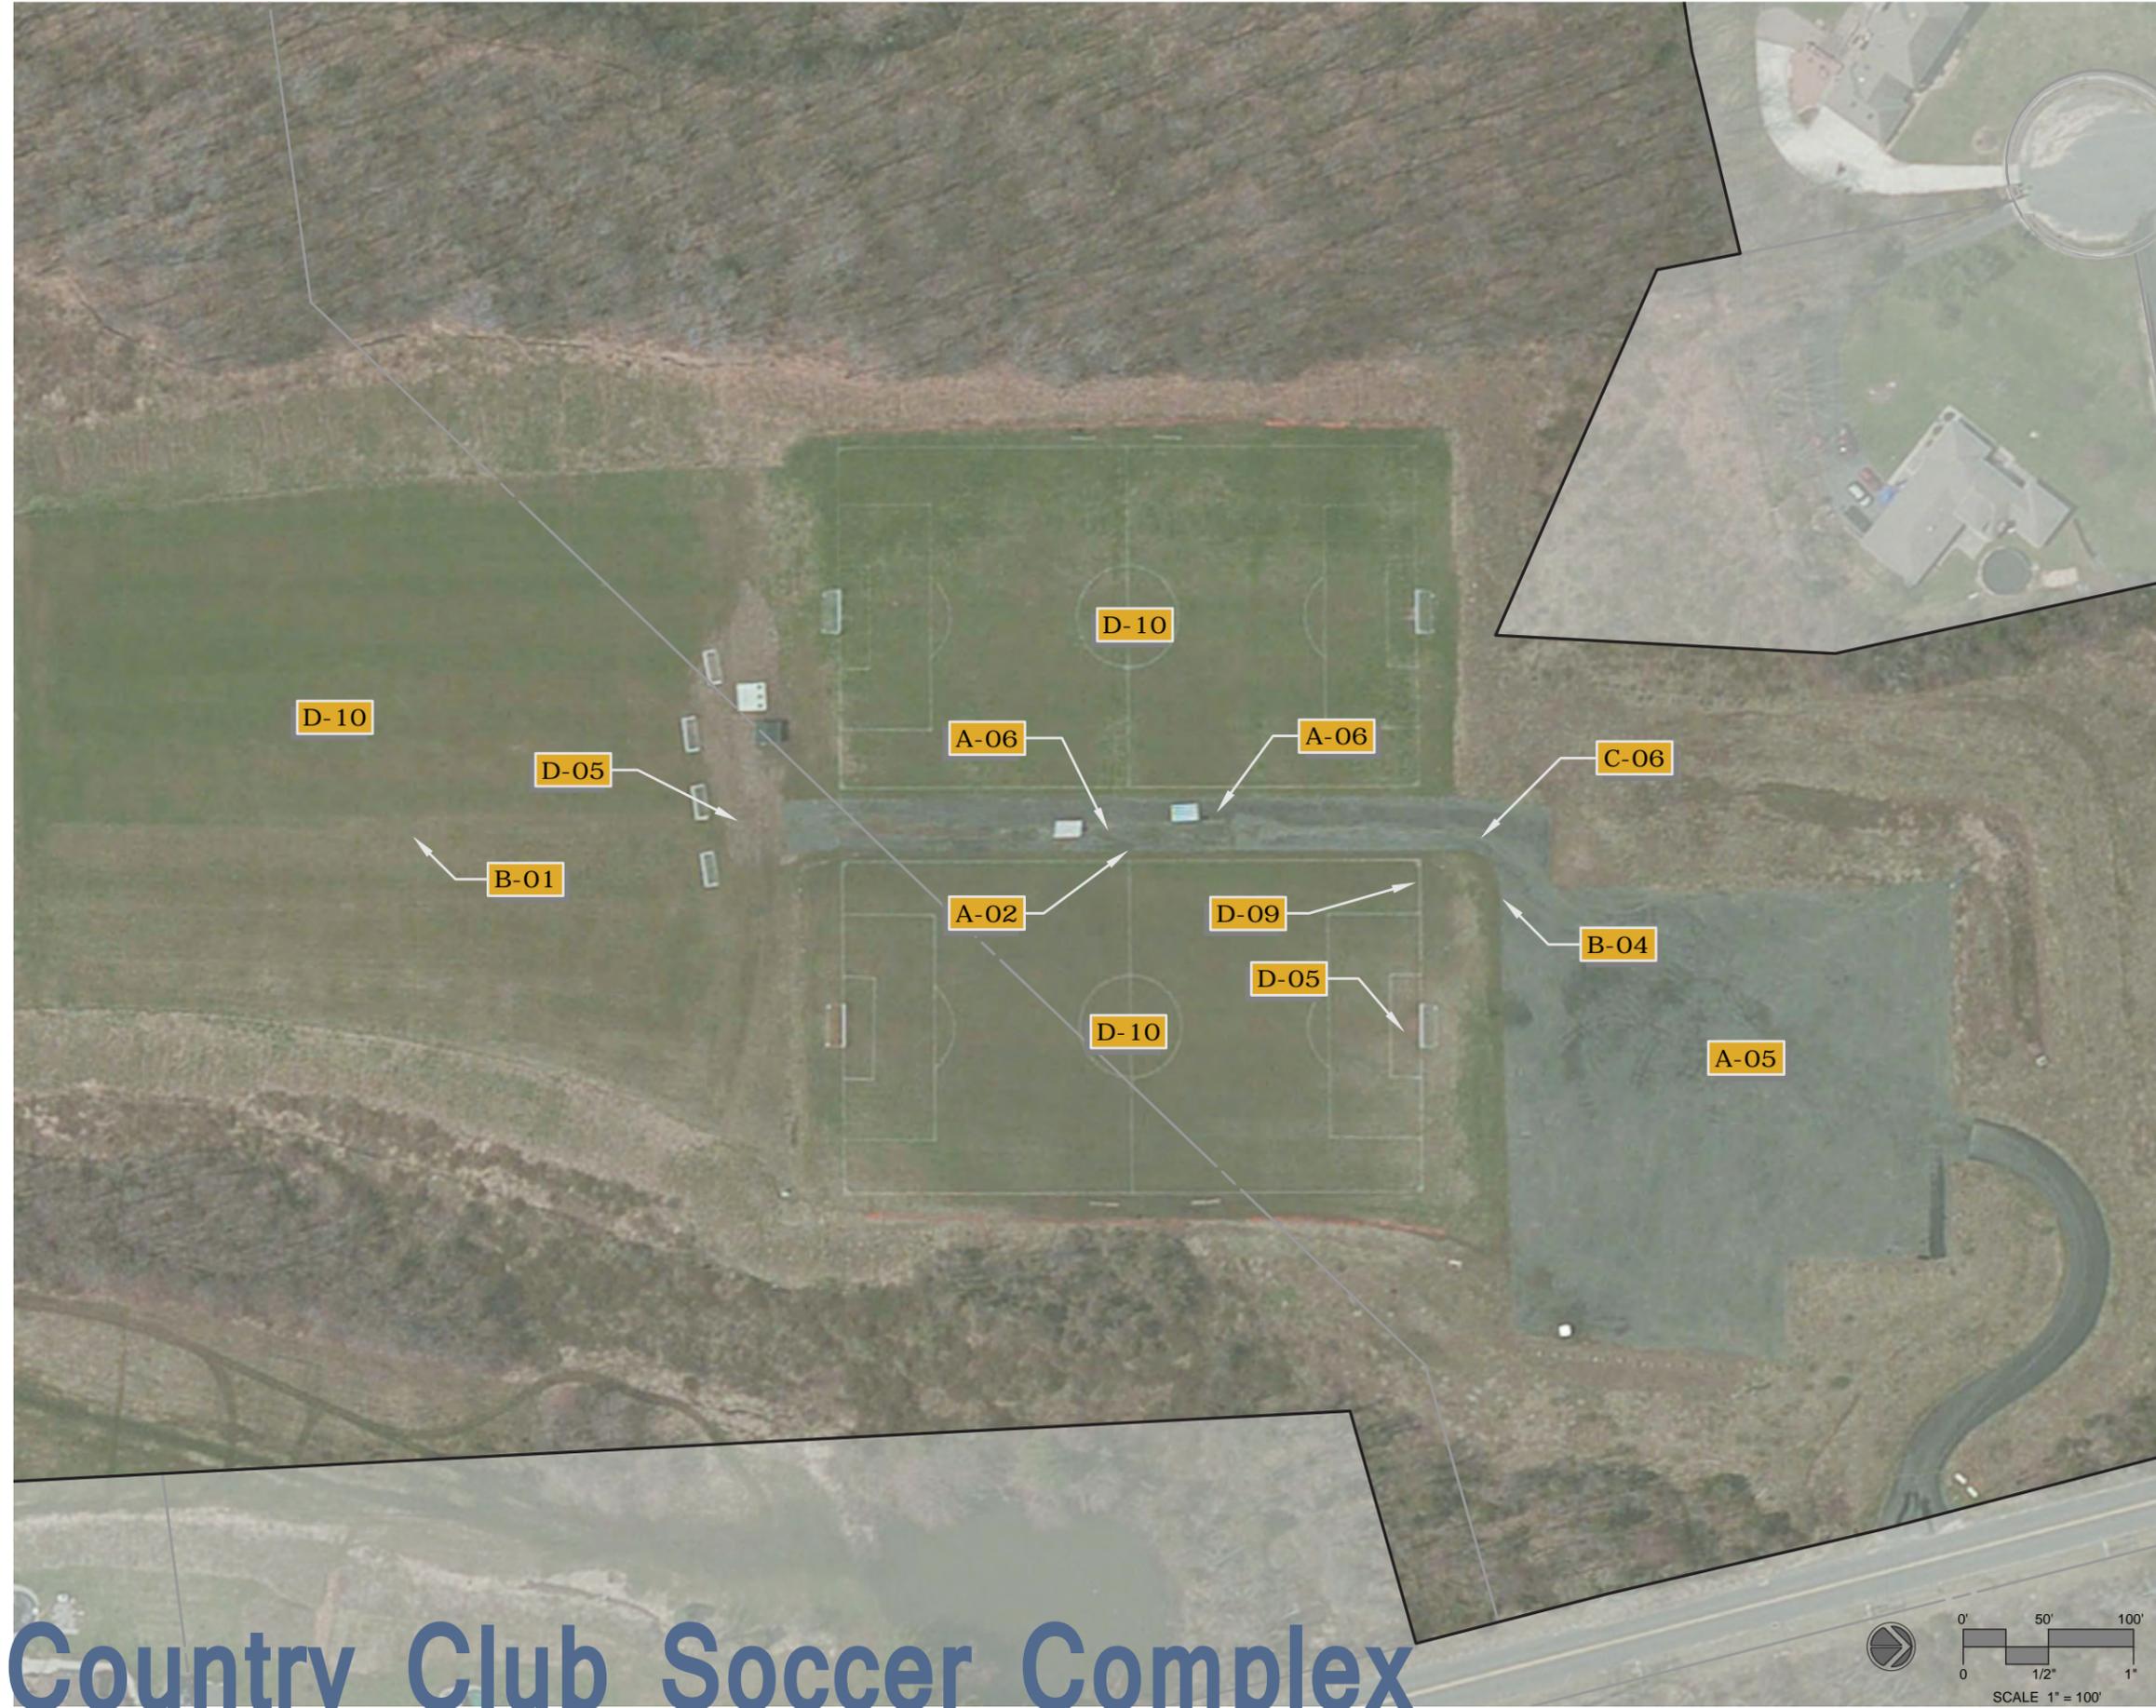
<u>SYMBOL</u>	<u>GENERAL SITE DESCRIPTION</u>
A-02	Drainage Issue
A-05	Pavement in Poor Condition
A-06	Bleachers Not to Code or Damaged
<u>SYMBOL</u>	<u>ACCESSIBILITY DESCRIPTION</u>
B-01	No Pedestrian Connection
B-04	No ADA Parking
<u>SYMBOL</u>	<u>GENERAL ATHLETIC FIELD DESCRIPTION</u>
C-06	Add Gate
<u>SYMBOL</u>	<u>FIELD TURF DESCRIPTION</u>
D-05	Bare Turf Area
D-09	Irrigation System Leak
D-10	Aerate, Overseed, Topdress

Lighted Soccer field is being overused creating bare and damaged turf areas throughout center of field.
