**Evaluation of Athletic  
Fields & Parks**  
Middletown, Connecticut  
April 8, 2015

**Prepared for:**  
City of Middletown  
245 DeKoven Drive  
Middletown, Connecticut 06457

MMI #2708-09-3

**Prepared by:**  
MILONE & MACBROOM, INC.  
99 Realty Drive  
Cheshire, Connecticut 06410  
(203) 271-1773  
[www.miloneandmacbroom.com](http://www.miloneandmacbroom.com)

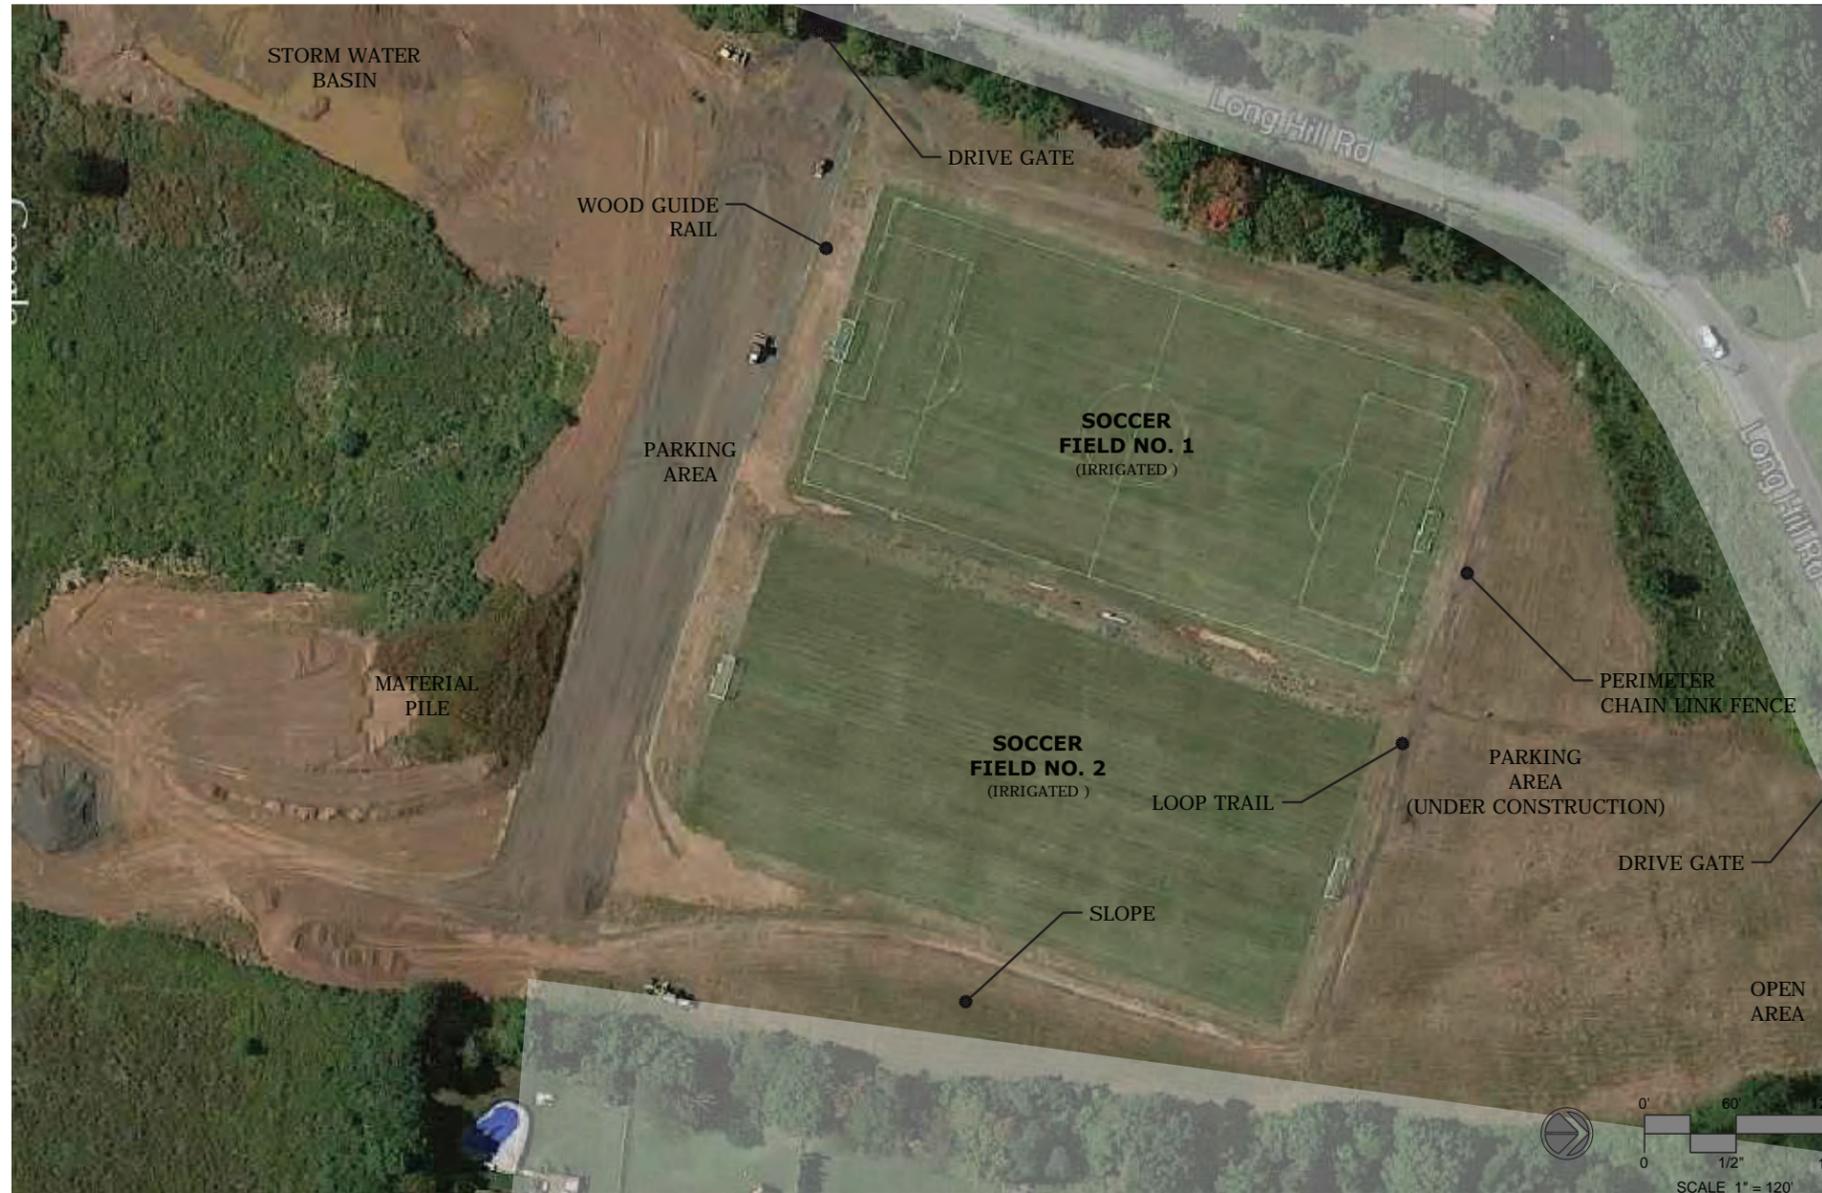
# Long Hill Soccer Fields

- Soccer Field-1** Good Condition, Turf worn from over use at goals, fields need additional attention to continue grown in of quality turf, areas along field edge should also receive care to prevent weed infiltration. Drainage issue between Field 1 and 2.
- Soccer Field-2** Good Condition, Turf slightly worn from over use at goals, fields need additional attention to continue grown in of quality turf, areas along field edge should also receive care to prevent weed infiltration. Large Drainage issue along east edge of field

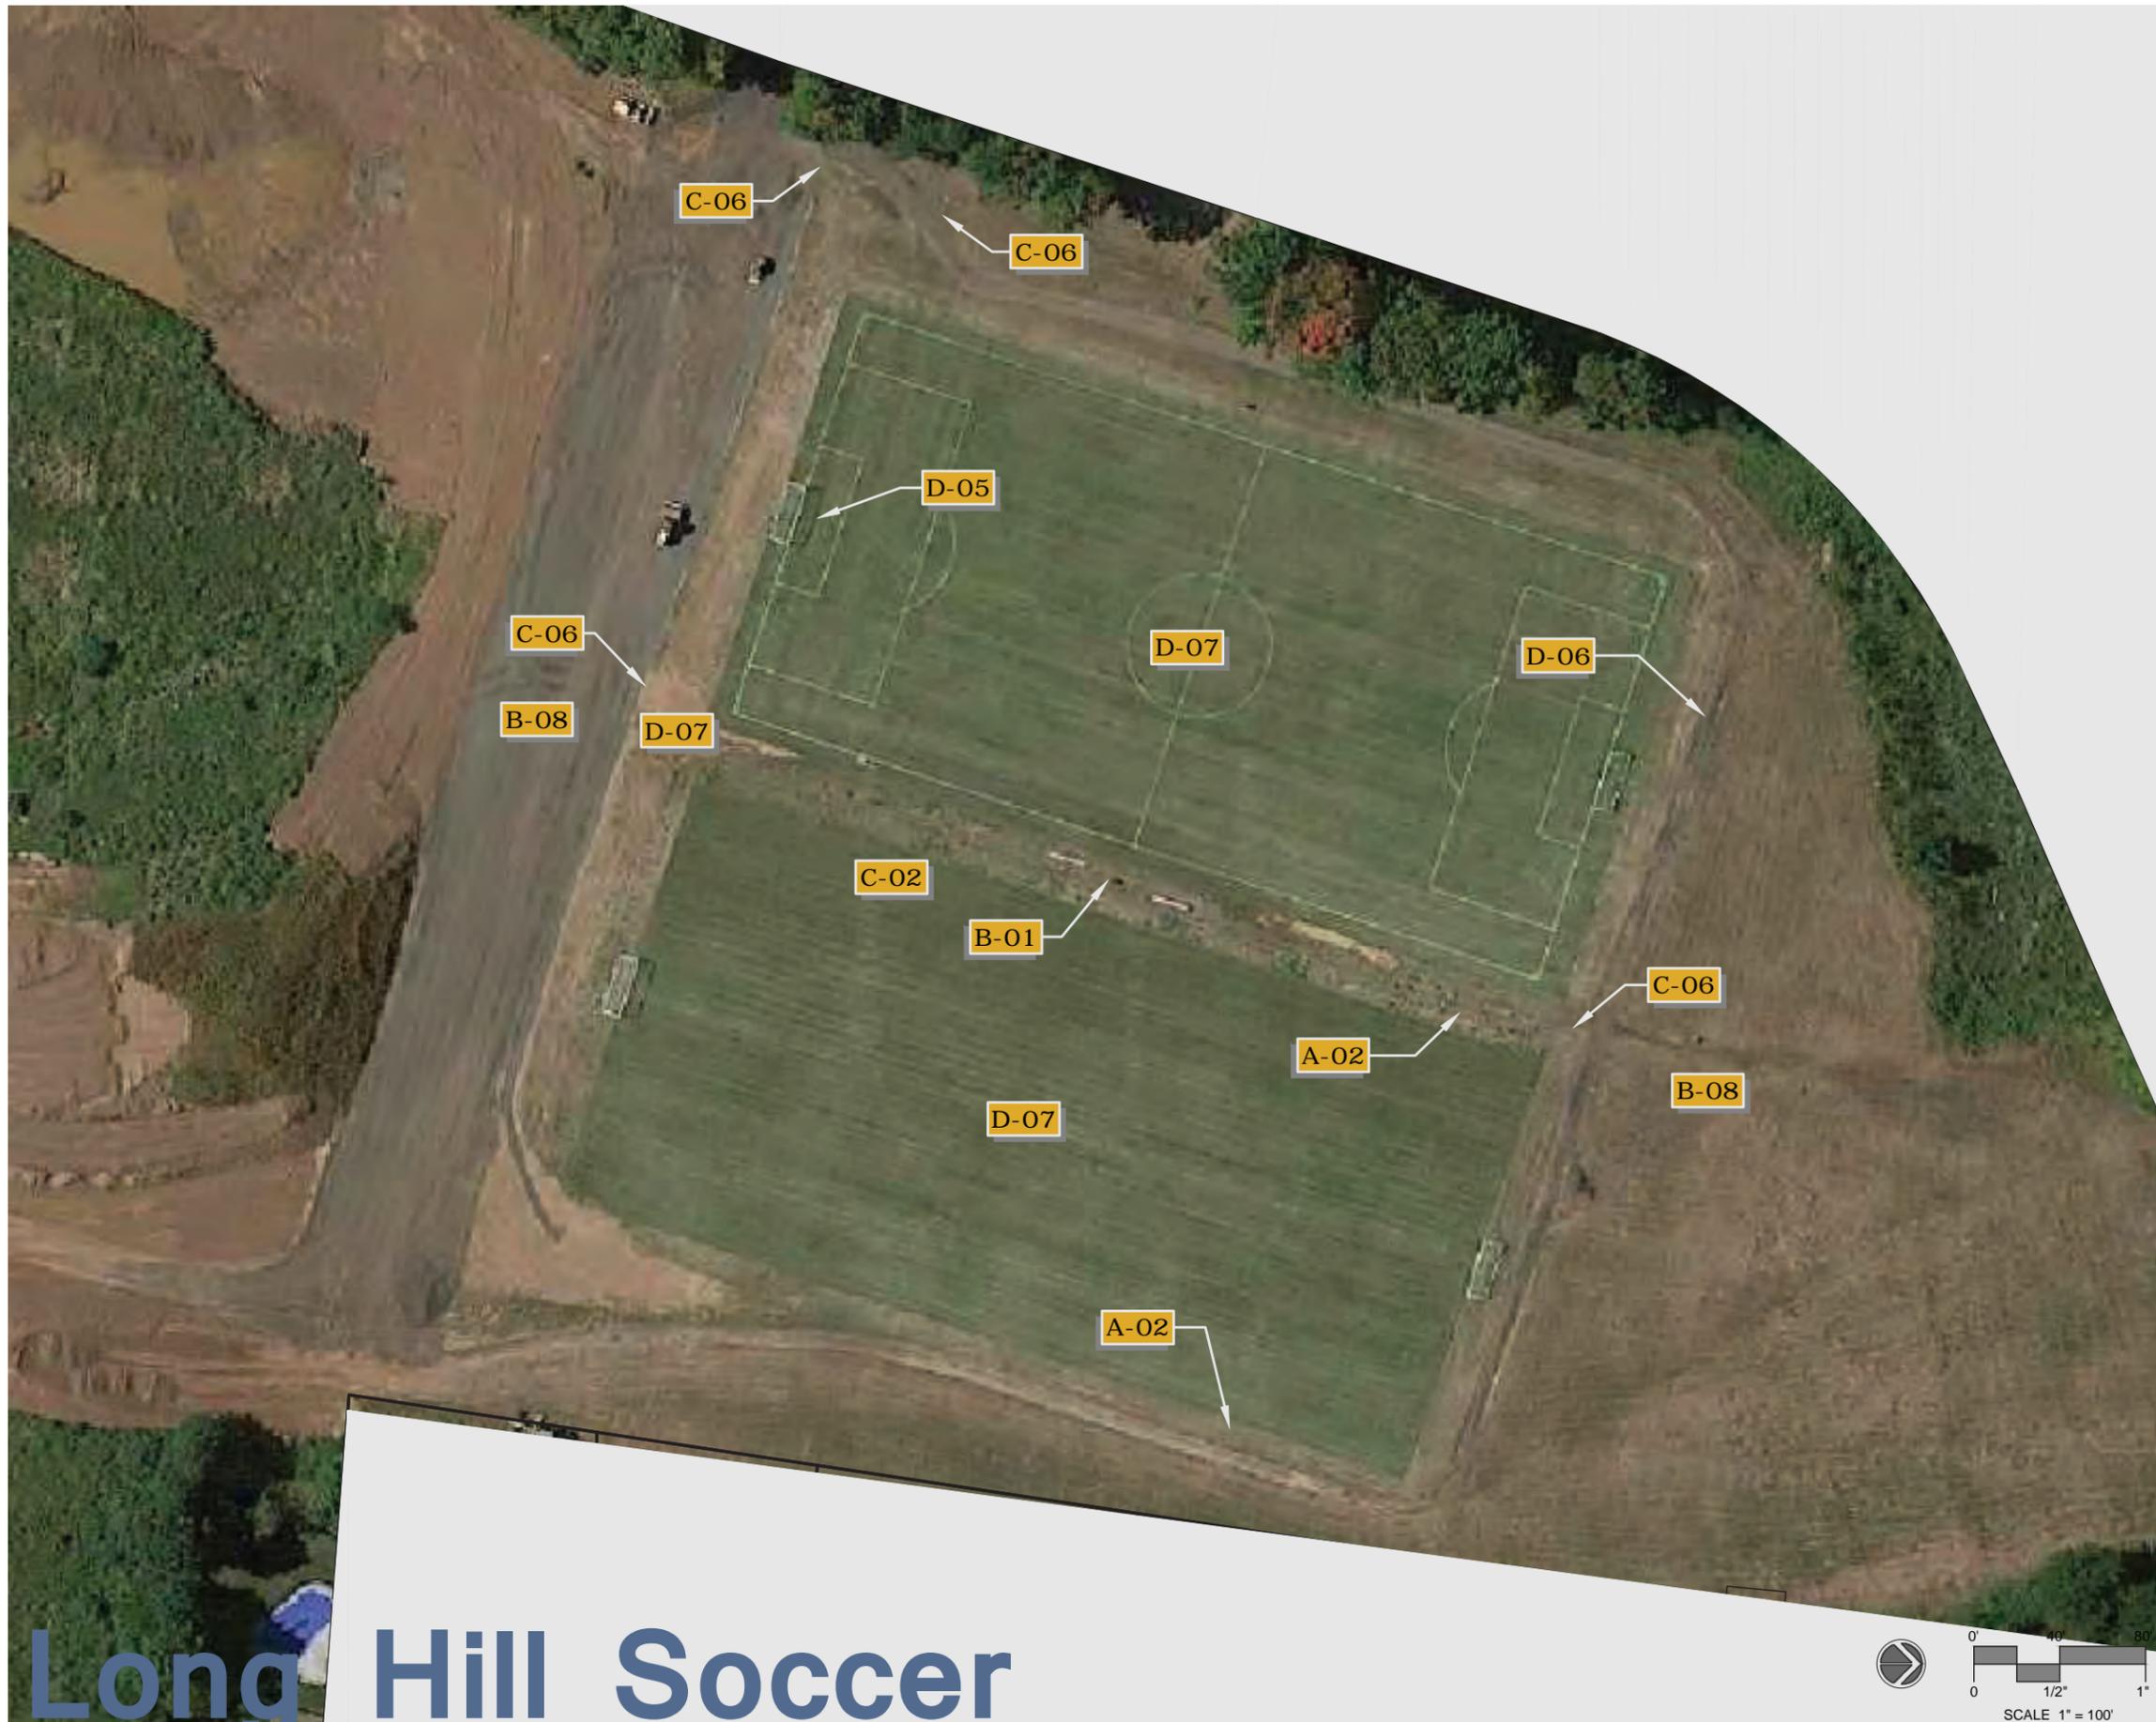
<u>GENERAL SITE DESCRIPTION</u>	
<b>A-02</b>	Drainage Issue
<u>ACCESSIBILITY DESCRIPTION</u>	
<b>B-01</b>	No Pedestrian Connection
<b>B-08</b>	Surface Not ADA Compliant
<u>GENERAL ATHLETIC FIELD DESCRIPTION</u>	
<b>C-02</b>	Lack of Spectator Seating
<b>C-06</b>	Opening in Fence/ Rail
<u>FIELD TURF DESCRIPTION</u>	
<b>D-05</b>	Bare Turf Area
<b>D-06</b>	Excessive Weed Growth
<b>D-07</b>	Turf needs Restoration

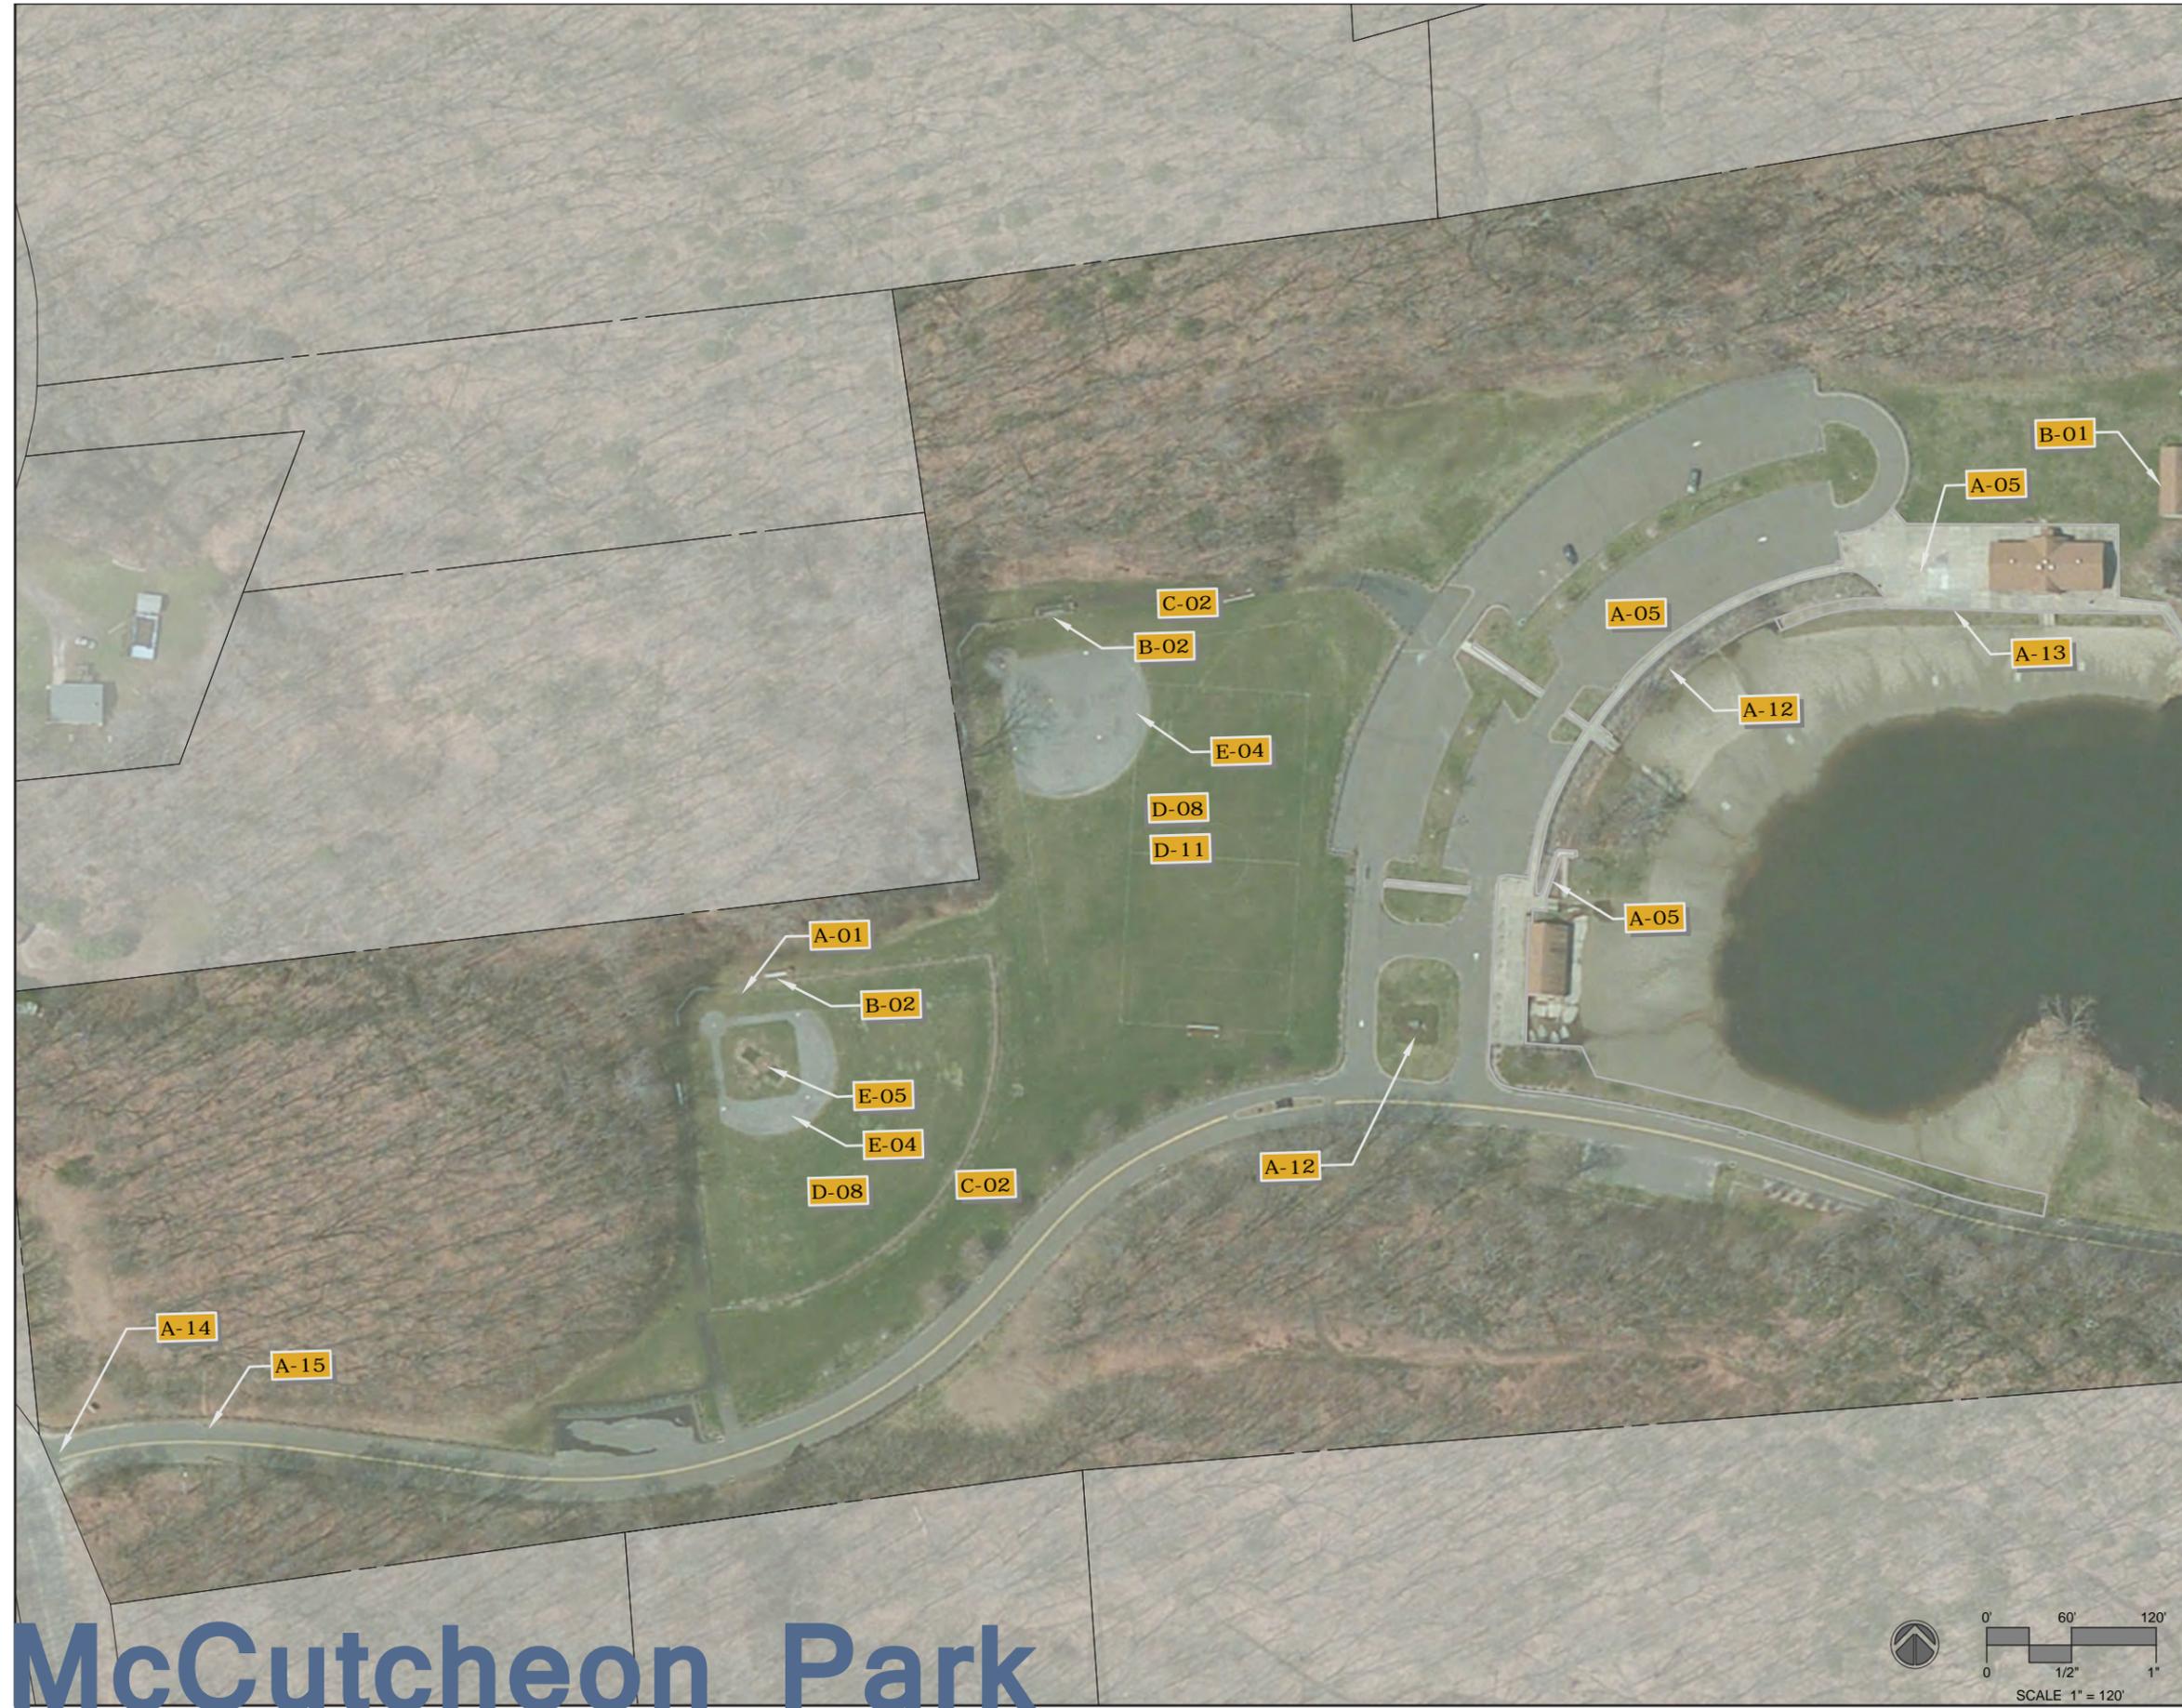
# McCutcheon Park

<u>GENERAL SITE DESCRIPTION</u>	
<b>A-01</b>	Repair Fence
<b>A-05</b>	Pavement in Poor Condition
<b>A-12</b>	Add/ Replace Plantings
<b>A-13</b>	No Railing on Wall
<b>A-14</b>	Park Entry Undefined
<b>A-15</b>	Gate Located in Travel Lanes
<u>ACCESSIBILITY DESCRIPTION</u>	
<b>B-01</b>	No Pedestrian Connection
<b>B-02</b>	No ADA Compliant Route
<u>GENERAL ATHLETIC FIELD DESCRIPTION</u>	
<b>C-02</b>	Lack of Spectator Seating
<u>FIELD TURF DESCRIPTION</u>	
<b>D-08</b>	Turf in Poor Condition
<b>D-11</b>	Check Irrigation System Function
<u>INFIELD DESCRIPTION</u>	
<b>E-04</b>	Excessive Weed Growth
<b>E-05</b>	Reconstruct Mound

Bituminous concrete in parking areas is cracked, ADA spaces are not striped correctly, crosswalks are not striped.

Field turf is in general need of rehabilitation, softball field grade appears to have inadequate pitch to drain.

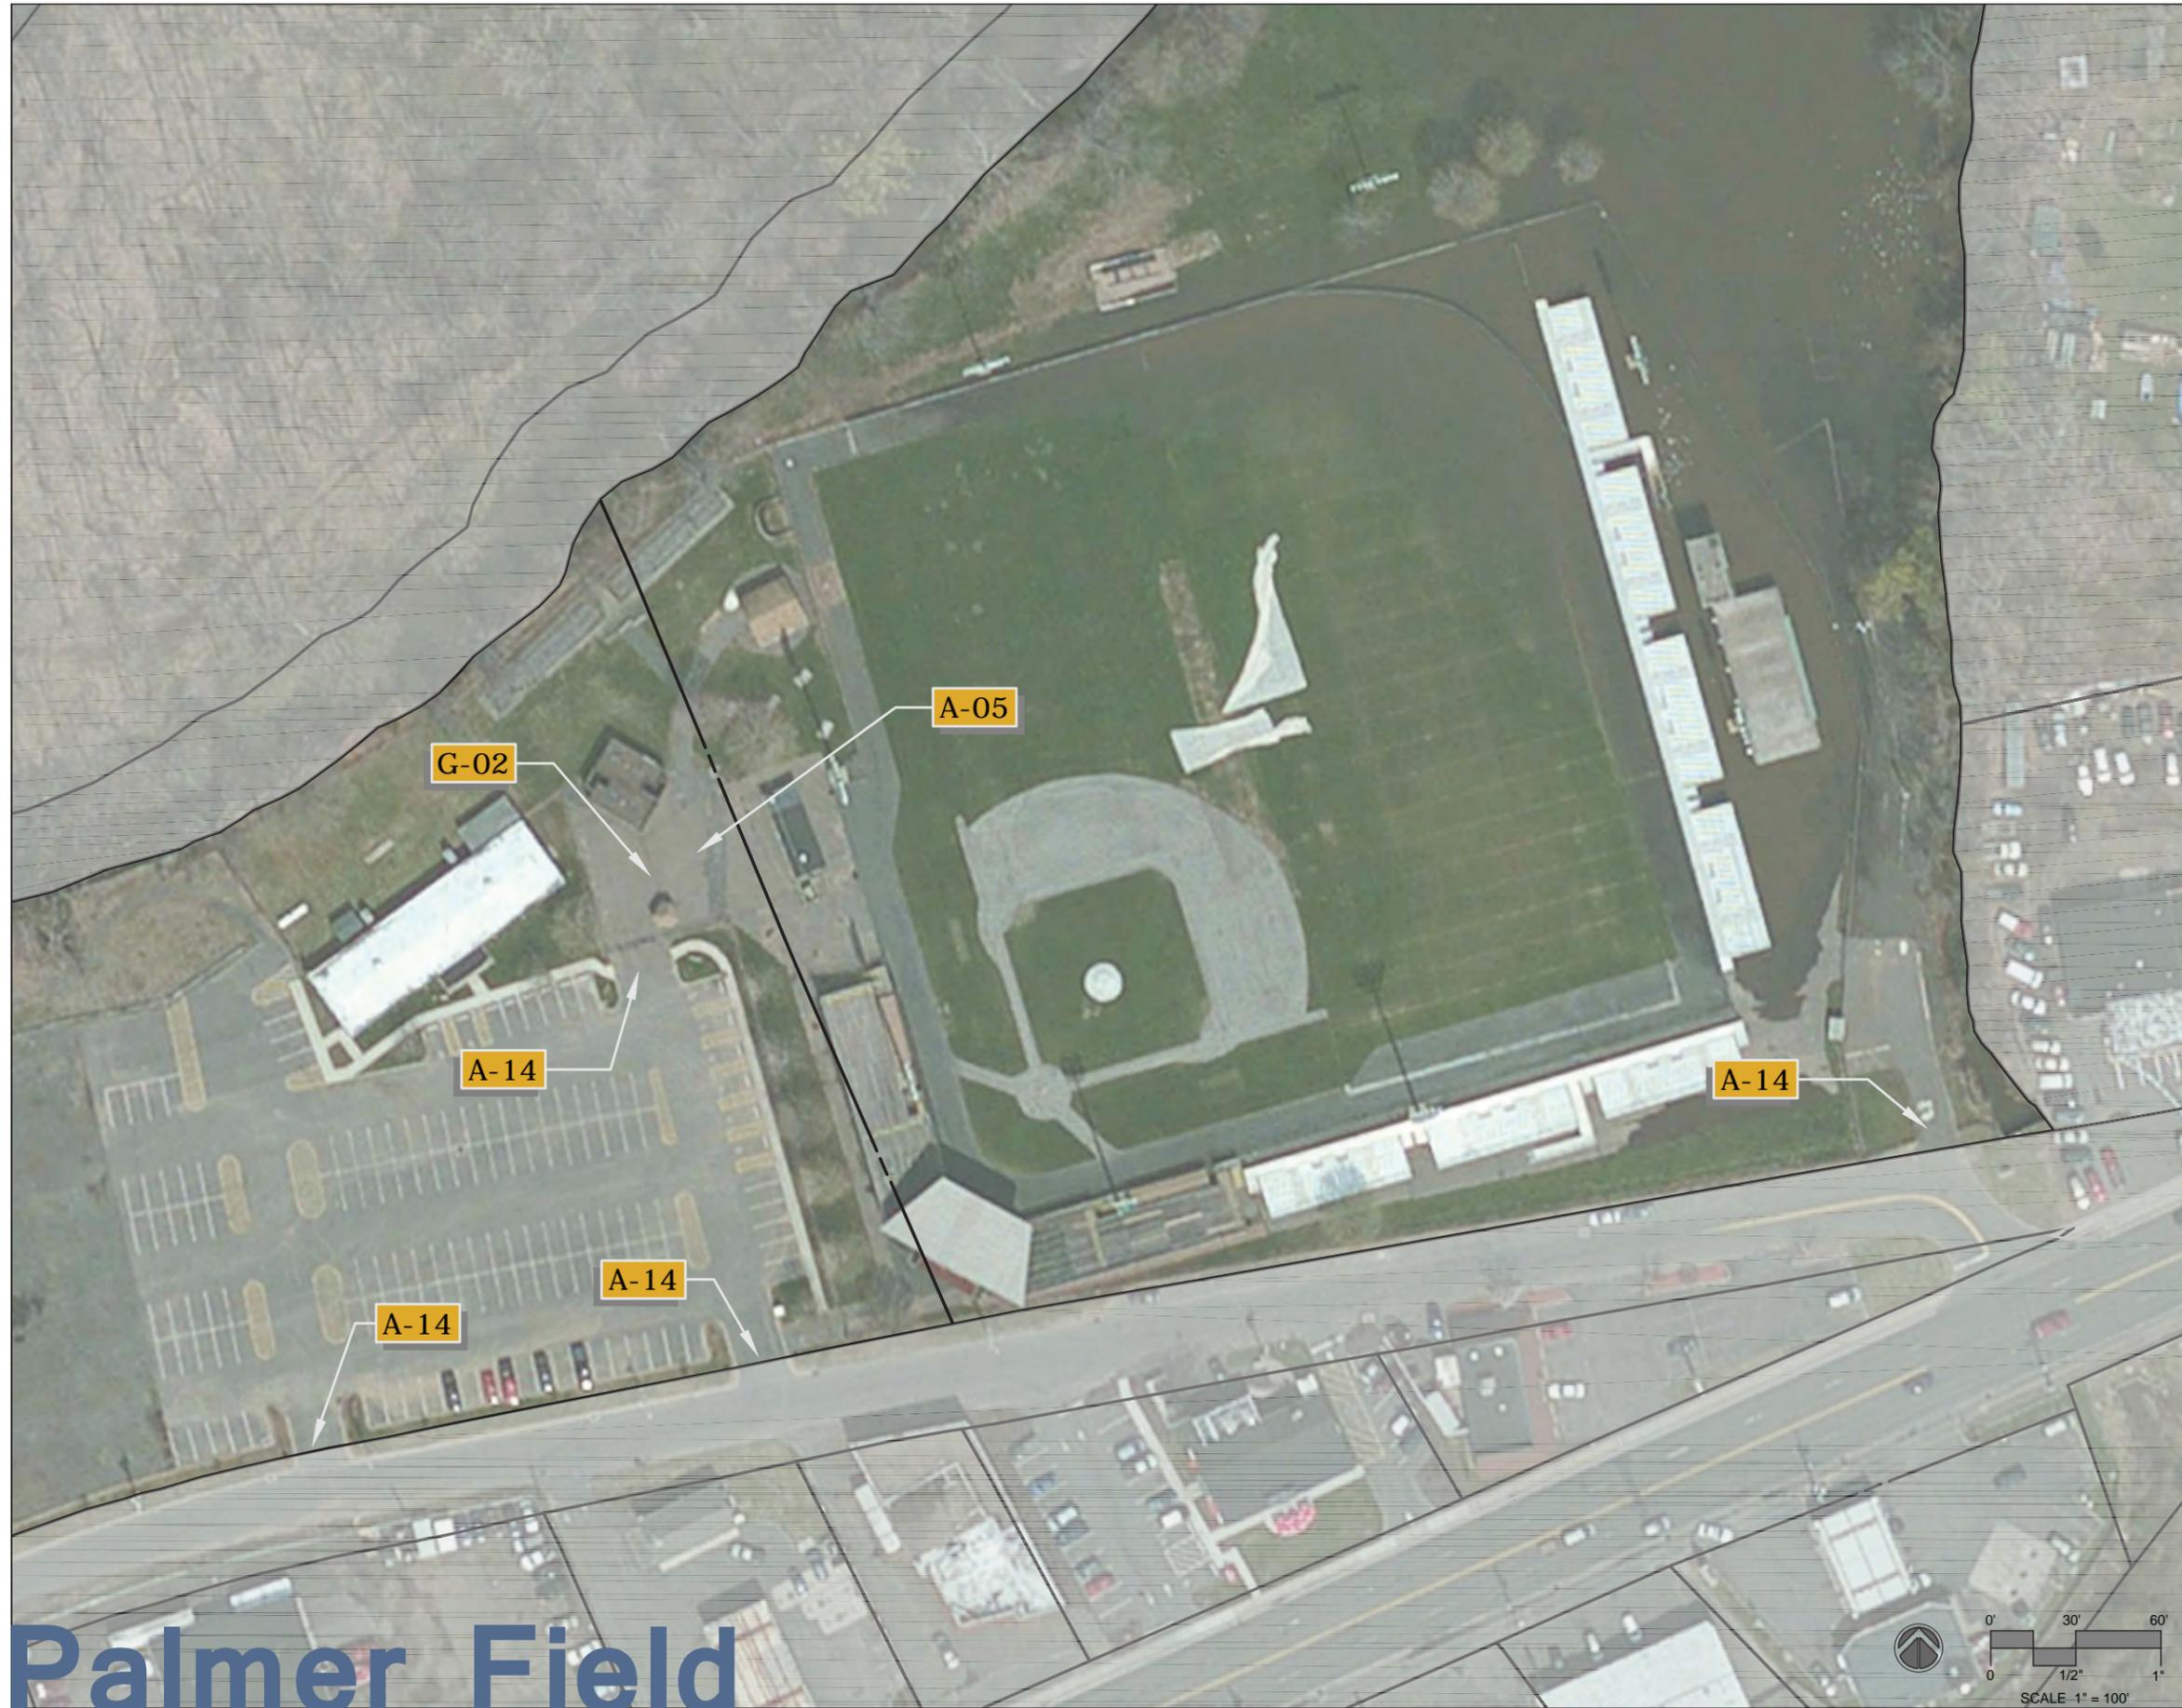
# Palmer Field

<u>SYMBOL</u>	<u>GENERAL SITE DESCRIPTION</u>
A-05	Pavement in Poor Condition
A-14	Park Entry Undefined
<u>SYMBOL</u>	<u>BUILDING FACILITIES DESCRIPTION</u>
G-02	Inconsistent Architecture Styles

Plaza pavement is in general poor condition.  
 Site buildings are well maintained, can be better organized on site.

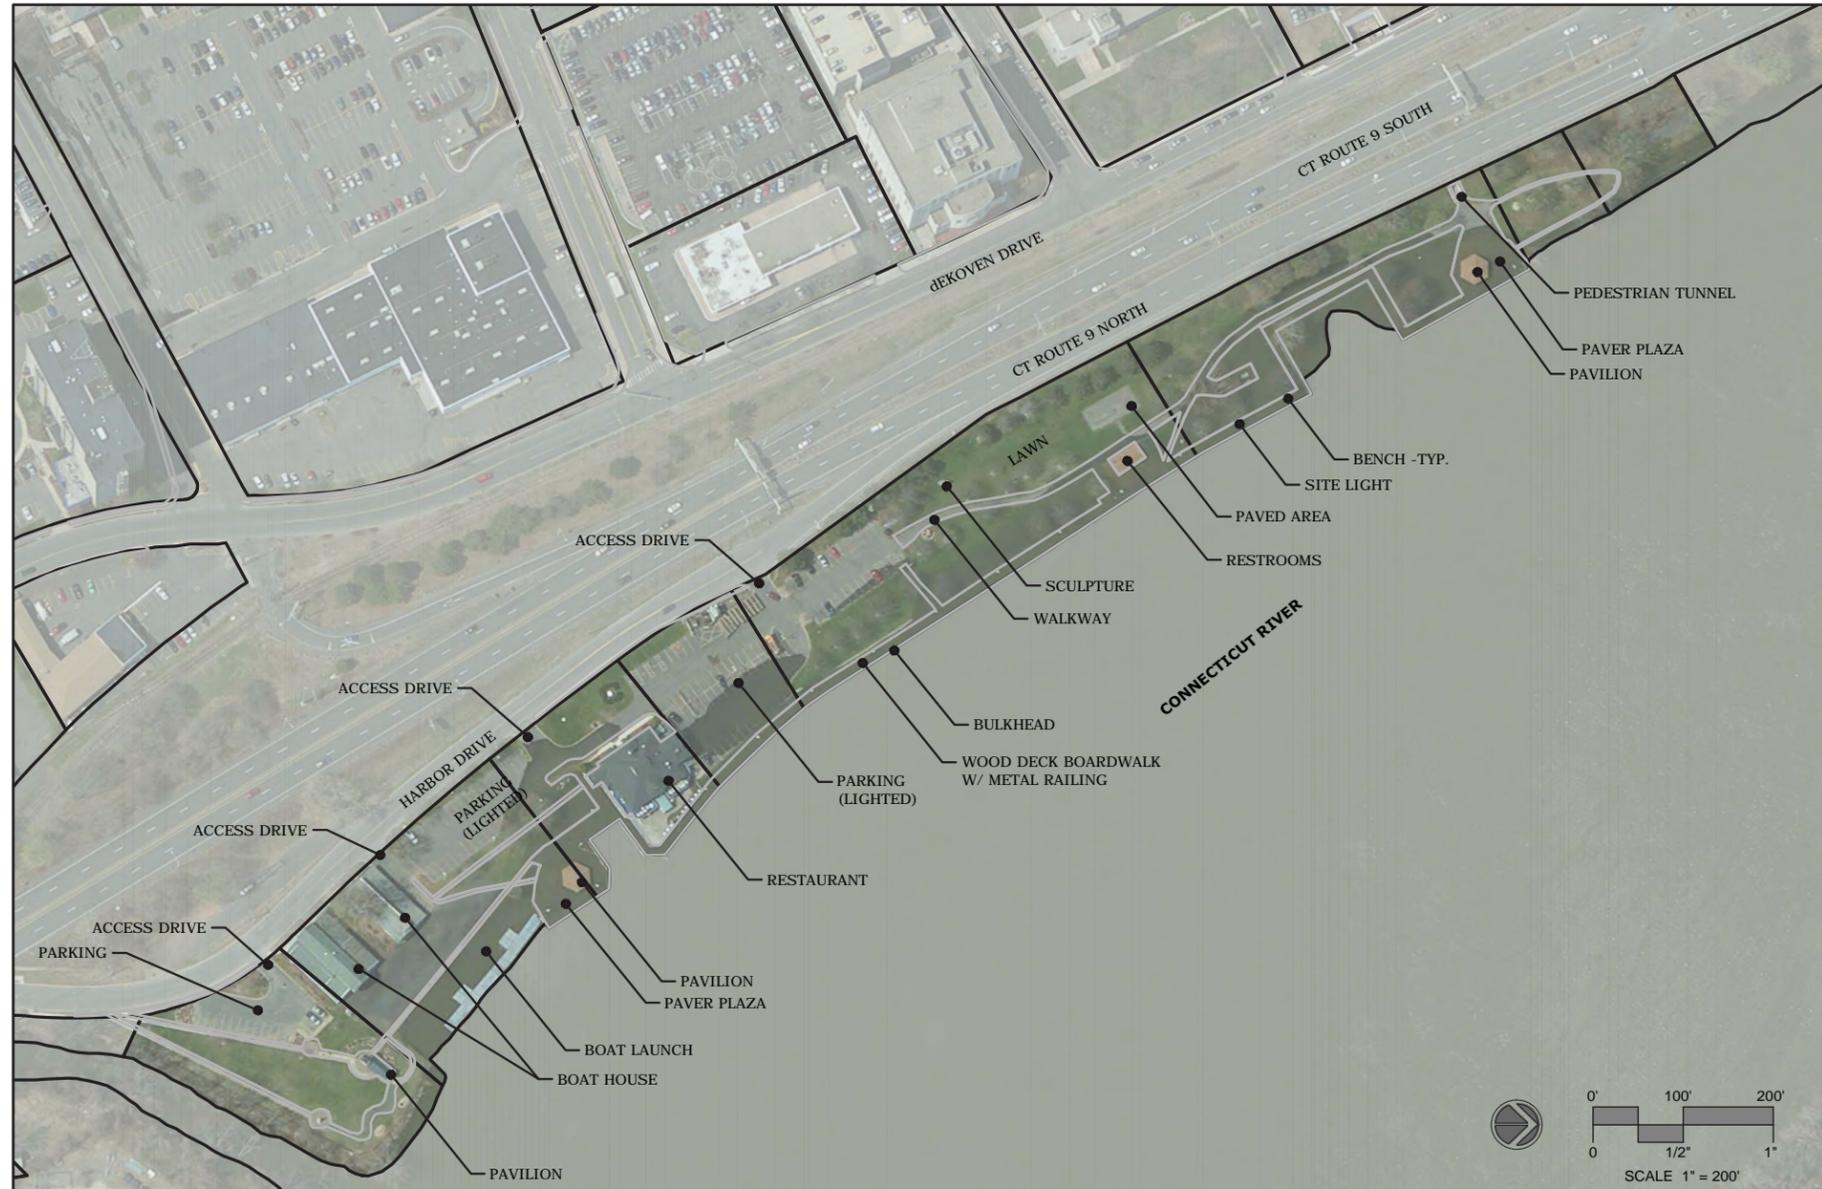
# Harbor Park

**Pedestrian Circulation** Wood decking river walk with paver plazas, and concrete and bituminous concrete connecting walks in good to fair condition.

**Site Facilities:** Evaluation of the site was limited to the condition of the pavement around the eastern two pavilions and the pedestrian connection between them. The pavement in this area is in poor condition and in need or repair.

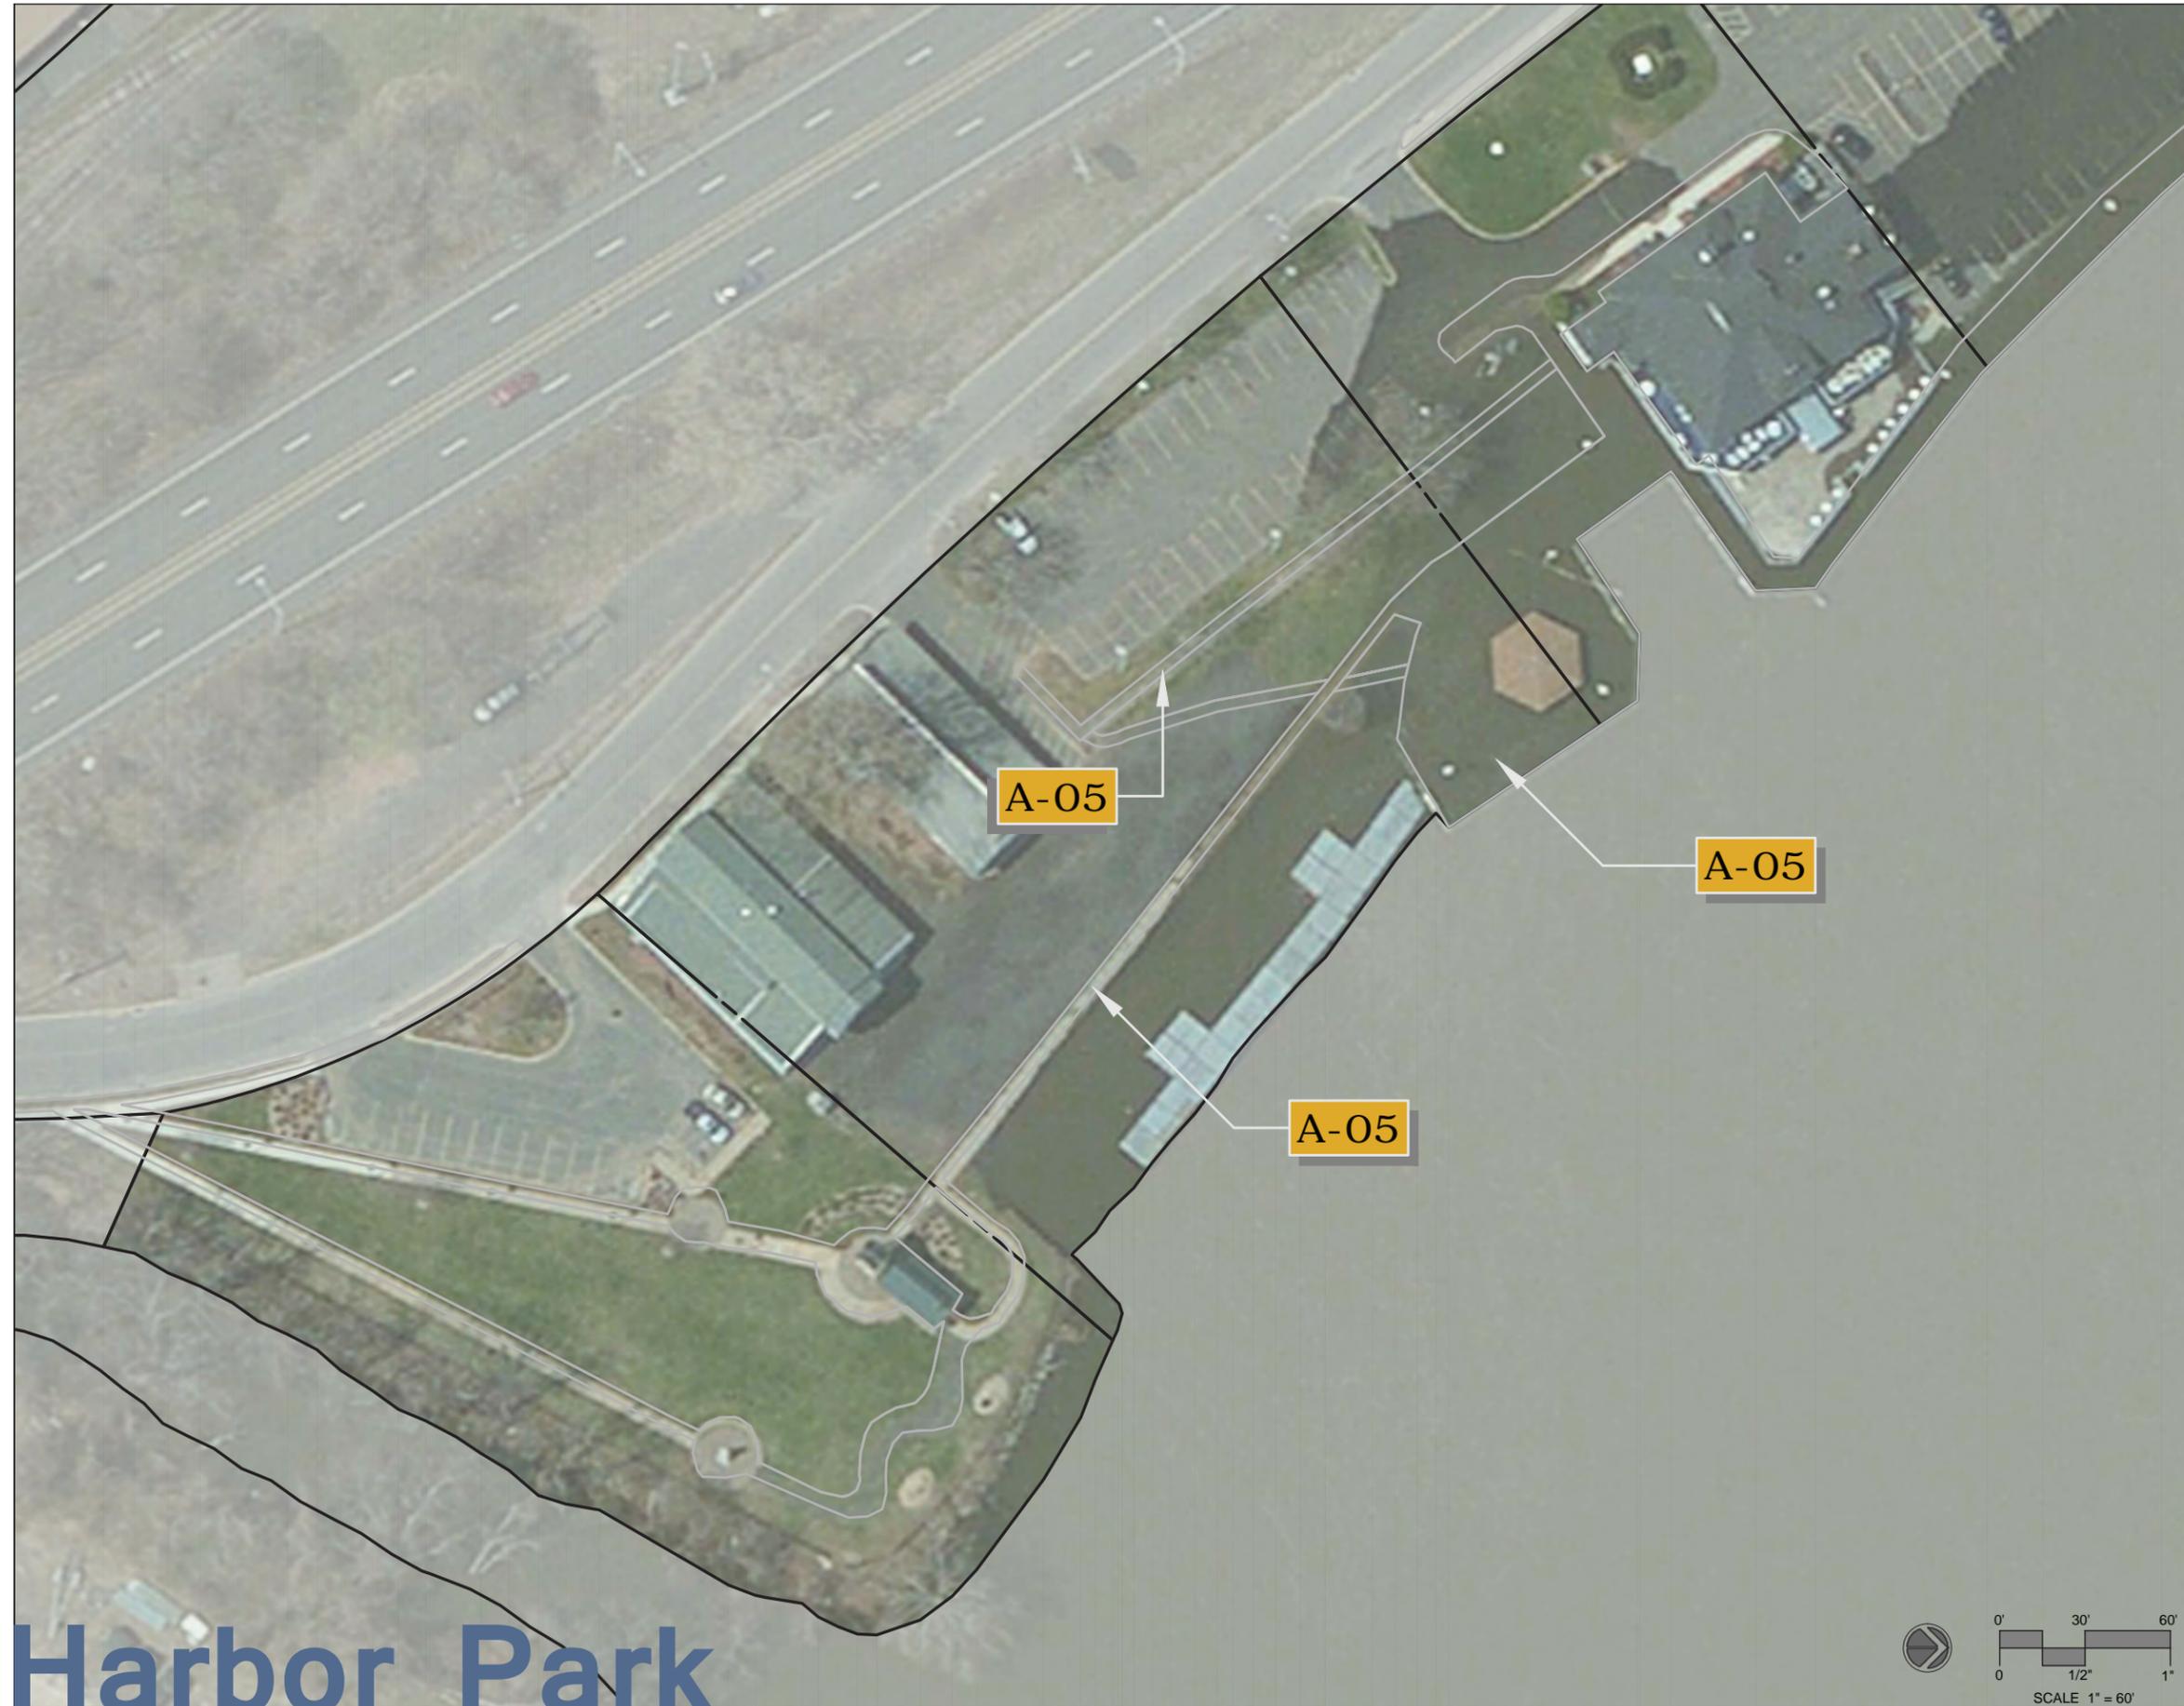
# Harbor Park

<u>SYMBOL</u>	<u>GENERAL SITE DESCRIPTION</u>
A-05	Pavement in Poor Condition

- Pedestrian pavements are in general poor condition.
- Octagonal pavilion is older.
- Wood bollards at parking area have unfinished appearance.
- Add detail to area of flagpoles.
