**Evaluation of Athletic  
Fields & Parks**  
Middletown, Connecticut  
April 8, 2015

**Prepared for:**  
City of Middletown  
245 DeKoven Drive  
Middletown, Connecticut 06457

MMI #2708-09-3

**Prepared by:**  
MILONE & MACBROOM, INC.  
99 Realty Drive  
Cheshire, Connecticut 06410  
(203) 271-1773  
[www.miloneandmacbroom.com](http://www.miloneandmacbroom.com)

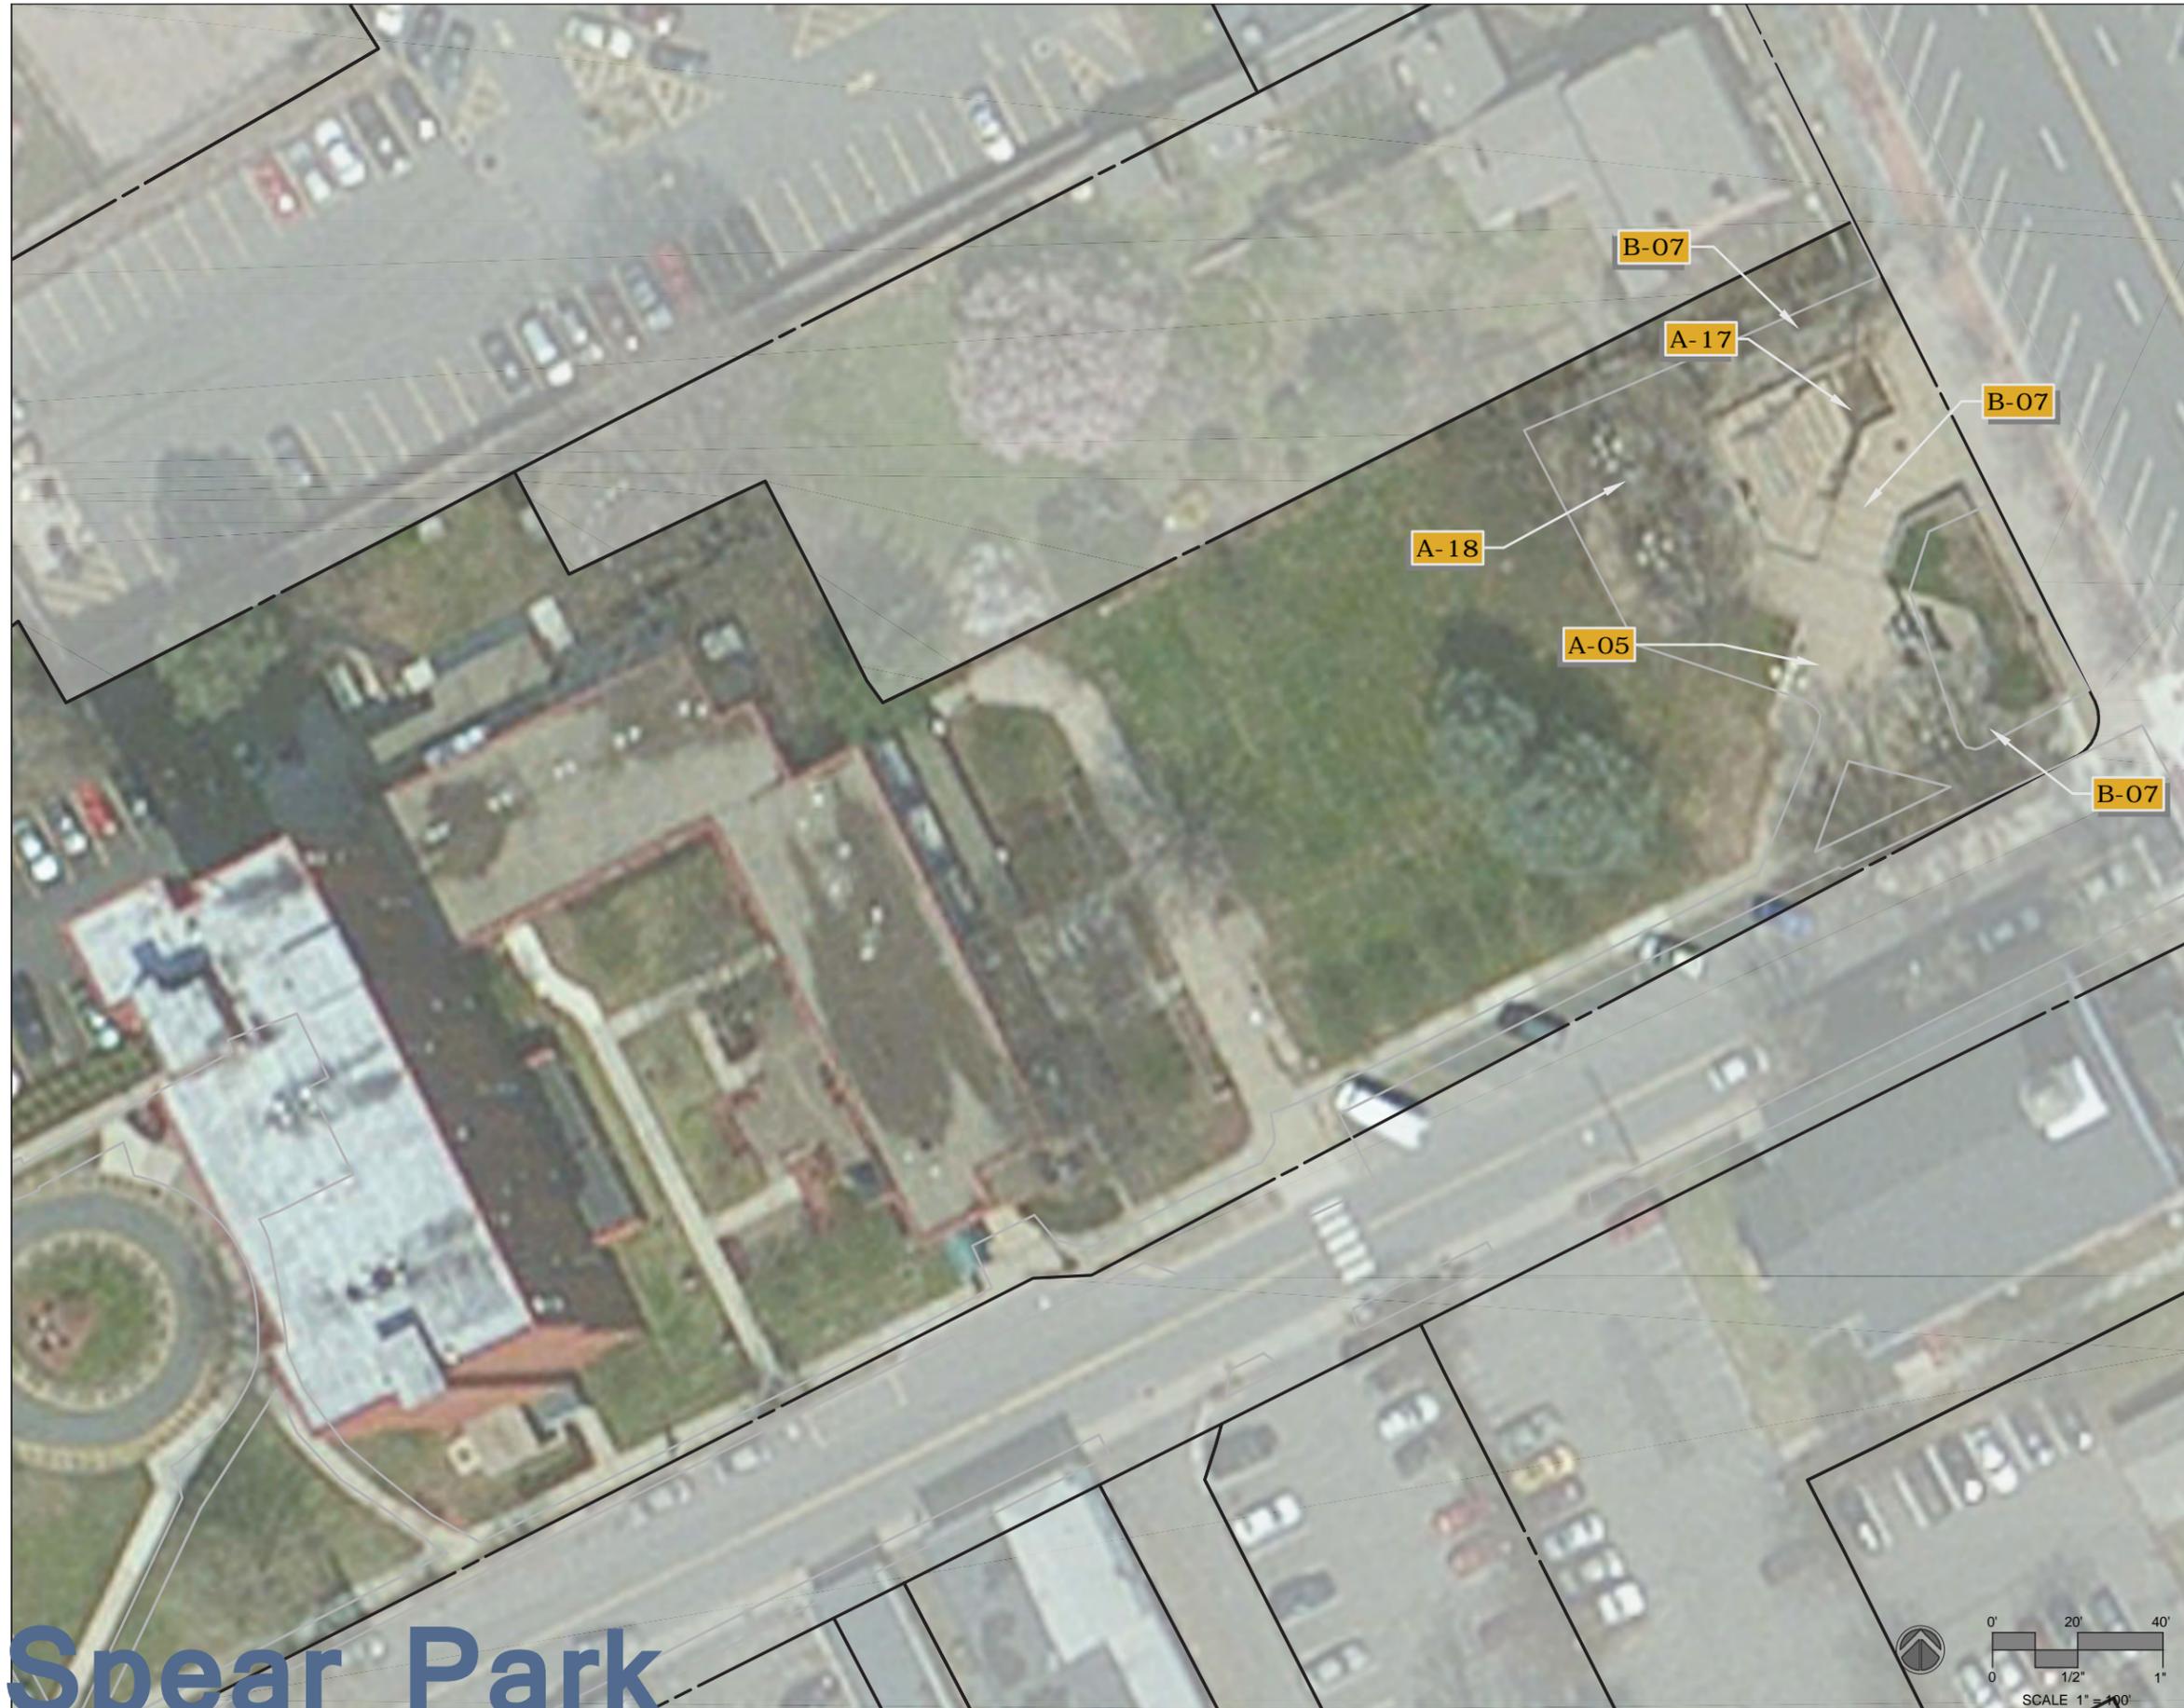
<u>SYMBOL</u>	<u>GENERAL SITE DESCRIPTION</u>
A-05	Pavement in Poor Condition
A-17	Fountain Not Working
A-18	Trees Out Growing Planters
<u>SYMBOL</u>	<u>ACCESSIBILITY DESCRIPTION</u>
B-07	Lack of Stair/ Ramp Railings
