HISTORIC RESOURCES INVENTORY FORM
for Buildings and Structures

- 1. BUILDING NAME: Common: _____ Historic: Samuel Galpin House
- 2. TOWN/CITY: Middletown VILLAGE: Westfield COUNTY: Middlesex
- 3. STREET & NUMBER (and/or location): 1087 Atkins Street
- 4. OWNER(S): Katrina B. Shepard PUBLIC PRIVATE
- 5. USE: Present: Residence Historic: same
- 6. ACCESSIBILITY TO PUBLIC: Exterior visible from public road: yes no
Interior accessible: yes, explain with occupant's permission no

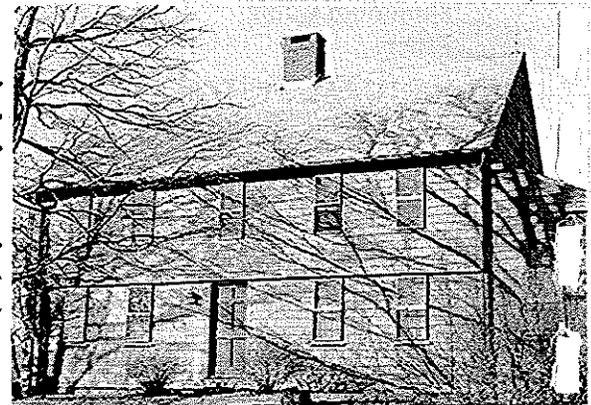
photographer: John E. Reynolds
date: 11/78 view: east
negative on file: Roll 51, #27-27A

Second floor overhang
Lean-to placed on north gable end (later addition)

The center-chimney, two-room-deep plan of this house is typical of mid-eighteenth century construction in the lower Connecticut River valley. The second floor overhang is also typical of this period.
