HISTORIC RESOURCES INVENTORY FORM  
For Buildings and Structures

- 1. BUILDING NAME: Common: \_\_\_\_\_ Historic: Wilcox-Keefe House
- 2. TOWN/CITY: Middletown VILLAGE: \_\_\_\_\_ COUNTY: Middlesex
- 3. STREET & NUMBER (and/or location): 160 Boston Road
- 4. OWNER(S): Leo A. & Denise A. Lensing PUBLIC  PRIVATE
- 5. USE: Present: Residence Historic: same
- 6. ACCESSIBILITY TO PUBLIC: Exterior visible from public road:  yes  no  
Interior accessible:  yes, explain \_\_\_\_\_  no

- 7. STYLE OF BUILDING: Federal DATE OF CONSTRUCTION: c. 1835  
(before 1841)
- 8. MATERIAL(S) (indicate use or location when appropriate):  
 clapboard      \_\_\_ asbestos siding      \_\_\_ brick  
\_\_\_ wood shingle      \_\_\_ asphalt siding      \_\_\_ fieldstone  
\_\_\_ board & batten      \_\_\_ stucco      \_\_\_ cobblestone  
\_\_\_ aluminum siding      \_\_\_ concrete: type: \_\_\_\_\_  cut stone: type: brownstone  
\_\_\_ other: \_\_\_\_\_ foundation

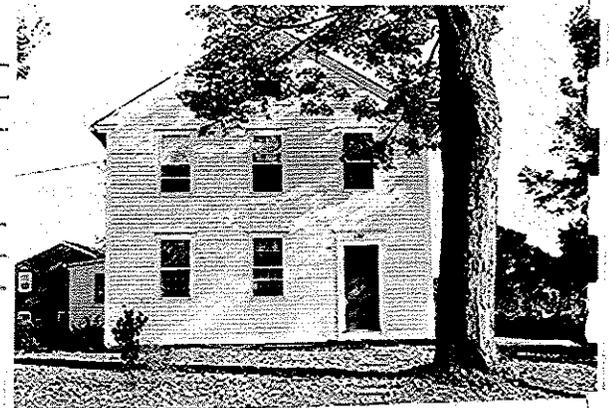
PHOTOGRAPH

The Wilcox-Keefe house is an early example of the use of the three-bay wide, gable-to-street configuration in Middletown. It displays a delicate cornice with short return rather than the pediment commonly found in Greek Revival houses of this type. The house shows the lingering influence of the Federal style in the treatment of the window caps and entranceway. The Wilcox-Keefe house represents a transitional phase from the Federal to the Greek Revival style, and is in fine, well-preserved condition.

photographer: Elizabeth Loomis  
date: 10/78 view: west  
negative on file: Roll 48, #17A-18
