HISTORIC RESOURCES INVENTORY FORM

- 1. BUILDING NAME: Common: Christian Science Church Historic: Second Randolph Pease House
- 2. TOWN/CITY: Middletown VILLAGE: _____ COUNTY: Middlesex
- 3. STREET & NUMBER (and/or location): 151 College Street
- 4. OWNER(S): First Church of Christ Scientist PUBLIC PRIVATE
- 5. USE: Present: Church Historic: Residence
- 6. ACCESSIBILITY TO PUBLIC: Exterior visible from public road: yes no
Interior accessible: yes, explain with Church's permission no

Second Randolph Pease House
151 College Street, Middletown, CT 06457

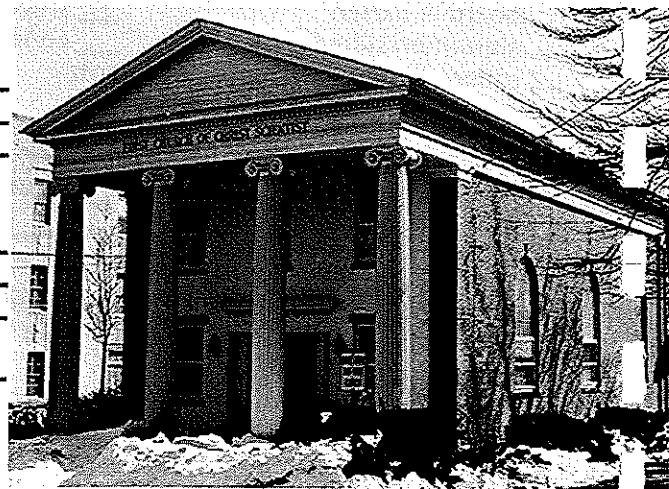
PHOTOGRAPH

Two story portico with fluted Ionic columns supporting denticulated pediment

photographer: Elizabeth Loomis
date: 2/78 view: north and west facades
negative on file: Roll 13, #29A
