HISTORIC RESOURCES INVENTORY FORM
For Buildings and Structures

- 1. BUILDING NAME: Common: Salvation Army Hall Historic: Middlesex Banking Co.
- 2. TOWN/CITY: Middletown VILLAGE: _____ COUNTY: Middlesex
- 3. STREET & NUMBER (and/or location): 179 Court Street
- 4. OWNER(S): The Salvation Army PUBLIC PRIVATE
- 5. USE: Present: Headquarters of The Salvation Army Historic: Bank
- 6. ACCESSIBILITY TO PUBLIC: Exterior visible from public road: yes no
Interior accessible: yes, explain with permission no

- 7. STYLE OF BUILDING: Romanesque Revival DATE OF CONSTRUCTION: 1884
- 8. MATERIAL(S) (indicate use or location when appropriate):
 clapboard asbestos siding brick
 wood shingle asphalt siding fieldstone
 board & batten stucco cobblestone
 aluminum siding concrete: type: _____ cut stone: type: brownstone
 other: _____ (coursed ashlar)

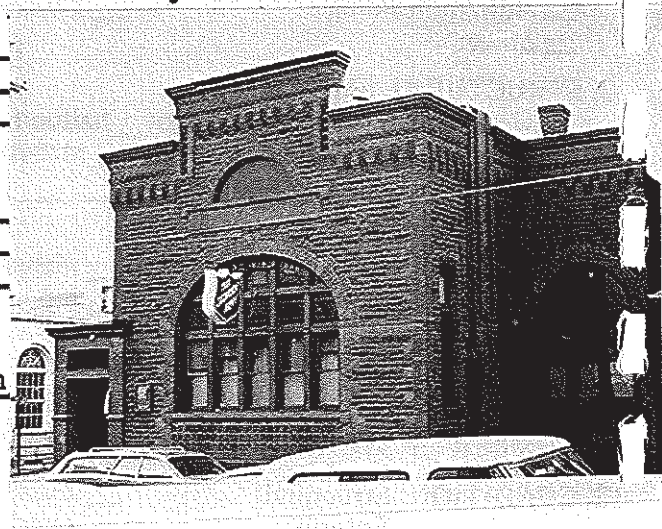
PHOTOGRAPH

This small, low building with its roughly textured surfaces reflects the influence of H.F. Richardson. Smooth and rock faced ashlar contrast with brick arches, quoins and corbelled parapet. This textural treatment is further emphasized by grouped courses of terra cotta tile and smooth, narrow brownstone sills. The main feature of the facade is a broad arched window with stained glass in its uppermost lights. This illuminates the building's largest room, originally used as the bank's lobby. This room retains much interior wood finish: deeply recessed ceiling panelled wainscoting; and dentillated moldings.

photographer: Elizabeth Loomis
date: 12/78 view: north
negative on file: ROLL 56, #34A-35
