HISTORIC RESOURCES INVENTORY FORM
For Buildings and Structures

- 1. BUILDING NAME: Common: Methodist Church Historic: The First Methodist Church
- 2. TOWN/CITY: Middletown VILLAGE: _____ COUNTY: Middlesex
- 3. STREET & NUMBER (and/or location): 24 Church Street
- 4. OWNER(S): First United Methodist Church PUBLIC PRIVATE
- 5. USE: Present: Church Historic: same
- 6. ACCESSIBILITY TO PUBLIC: Exterior visible from public road: yes no
Interior accessible: yes, explain house of worship no

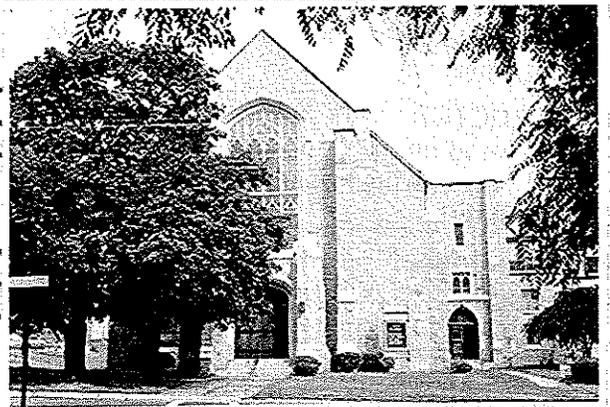
PHOTOGRAPH

Although the granite construction of the Methodist Church is unusual in Middletown, the use of the Gothic style is common. The gabled nave is buttressed and the corners are capped with pinnacles. The chief features of the facade are the compound-arched entranceway with double doors, and the tall pointed arched stained glass window.

photographer: John E. Reynolds
date: 11/78 view: south
negative on file: Roll 51, #2-2A
