HISTORIC RESOURCES INVENTORY FORM
for Buildings and Structures

- 1. BUILDING NAME: Common: _____ Historic: Levaughn-Arnold House
- 2. TOWN/CITY: Middletown VILLAGE: _____ COUNTY: Middlesex
- 3. STREET & NUMBER (and/or location): 97 Chestnut Street
- 4. OWNER(S): Walter A. Seagrave PUBLIC X PRIVATE
- 5. USE: Present: Residence Historic: same
- 6. ACCESSIBILITY TO PUBLIC: Exterior visible from public road: X yes no
Interior accessible: X yes, explain with permission no

- 7. STYLE OF BUILDING: Italianate DATE OF CONSTRUCTION: 1870-74
- 8. MATERIAL(S) (indicate use or location when appropriate):

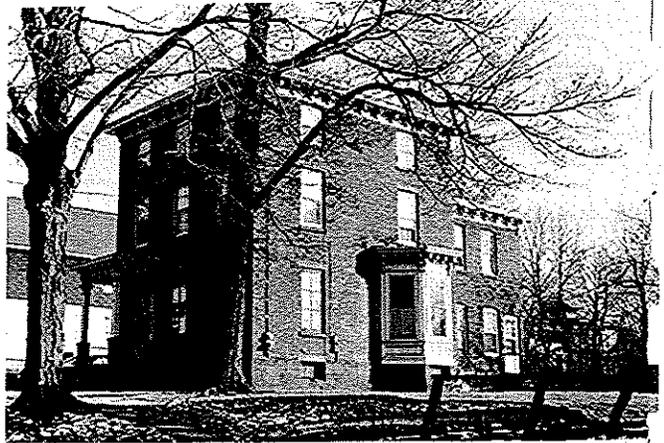
photographer: Robert Svec
date: 12/78 view: northwest
negative on file: Roll 55, #16-16A

The most significant aspect of this tall Italianate residence is its unaltered condition and well-preserved appearance. The house has a large original two-story ell at the rear. It displays an entrance porch on the main facade and a bay window on the west side. These two features exhibit brackets, like the cornice that borders the nearly flat roof; and illustrate the decorative characteristics of the Italianate style. This building type was popular in the vicinity during the 1860s and 70s. Other Italianate houses of note in the neighborhood are at 77 Chestnut Street, and 8 and 14 Walnut Street.
