HISTORIC RESOURCES INVENTORY FORM
For Buildings and Structures

- 1. BUILDING NAME: Common: _____ Historic: Mary & Luther Eldridge House
- 2. TOWN/CITY: Middletown VILLAGE: _____ COUNTY: Middlesex
- 3. STREET & NUMBER (and/or location): 99 East Main Street
- 4. OWNER(S): Elizabeth and Wanda M. Winner PUBLIC PRIVATE
- 5. USE: Present: Residence Historic: same
- 6. ACCESSIBILITY TO PUBLIC: Exterior visible from public road: yes no
Interior accessible: yes, explain _____ no

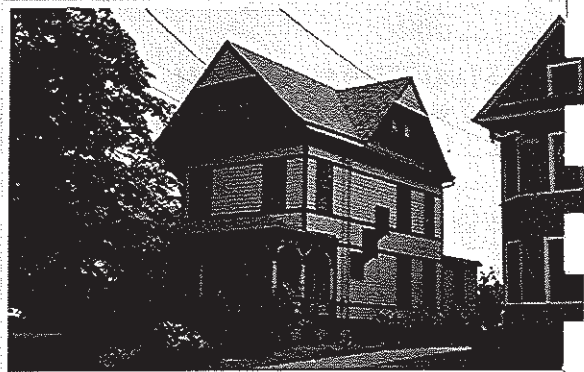
photographer: Robert Svec
date: 6/78 view: east
negative on file: Roll 27, #11

Leaded stained glass windows on south side
Chimney pots on north side

18. HISTORICAL OR ARCHITECTURAL IMPORTANCE: This house, built for Luther Eldridge, a superintendent of the Russell Manufacturing Company, was constructed after his wife Mary purchased the property in 1887. It displays many features characteristic of the Queen Anne style. The large porch is decorated by posts with knobs and brackets. Porch balusters connected by horizontal cross-members create a recurring rectangular design below the railing. Projecting attic gables beneath the steeply pitched roof are covered by fish scale shingles. Similar shingling occurs on the second story and is contrasted by the clapboarded first story. The north side of the house exhibits a diagonal row of three leaded, stained-glass windows. A thin detailed chimney, topped by two chimney pots, is on the south side of the structure. The building's varied surfaces are highlighted by the use of dark and light paint.
