**RESOURCES INVENTORY FORM**  
 Buildings and Structures

BUILDING NAME: Common: Post Office Historic: same

ADDRESS & NUMBER (and/or location): 291 Main Street

STYLE OF BUILDING: Renaissance Revival DATE OF CONSTRUCTION: 1916

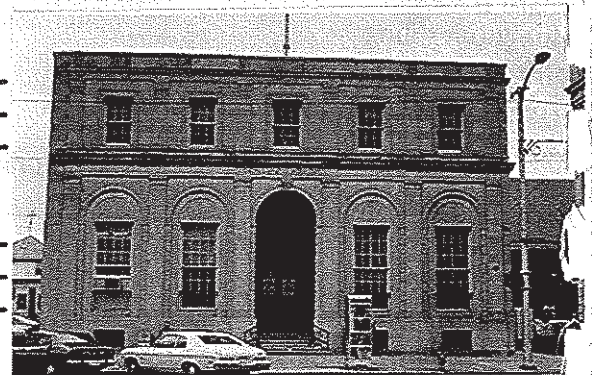
photographer: Elizabeth Loomis  
date: 5/78 view: east  
negative on file: Roll 25, #13

Contemporary sources indicate that the new Post Office was a source of civic pride for the citizens of Middletown. Its facade of smooth limestone distinguished it in a city center where brick and Portland brownstone were the common building materials. The classical facade displays a two story arrangement of arched windows and pilasters supporting an elaborate entablature. The interior features a large two story open lobby.
