HISTORIC RESOURCES INVENTORY FORM

1. BUILDING NAME: Common: _____ Historic: "Watch House"; East Long Hill School
2. TOWN/CITY: Middletown VILLAGE: Long Hill COUNTY: Middlesex
3. STREET & NUMBER (and/or location): 30 Maple Shade Road
4. OWNER(S): John and Mary Risley PUBLIC PRIVATE
5. USE: Present: Residence Historic: School; watchhouse
6. ACCESSIBILITY TO PUBLIC: Exterior visible from public road: yes no
Interior accessible: yes, explain with owner's permission no

7. STYLE OF BUILDING: Stone Blockhouse, 20' Square DATE OF CONSTRUCTION: 1675-1676
8. MATERIAL(S) (indicate use or location when appropriate):
 ___ clapboard ___ asbestos siding ___ brick
 ___ wood shingle ___ asphalt siding ___ fieldstone
 ___ board & batten ___ stucco ___ cobblestone
 ___ aluminum siding ___ concrete: type: _____ cut stone: type: brownstone
 ___ other: _____ rubble, north section

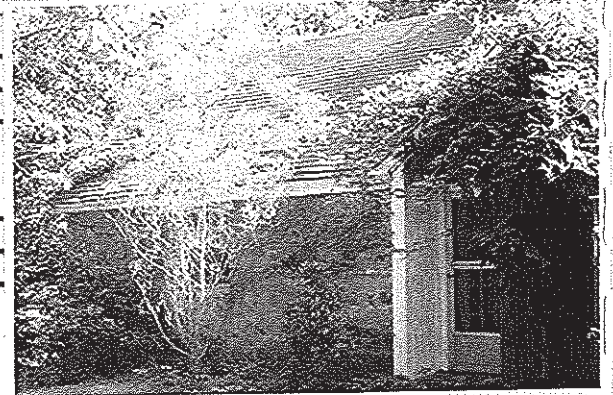
PHOTOGRAPH

11. NUMBER OF STORIES: 1 APPROXIMATE DIMENSIONS: Presently 20'x40'
12. CONDITION: Structural: ___ excellent good ___ fair ___ deteriorated
 Exterior: ___ excellent good ___ fair ___ deteriorated

13. INTEGRITY: Location: on original site Expanded to accomodate school needs; interior
 Alterations: ___ no yes, explain: renovated; connected to another structure at south end

photographer: John E. Reynolds
date: 7/78 view: west
negative on file: Roll 34, #23
