HISTORIC RESOURCES INVENTORY FORM
for Buildings and Structures

- 1. BUILDING NAME: Common: VFW Building Historic: Stueck's Modern Tavern
- 2. TOWN/CITY: Middletown VILLAGE: _____ COUNTY: Middlesex
- 3. STREET & NUMBER (and/or location): 64-70 Washington Street
- 4. OWNER(S): Veterans of Foreign Wars PUBLIC PRIVATE
- 5. USE: Present: VFW & Stores Historic: Tavern, restaurant & stores
- 6. ACCESSIBILITY TO PUBLIC: Exterior visible from public road: yes no
Interior accessible: yes, explain _____ shops _____ no

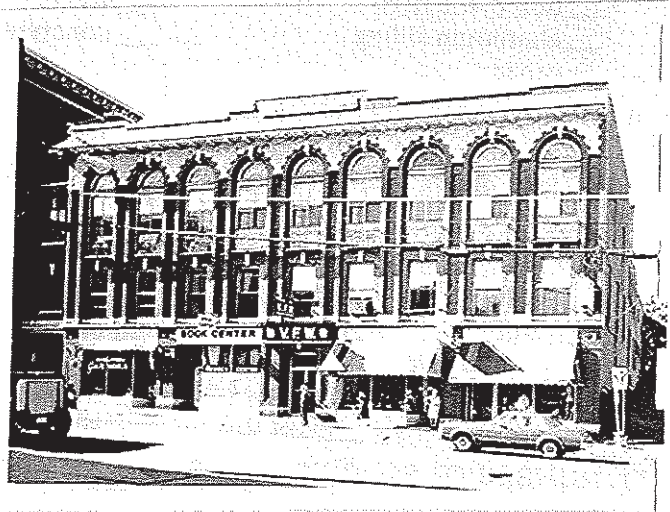
PHOTOGRAPH

Long shingled hood stretching the length of the facade just under the cornice
Wrought iron balconies on each of the nine top floor windows

The facade is veneered in a bright red hard-surfaced brick. The nine-bay front features third-floor windows double the height of those below. Bold, notched brick-work against a field of stucco accents the arched heads of these windows, which provide light for a large open hall on the top floor. The over-all effect of the building's design is one of a richness of detail not found on other commercial buildings in Middletown.

photographer: Roger Sherman
date: 9/78 view: south
negative on file: Roll 39, #1-1A
