HISTORIC RESOURCES INVENTORY FORM
for Buildings and Structures

- 1. BUILDING NAME: Common: _____ Historic: A.M. Colegrove Mansion
- 2. TOWN/CITY: Middletown VILLAGE: _____ COUNTY: Middlesex
- 3. STREET & NUMBER (and/or location): 456 Wadsworth Street
- 4. OWNER(S): Edmond and Bertha McRae PUBLIC PRIVATE
- 5. USE: Present: Residential Historic: same
- 6. ACCESSIBILITY TO PUBLIC: Exterior visible from public road: yes no
Interior accessible: yes, explain _____ no

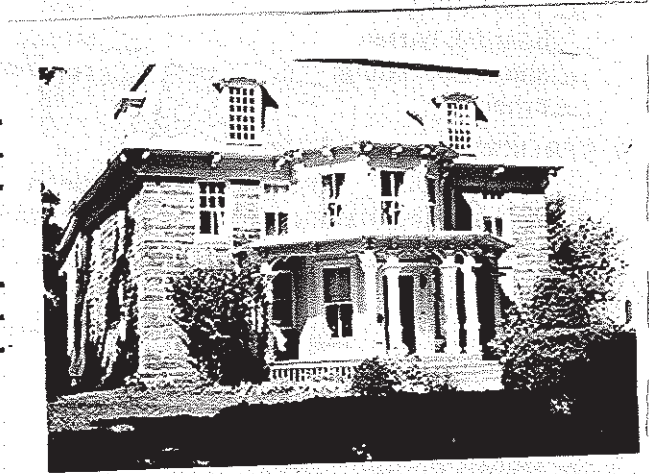
PHOTOGRAPH

- 13. INTEGRITY: Location: on original site moved, when: _____
Alterations: no yes, explain: Upper part of tower removed; much decorative trim removed
- 14. RELATED OUTBUILDINGS OR LANDSCAPE FEATURES:
 barn shed garage other landscape features or buildings: _____
 carriage house shop garden _____

As originally constructed, this house was one of the showpieces of the Second Empire style in Middletown, and was featured in the pictorial publication, Scenes of Middlesex County of 1892. It exhibited a wealth of stylistic detailing and an elaborate tower. It still retains the mansard roof, pedimented dormer windows, and bold, wood accenting typical of the style. The facade retains the circular porch and second floor bay which supported the tower with a belfry.

photographer: Roger Sherman
date: 10/78 view: south
negative on file: Roll 42, #4
