The Downtown Housing Analysis of Impediments and Architectural Feasibility Study

360 MAIN STREET
Middletown, CT

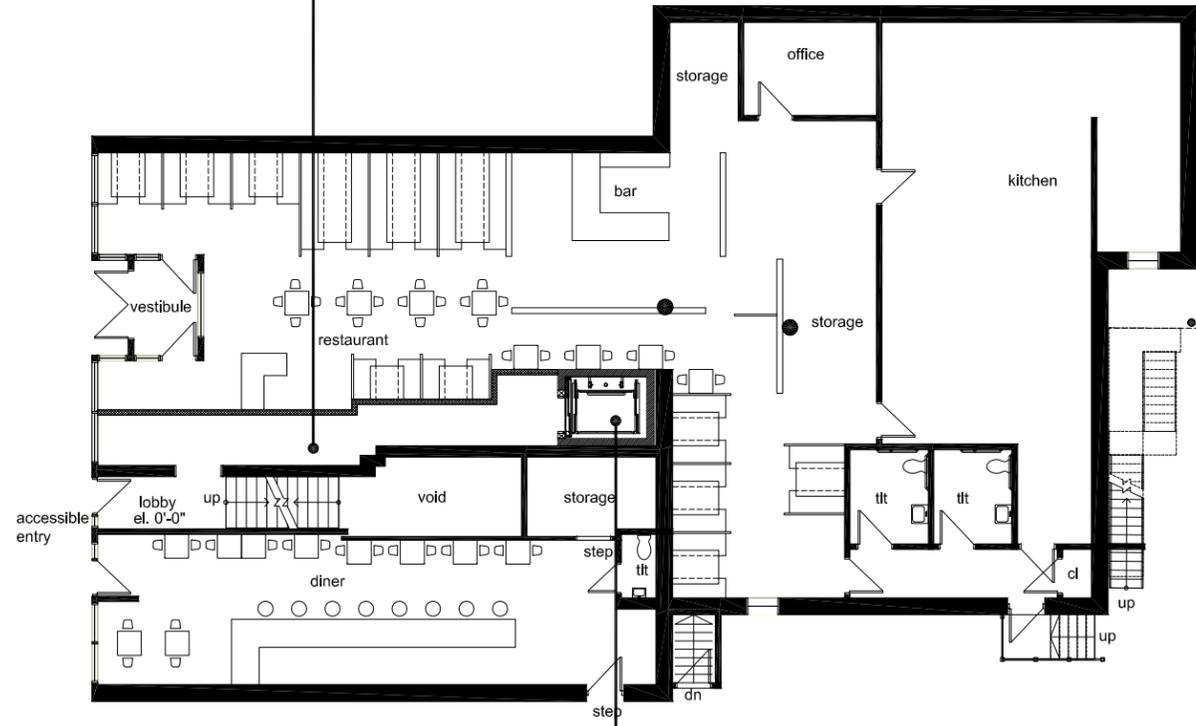
PROPOSE REHABILITATION OF THE UPPER FLOORS FOR
HANDICAP ACCESSIBILITY
FIRST FLOOR

New corridor providing access to Limited Use/Limited Access Lift

Limited Use/Limited Access Lift
