HISTORIC RESOURCES INVENTORY FORM
For Buildings and Structures

- 1. BUILDING NAME: Common: _____ Historic: Wetmore-North House
- 2. TOWN/CITY: Middletown VILLAGE: _____ COUNTY: Middlesex
- 3. STREET & NUMBER (and/or location): 479 Boston Road
- 4. OWNER(S): Leslie Hare PUBLIC PRIVATE
- 5. USE: Present: Residence Historic: same
- 6. ACCESSIBILITY TO PUBLIC: Exterior visible from public road: xyes no
Interior accessible: xyes, explain with owner's permission no

- 7. STYLE OF BUILDING: Colonial; Federal alterations DATE OF CONSTRUCTION: c. 1765

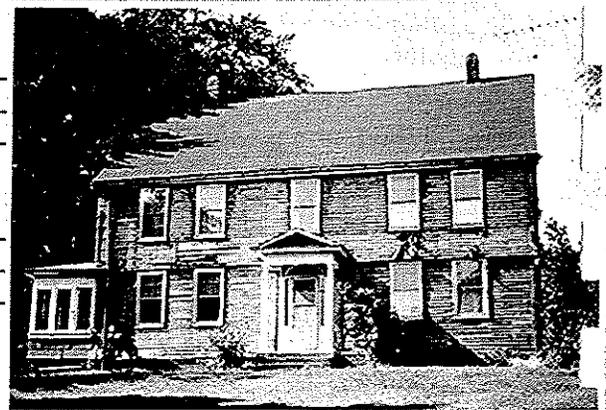
PHOTOGRAPH

16. INTERRELATIONSHIP OF BUILDING AND SURROUNDINGS: This large Colonial house faces east from the north side of Boston Road. It occupies a rise which slopes down a broad lawn to George Street. A large copper beech tree shades the house on the west. This section of Staddle Hill displays recent residential development.

Federal period fanlight over entrance

The house retains the double overhang typical of the period of its construction as well as later Federal elements. The imposing scale of this house reflects the prominent standing of the Wetmore family in eighteenth-century Middletown. The present owners are currently removing later siding to reveal the original narrow clapboarding. The house occupies an impressive site on a hill, with fields to the south.

photographer: Roger Sherman
date: 9/78 view: east
negative on file: Roll 42, #31-31A
