HISTORIC RESOURCES INVENTORY FORM  
For Buildings and Structures

- 1. BUILDING NAME: Common: \_\_\_\_\_ Historic: Nathaniel Bacon House
- 2. TOWN/CITY: Middletown VILLAGE: Westfield COUNTY: Middlesex
- 3. STREET & NUMBER (and/or location): 8 Boardman Lane
- 4. OWNER(S): Parker Hannifin Corporation PUBLIC  PRIVATE
- 5. USE: Present: Vacant Historic: Residence
- 6. ACCESSIBILITY TO PUBLIC: Exterior visible from public road:  yes  no  
Interior accessible:  yes, explain \_\_\_\_\_  no

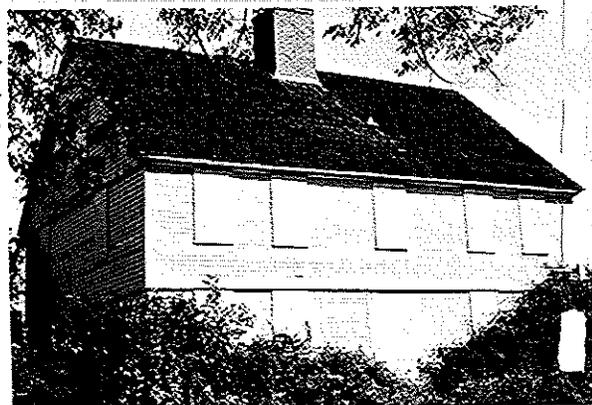
photographer: John E. Reynolds  
date: 9/78 view: south  
negative on file: Roll 47, #18A-19

- 11. NUMBER OF STORIES: 2 1/2 APPROXIMATE DIMENSIONS: 28'x38'; rear wing 21'x26'
- 12. CONDITION: Structural: \_\_\_ excellent  good \_\_\_ fair \_\_\_ deteriorated  
 Exterior: \_\_\_ excellent \_\_\_ good  fair \_\_\_ deteriorated

This house displays the center-chimney, two-room deep plan, and double overhang characteristic of mid-eighteenth century house construction in the lower Connecticut valley. The interior is largely original and contains much fine detail work including panelling of dados and fireplace walls, a triple-run staircase, and a corner cupboard.

been zoned industrial; EIS Automotive Corp., a subsidiary of Parker Hannifin, may use this land for expansion. The house may be saved; however, its setting could be destroyed. The house is now vacant and boarded up, leaving it vulnerable to deterioration caused by neglect or vandalism.
