II. HISTORIC RESOURCES INVENTORY FORM
 for Buildings and Structures

1. BUILDING NAME: Common: _____ Historic: John Hubbard House
 TOWN/CITY: Middletown VILLAGE: _____ COUNTY: Middlesex
 3. STREET & NUMBER (and/or location): 332 Freeman Road
 OWNER(S): Karen and Paul Torop PUBLIC PRIVATE
 5. USE: Present: Residence Historic: same
 ACCESSIBILITY TO PUBLIC: Exterior visible from public road: yes no
 Interior accessible: yes, explain no

7. STYLE OF BUILDING: Center-Chimney Colonial DATE OF CONSTRUCTION: 1781
 8. MATERIAL(S) (indicate use or location when appropriate):
 ___ clapboard ___ asbestos siding ___ brick
 ___ wood shingle ___ asphalt siding ___ fieldstone
 ___ board & batten ___ stucco ___ cobblestone
 aluminum siding ___ concrete: type: _____ cut stone: type: granite
 ___ other: _____ foundation

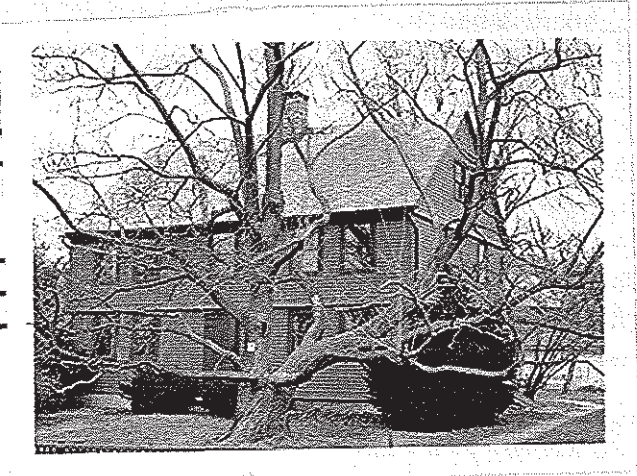
photographer: Robert Svec
date: 12/78 view: south
negative on file: Roll 52, #14A

This Colonial house is a distinctive feature of the area. The five-bay facade has a notable central entrance. Five small, rectangular lights are above the door that displays decorative strap hinges. The broad, gabled roof is crowned by a large center chimney. The sides of the building exhibit double overhangs.

The structure, despite its aluminum sided walls, has retained much of its original character. Sited near fields bordered by stone walls, it is reminiscent of an era when a small group of families farmed this outlying area of town.
