HISTORIC RESOURCES INVENTORY FORM  
For Buildings and Structures

- 1. BUILDING NAME: Common: Odd Fellows Hall Historic: Universalist Church
- 2. TOWN/CITY: Middletown VILLAGE: \_\_\_\_\_ COUNTY: Middlesex
- 3. STREET & NUMBER (and/or location): 203-207 Main Street
- 4. OWNER(S): City of Middletown  PUBLIC  PRIVATE
- 5. USE: Present: Theatre, meeting hall; stores 'historic: Church; stores
- 6. ACCESSIBILITY TO PUBLIC: Exterior visible from public road:  yes  no  
Interior accessible:  yes, explain permission of owner  no

- 7. STYLE OF BUILDING: Greek Revival DATE OF CONSTRUCTION: 1839
- 8. MATERIAL(S) (indicate use or location when appropriate):

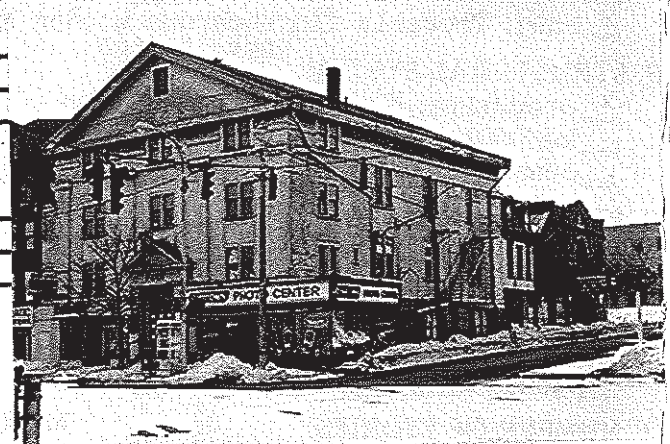
photographer: Elizabeth Loomis  
date: 2/78 view: northeast  
negative on file: Roll 13, #26

- 13. INTEGRITY: Location:  on original site  moved, when: \_\_\_\_\_  
Alterations:  no  yes, explain: Northeast storefront extended; pressed metal sign panel added

Prominent brownstone entrance steps one-half story up from street level  
Paneled wood entrance doors

The Greek Revival style of the 1839 Universalist Church is strongly echoed by the 1842 brick Baptist Church, similarly sited one block to the south. Both buildings display a high front entrance, "temple front" to the street, pilasters and pedimented gable. Originally topped by a square two-tiered belfry and lantern, the Universalist Church has undergone considerable alteration. The bell tower is gone, the whole exterior surface has been stuccoed, and the northeast street-level storefront has been extended to provide display windows. The building retains its imposing mass with classical lines, and functions well as an urban meeting hall.
