Condition Assessment Report

Lisbon Waste-To-Energy Facility

Lisbon, CT
December 16, 2025

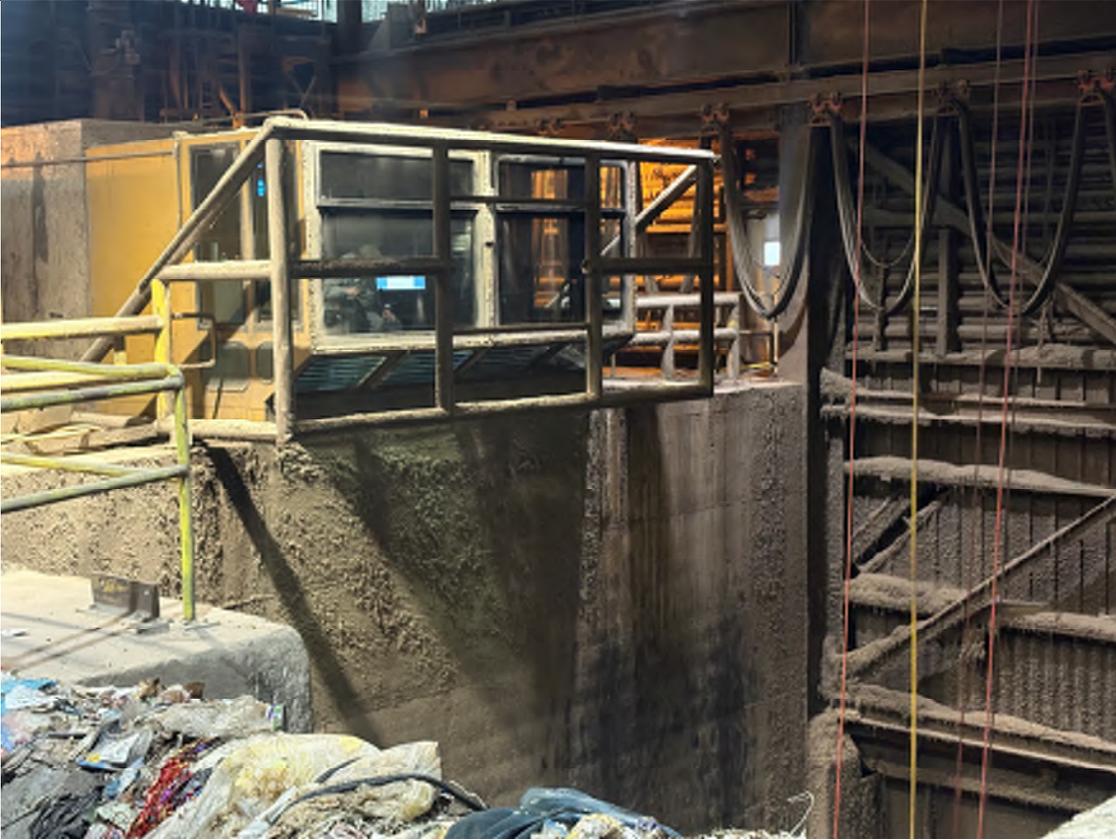
<ul style="list-style-type: none">• Crane observation room with center steel bar removed for better visibility for the operators.
Photograph #8	Remarks

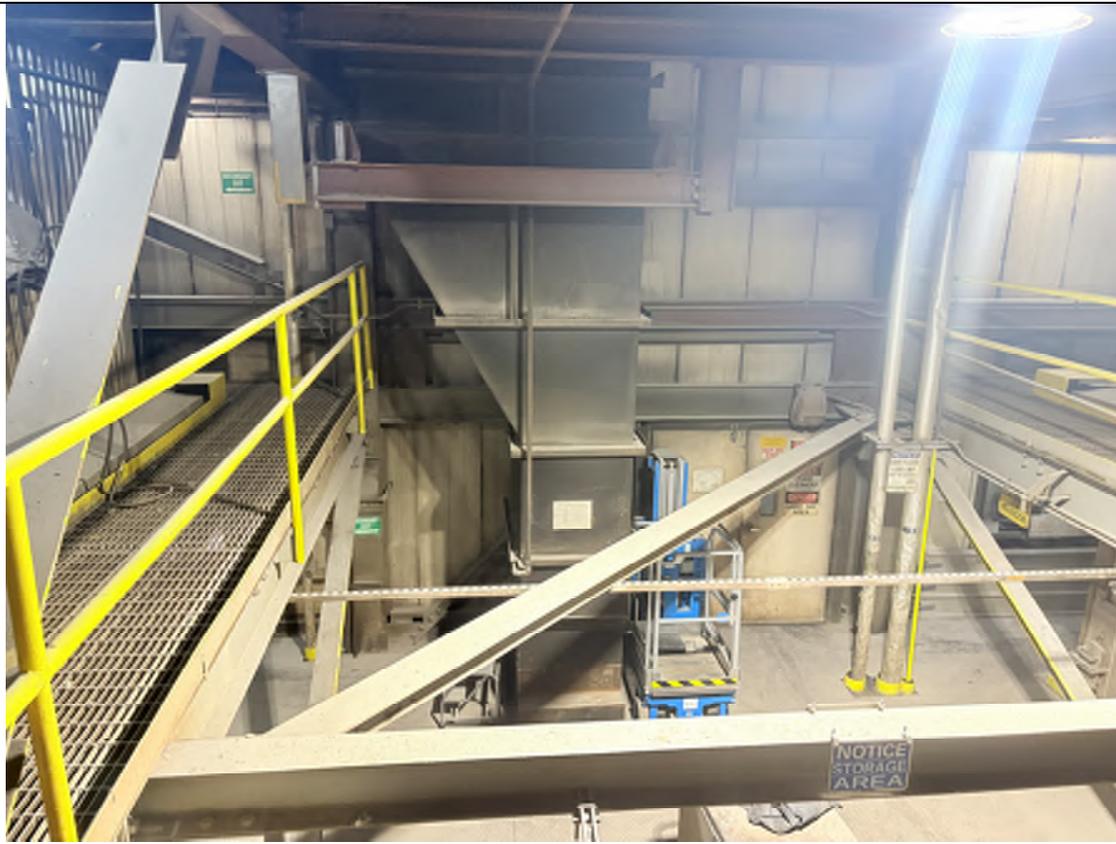
Photograph #9

- Good housekeeping observed around intake air duct.

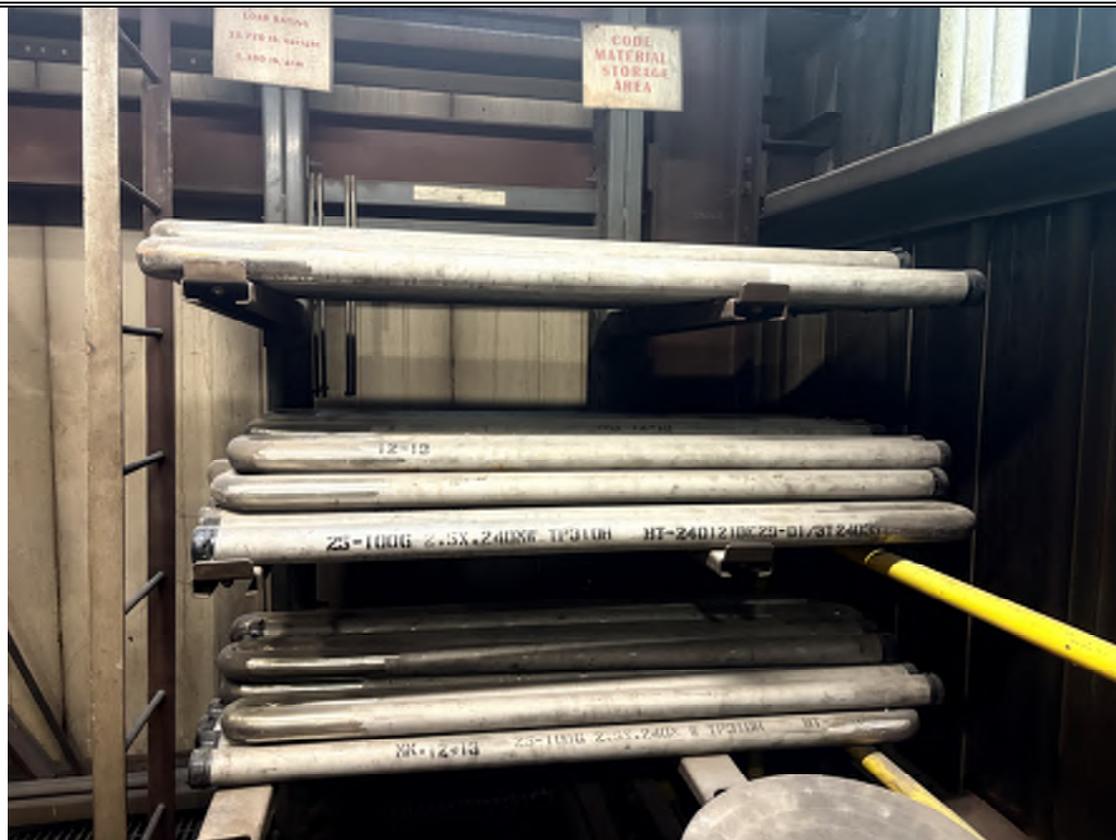
Photograph #10

- Storage for additional superheater tubes in the boiler building.

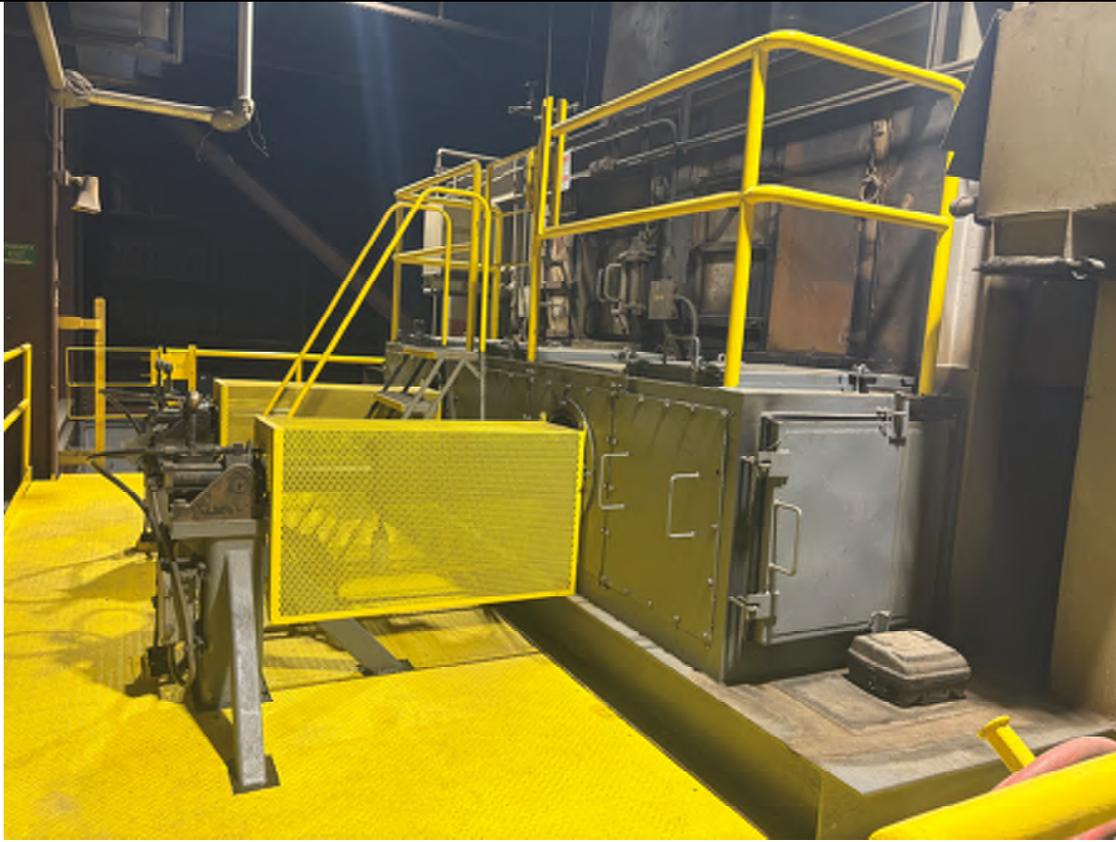
Photograph #13

- Boiler ram feeders associated access appears well maintained.

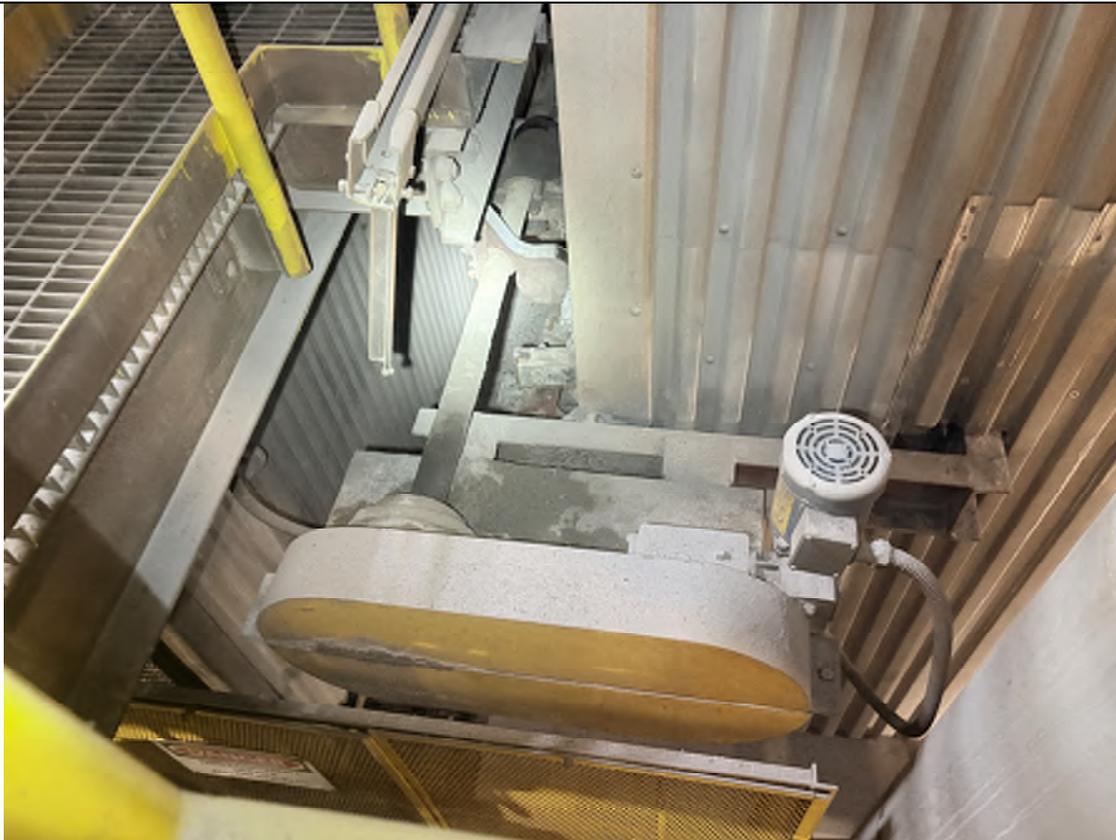
Photograph #14

- Gearbox for economizer rappers.

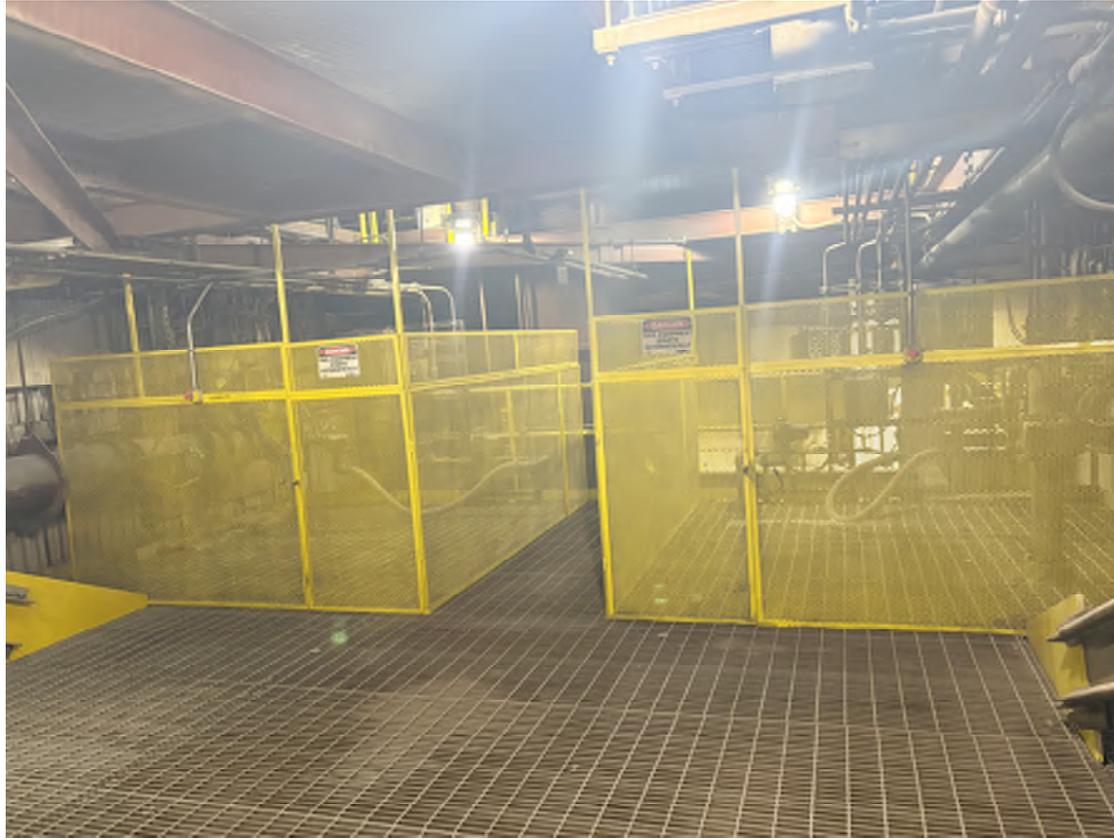
Photograph #15

- Auxiliary burners enclosed by a gate for safety.

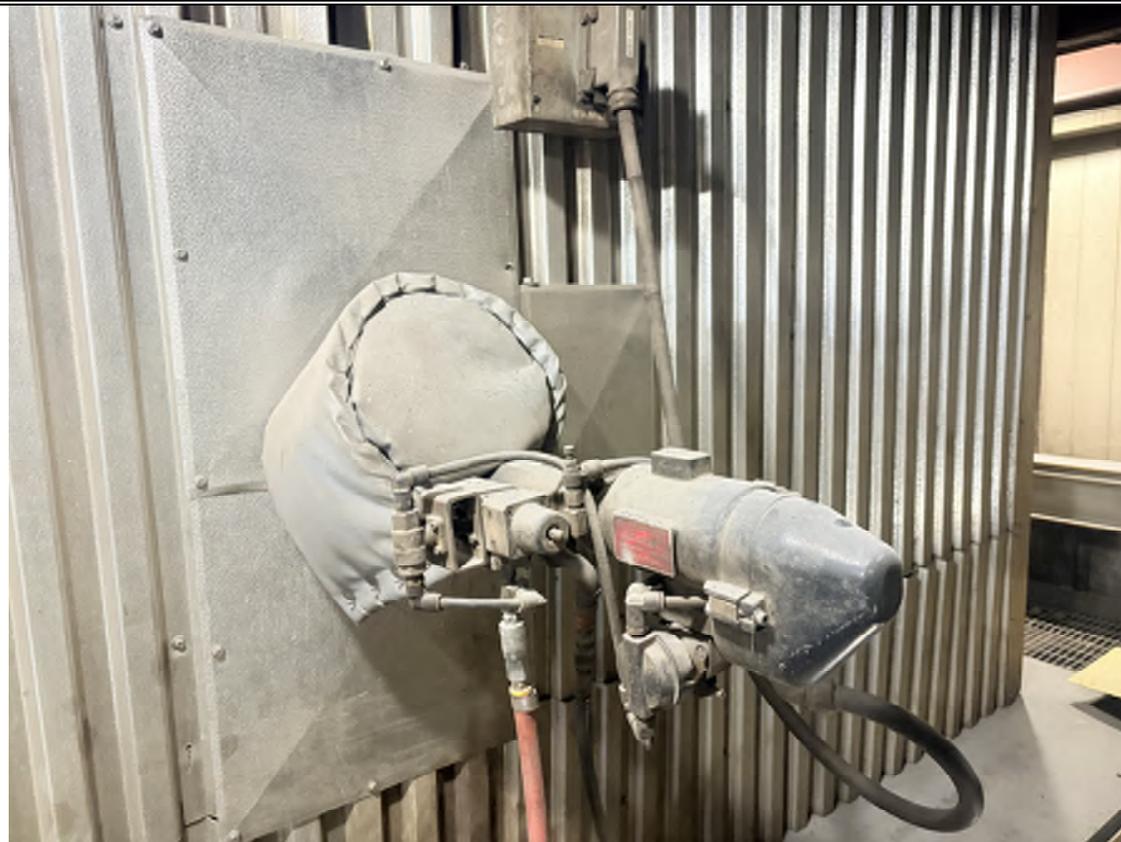
Photograph #18

- Infrared thermometer in place for combustion and SNCR control

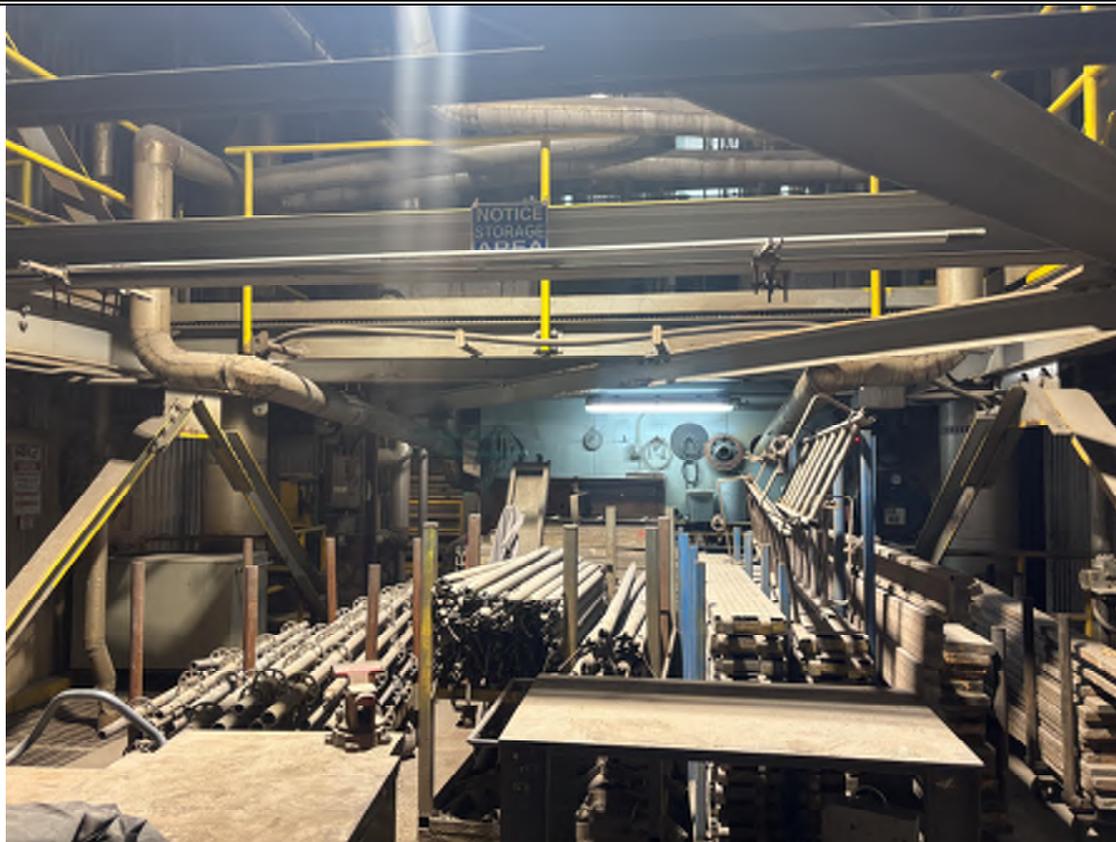
Photograph #24

- Storage area in boiler house organized holding broken down scaffolding from previous outage.

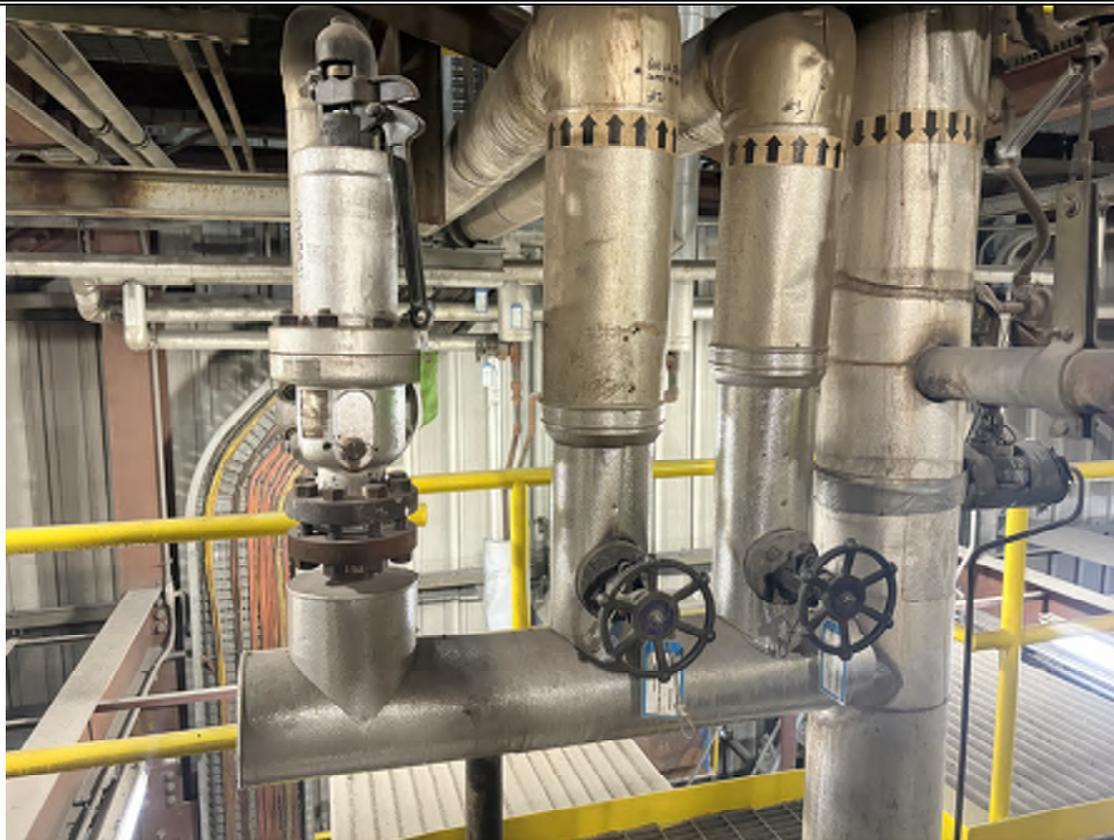
Photograph #26

- Supply lines for Unit 1 and 1 Sootblowing station. Appear well maintained and identification intact.

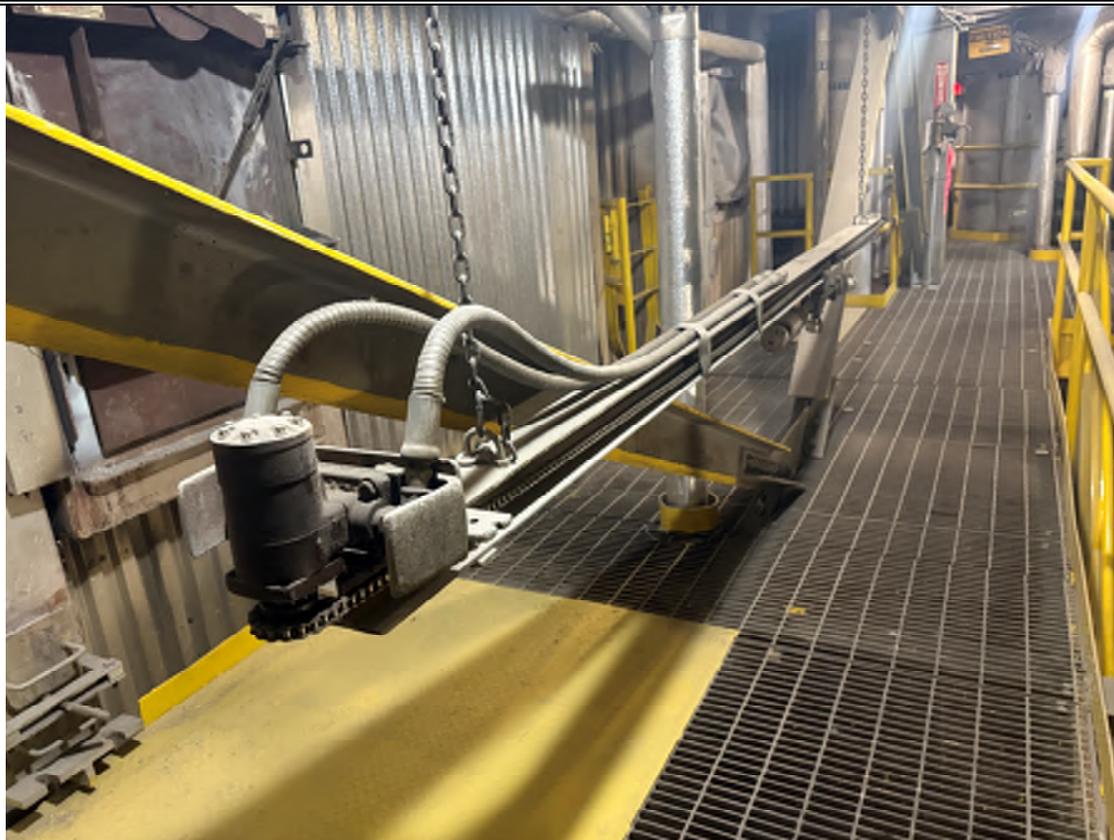
Photograph #28

- Support beam for offline pressure wash cleaning system.

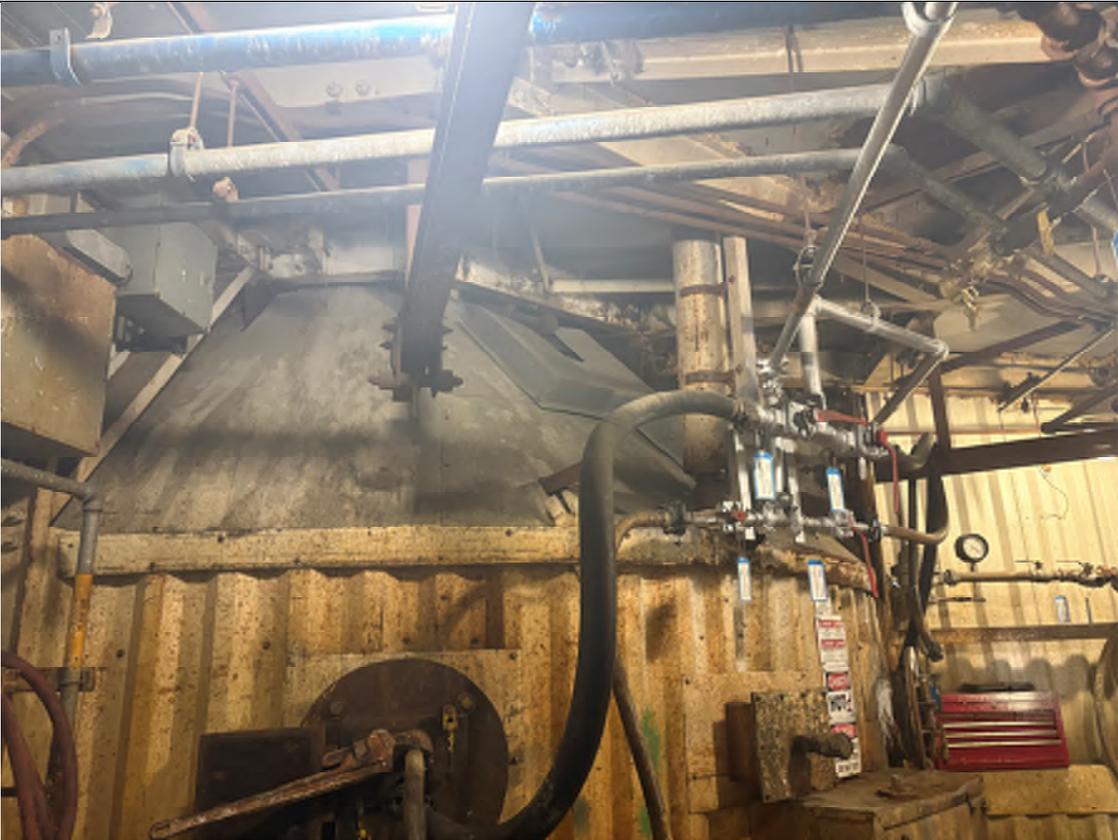
A wide-angle photograph of the upper vessel of a scrubber. The vessel is a large, cylindrical metal structure with a conical top. It is surrounded by a complex network of pipes, valves, and structural beams. The interior of the vessel is visible, showing a dark, possibly wet surface. The surrounding area is filled with industrial equipment, including a red toolbox and various pipes.	<ul style="list-style-type: none">• Upper vessel of the scrubber.
Photograph #30	Remarks

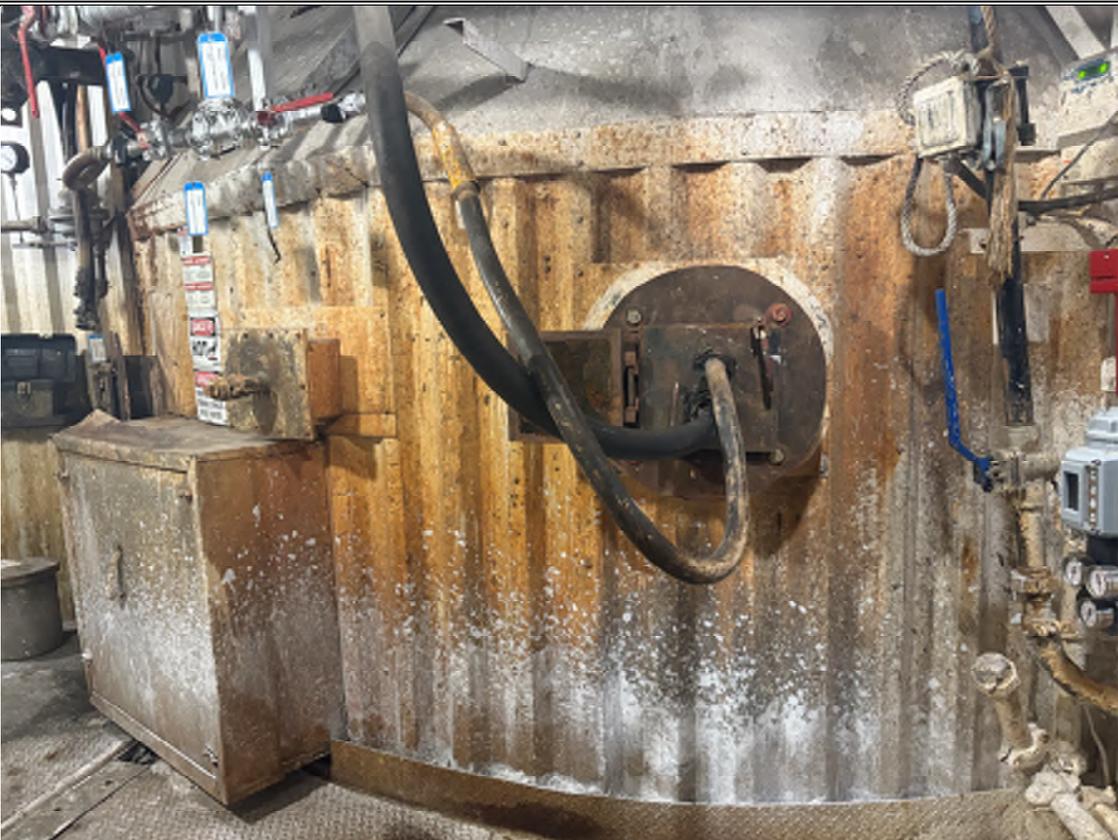
A close-up photograph of the scrubber inlet. The inlet is a circular opening in the side of the vessel. Several black hoses are connected to the inlet, and there are several blue-handled valves and nozzles. The surrounding area is filled with industrial equipment, including a red toolbox and various pipes.	<ul style="list-style-type: none">• Lime nozzle injection locations at the Scrubber inlet.

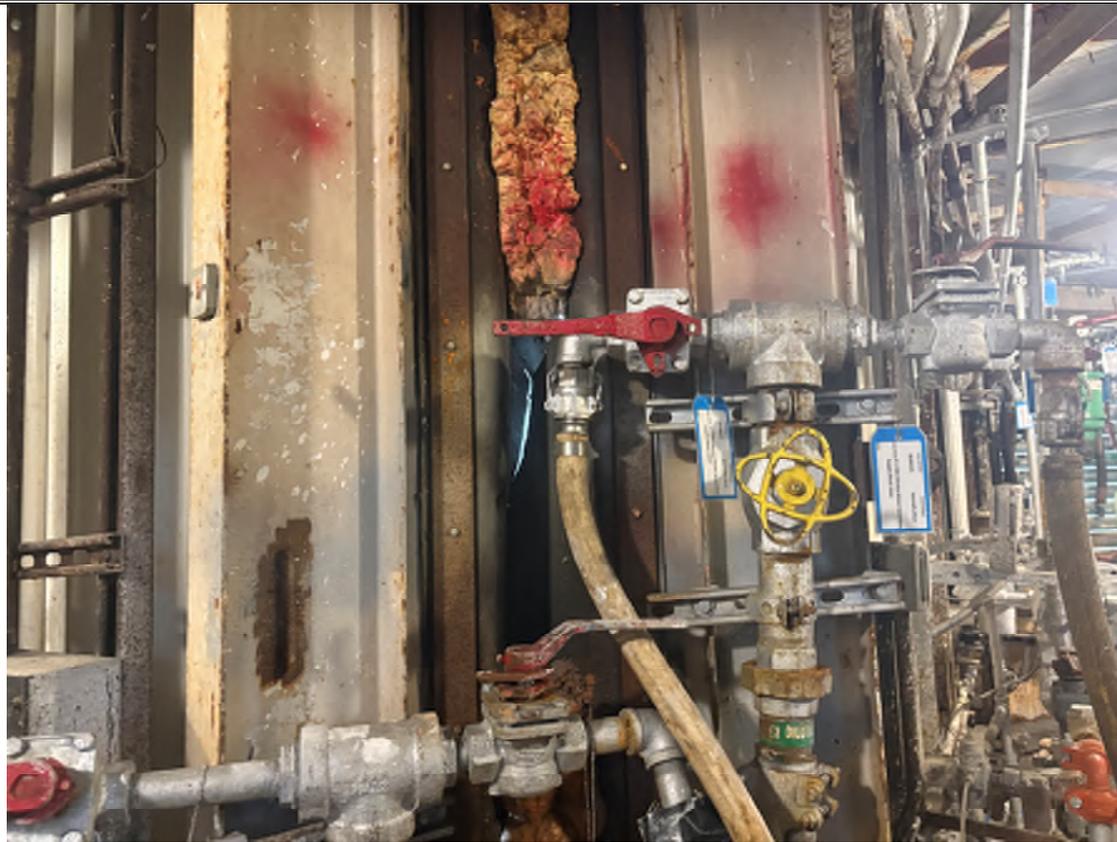
Photograph #32

- Slurry and dilution water supply system.

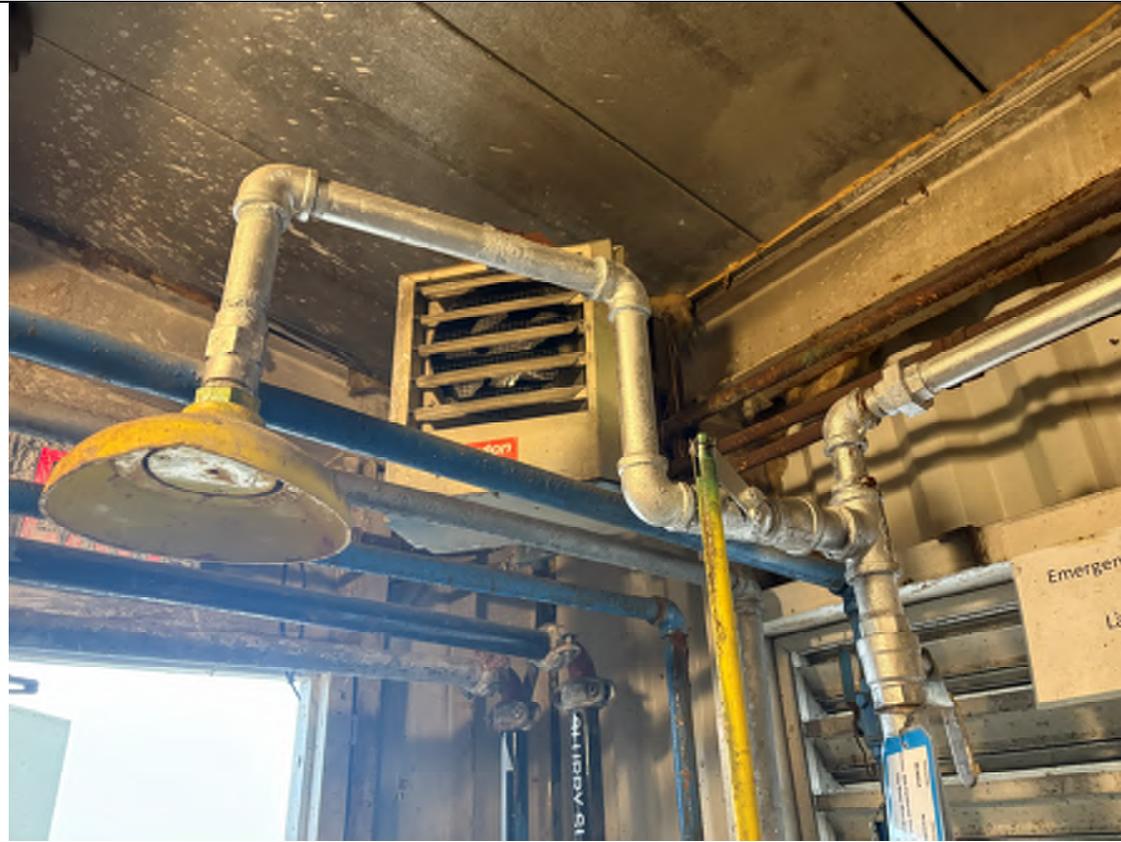
Photograph #33

- Heater in scrubber house used during winter months for temperature control.

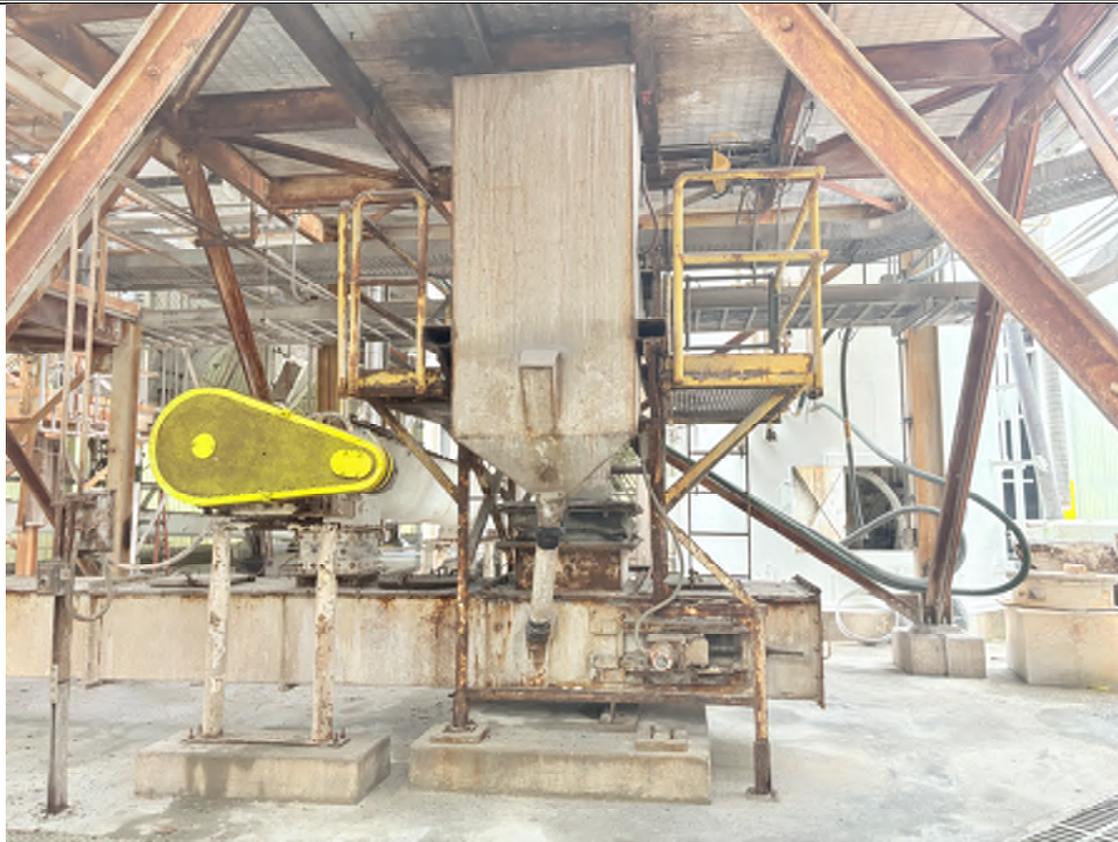
Photograph #35

- Scrubber hoppers.

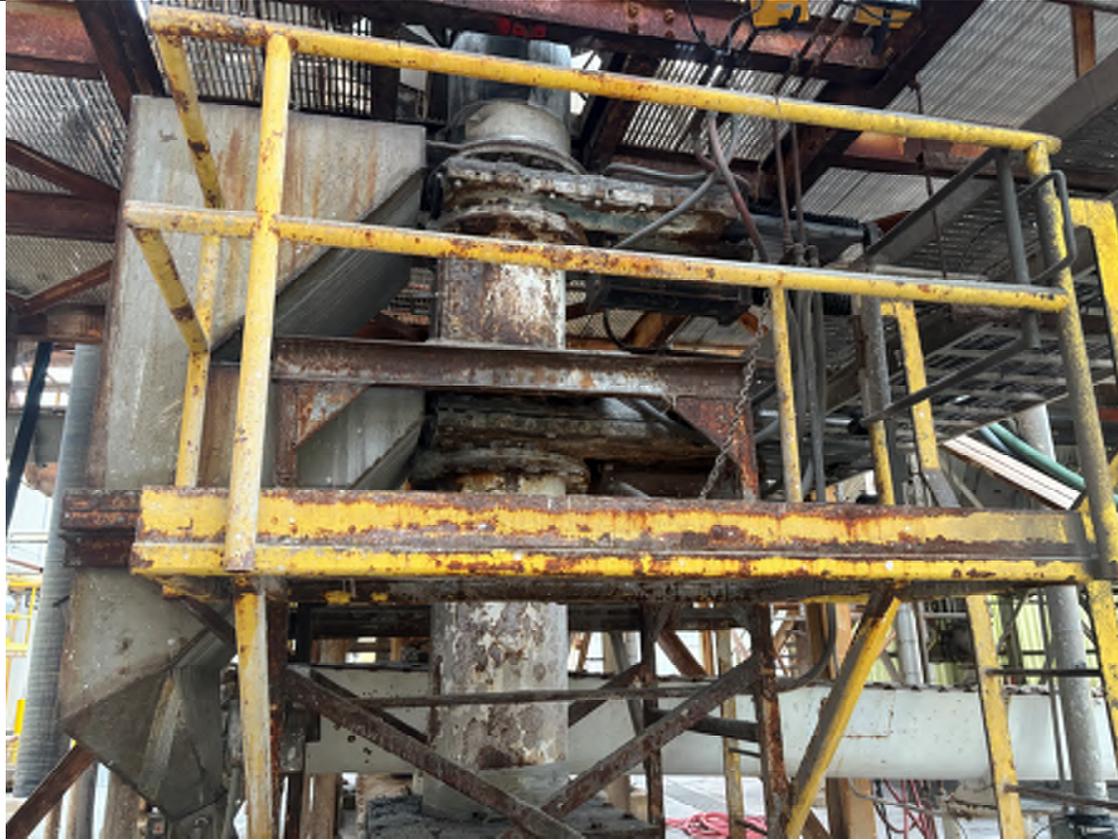
Photograph #36

- Scrubber hopper with slide gate.

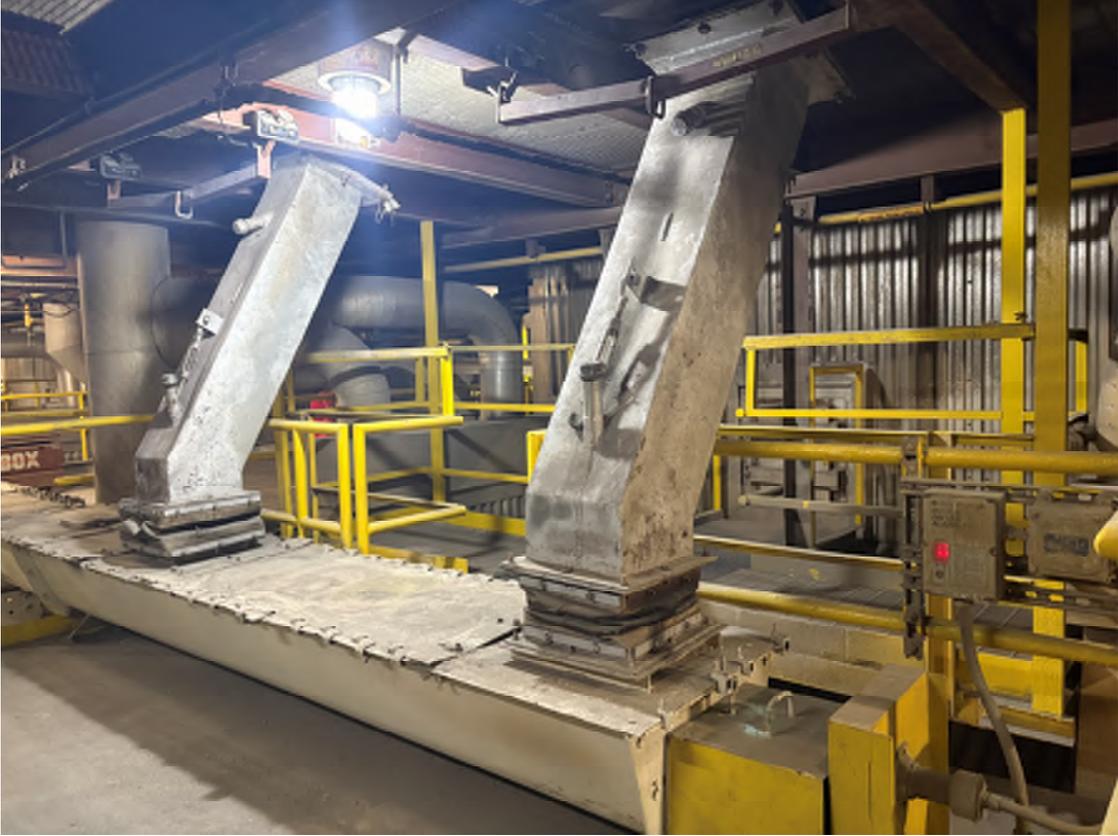
Photograph #40 shows two large, vertical, metal structures, possibly part of an ash collection system, mounted on a platform. The structures are made of heavy-duty metal and are positioned side-by-side. The background shows a complex industrial environment with various pipes, railings, and structural elements. A bright light source is visible in the upper left corner, illuminating the scene.	<ul style="list-style-type: none">• Ash collection below economizers.
Photograph #41	Remarks

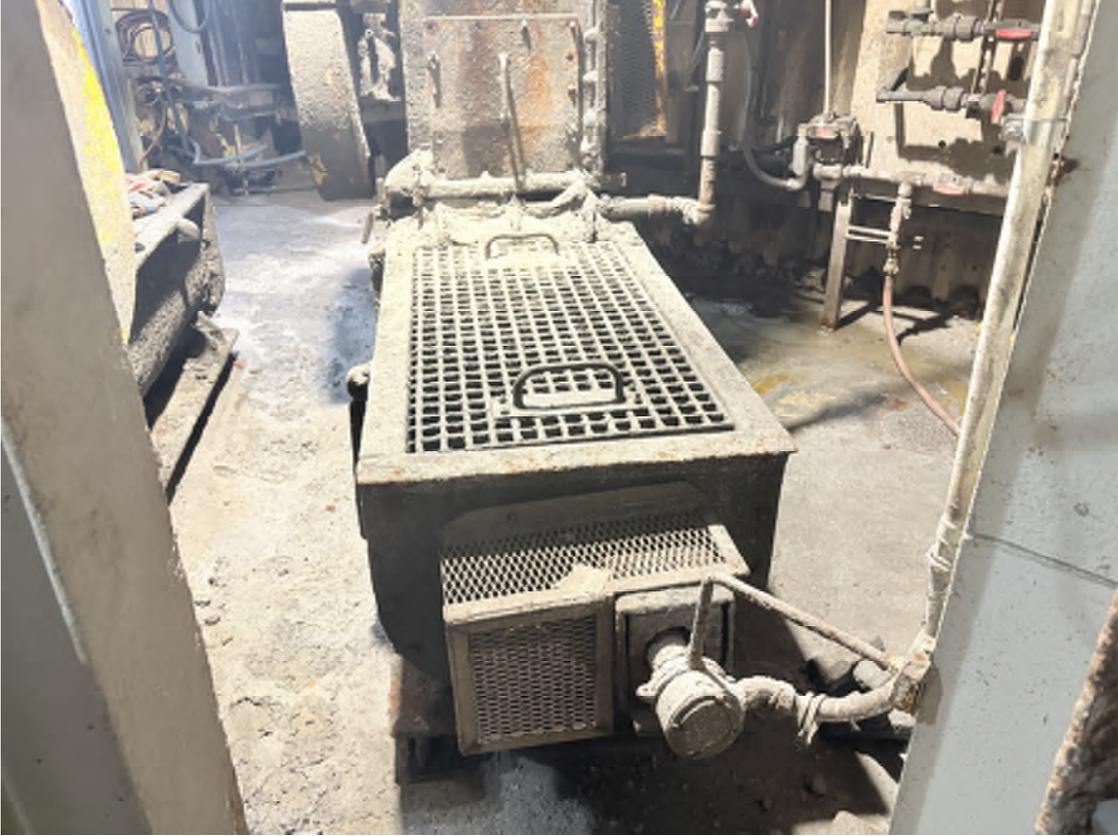
<ul style="list-style-type: none"><li data-bbox="1224 254 1463 285">• Fly ash pugmill.
Photograph #45	Remarks

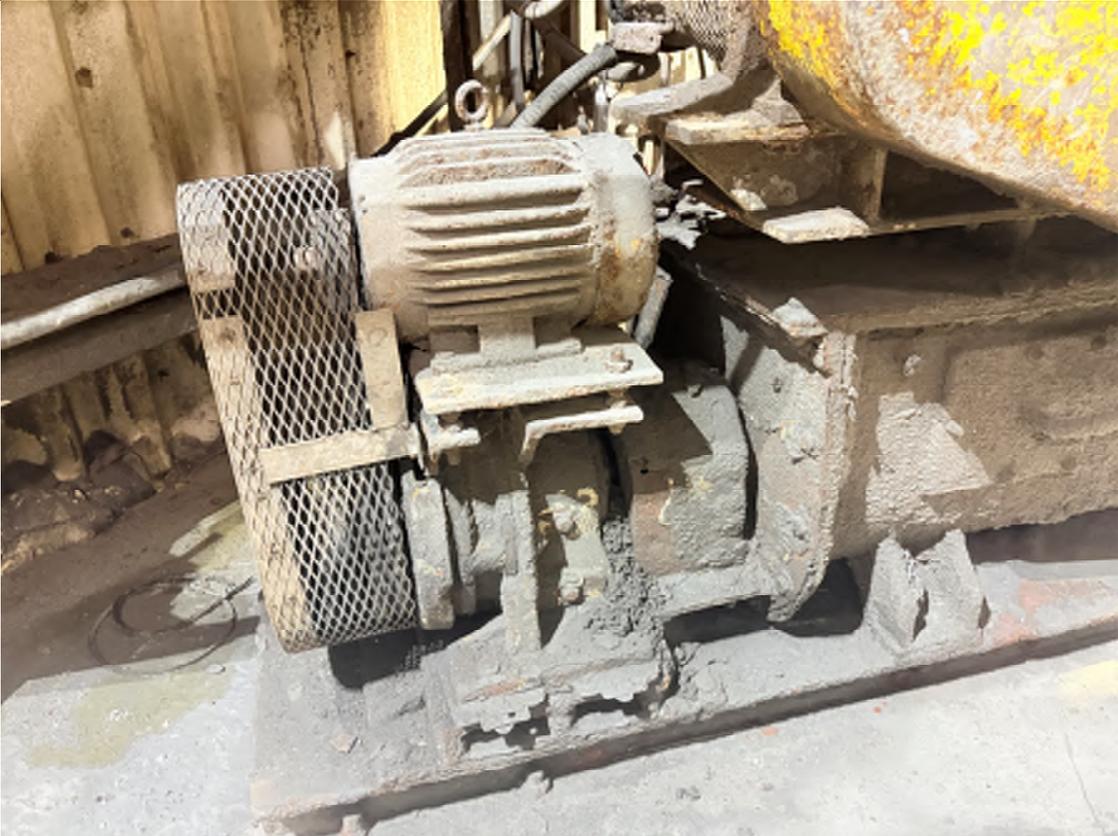
<ul style="list-style-type: none"><li data-bbox="1224 1157 1487 1188">• Motor for pugmill.

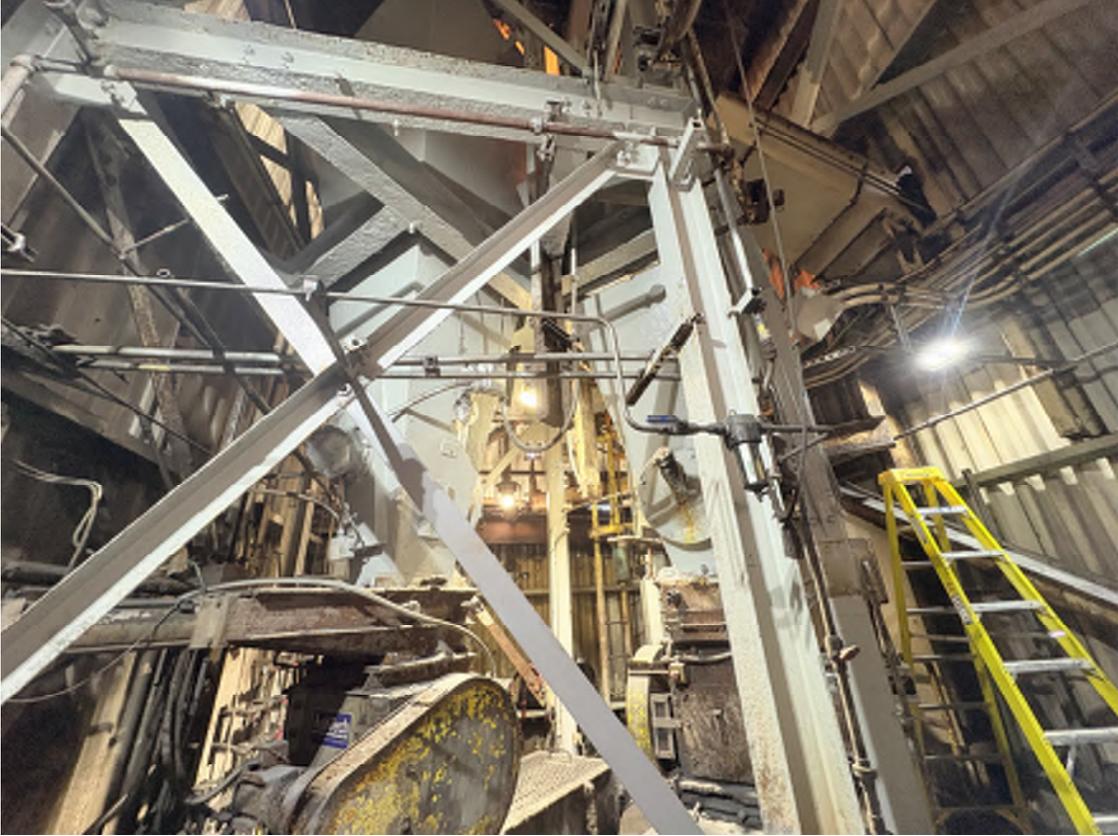
<ul style="list-style-type: none">• Structure around pugmill and fly ash silo
Photograph #47	Remarks

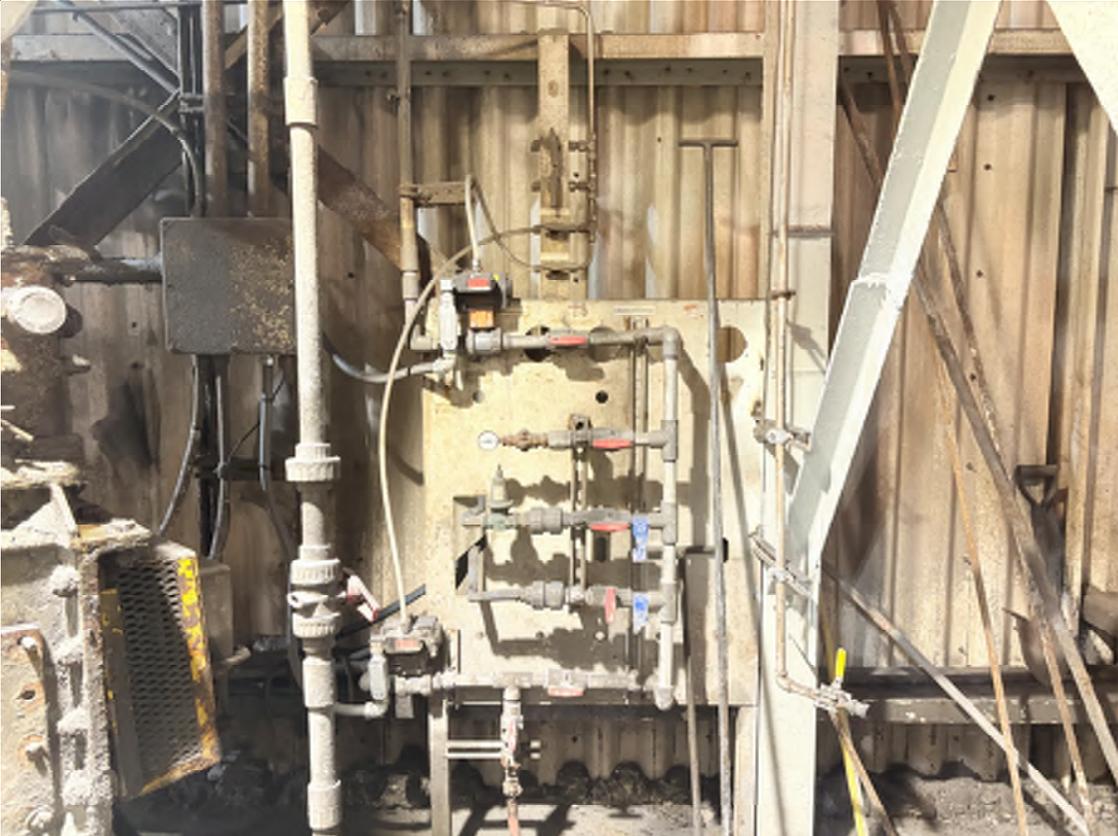
<ul style="list-style-type: none">• Water control system for pugmill

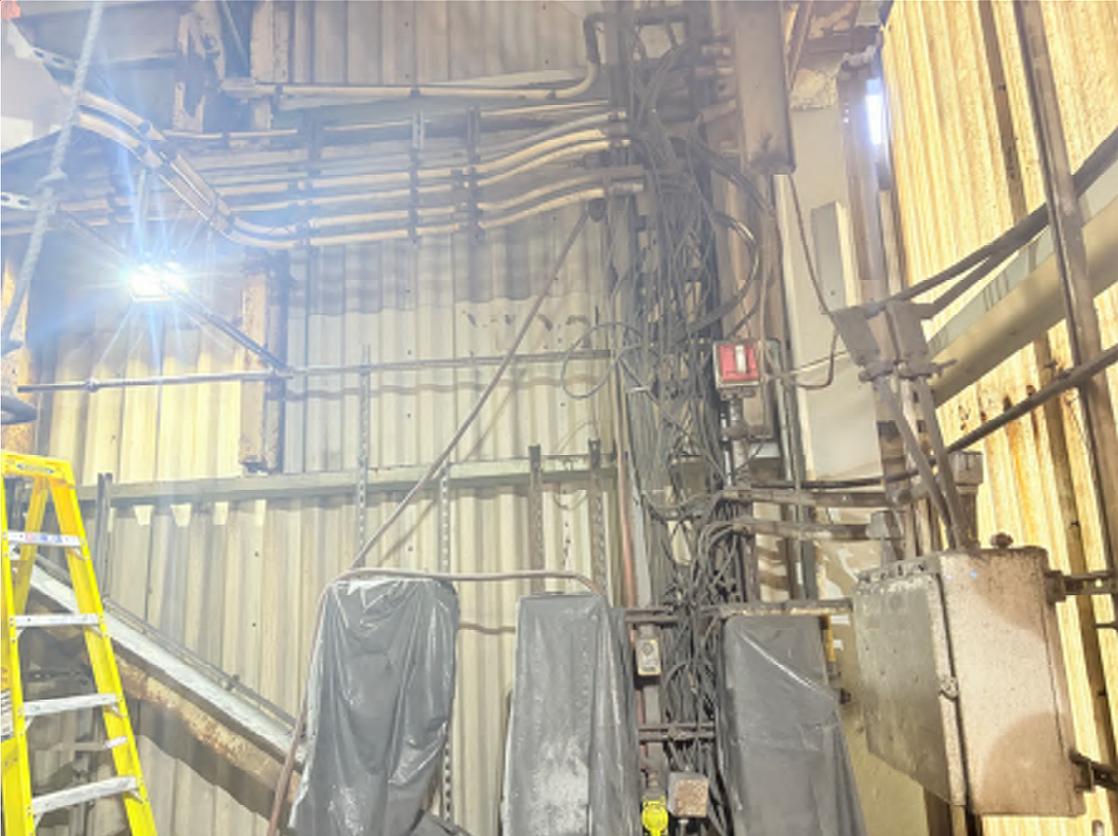
A photograph showing a different section of the pugmill enclosure. The walls are made of corrugated metal panels. A yellow step ladder is visible on the left side. The interior is filled with various mechanical components, including pipes, cables, and metal frames. A bright light source is visible on the left, creating a lens flare effect. The overall scene is industrial and somewhat cluttered.	<ul style="list-style-type: none">• New sections of exterior wall of pugmill enclosure.

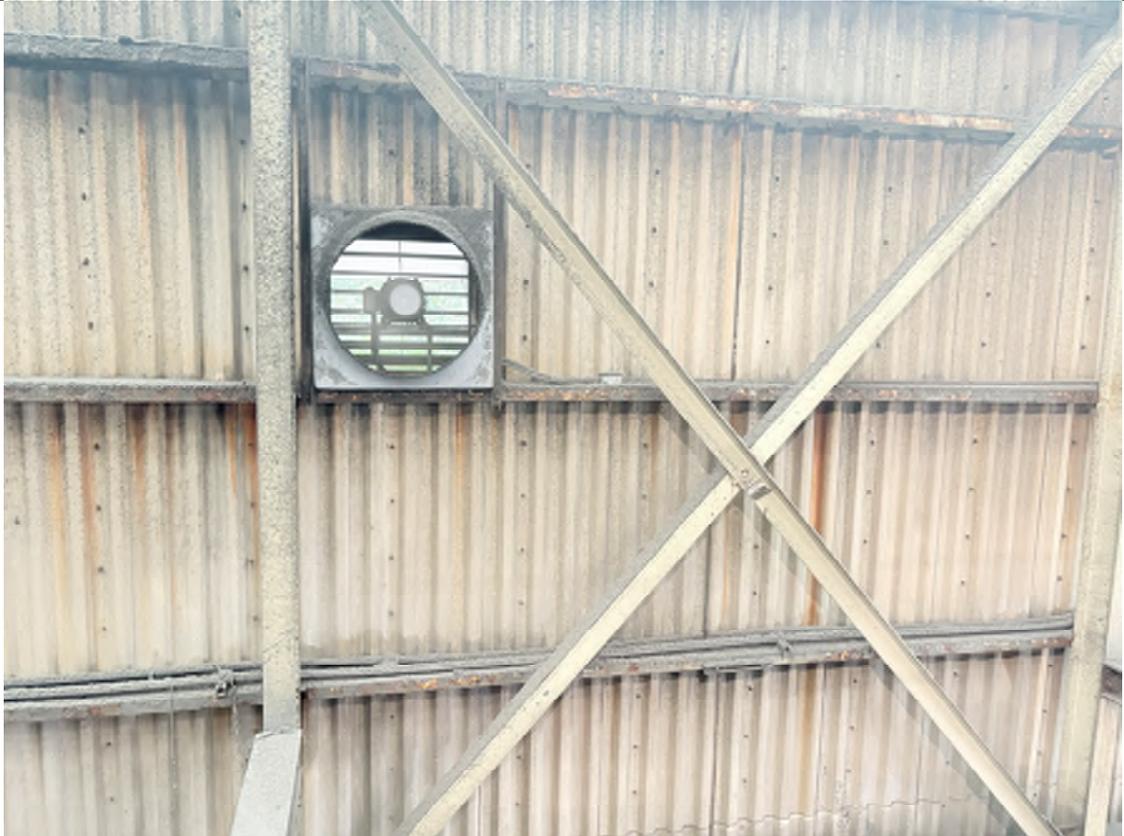
<ul style="list-style-type: none">Exterior fan appears to be working properly.Facility blows outside air into ash building enclosure – reducing possibility of fugitive emissions exiting building
