Condition Assessment Report

Lisbon Waste-To-Energy Facility

Lisbon, CT
December 16, 2025

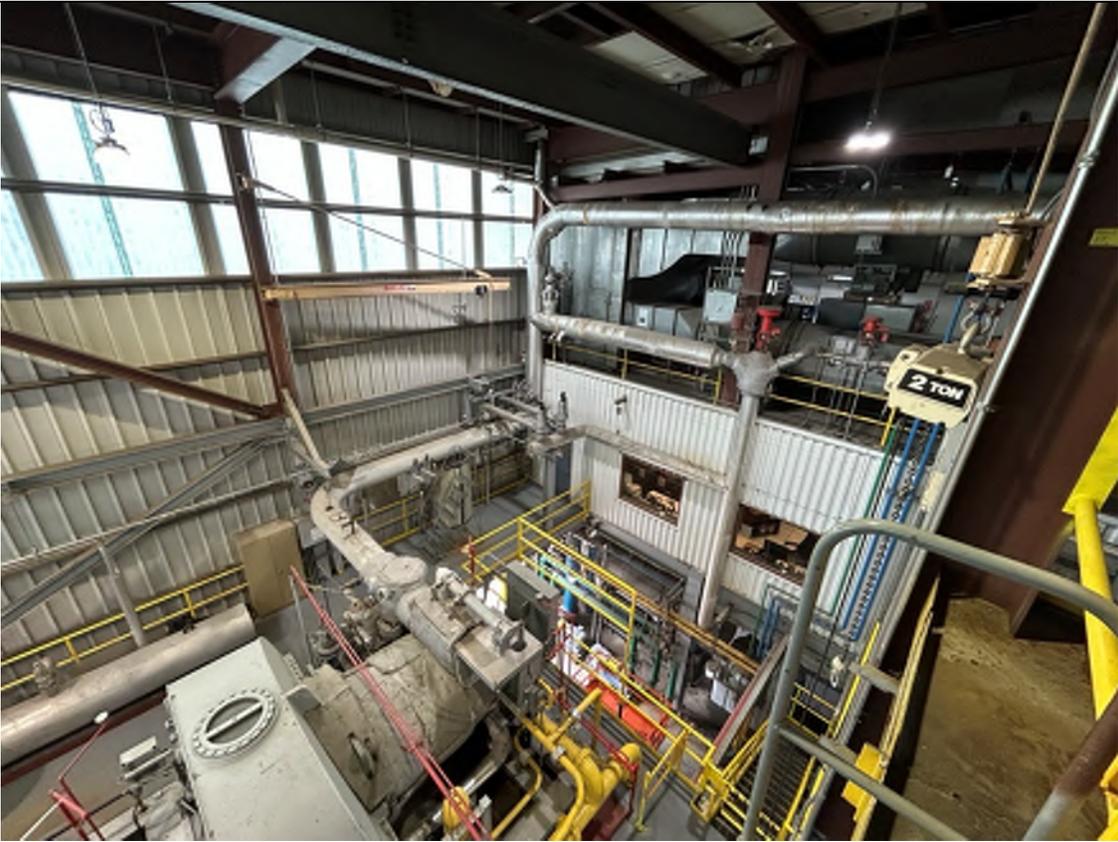
Turbine Generator Photo Log	June 2025
Photograph #54	Remarks

A wide-angle photograph of a large industrial turbine hall. The room is filled with complex machinery, including a large turbine generator unit in the center. Numerous pipes, some painted yellow, run across the floor and up to the ceiling. A control room is visible in the background, elevated on a platform. The ceiling is high with exposed steel beams and lighting fixtures. Large windows on the left side allow natural light into the space.	<ul style="list-style-type: none">• Turbine Hall and Control Room.
Photograph #55	Remarks

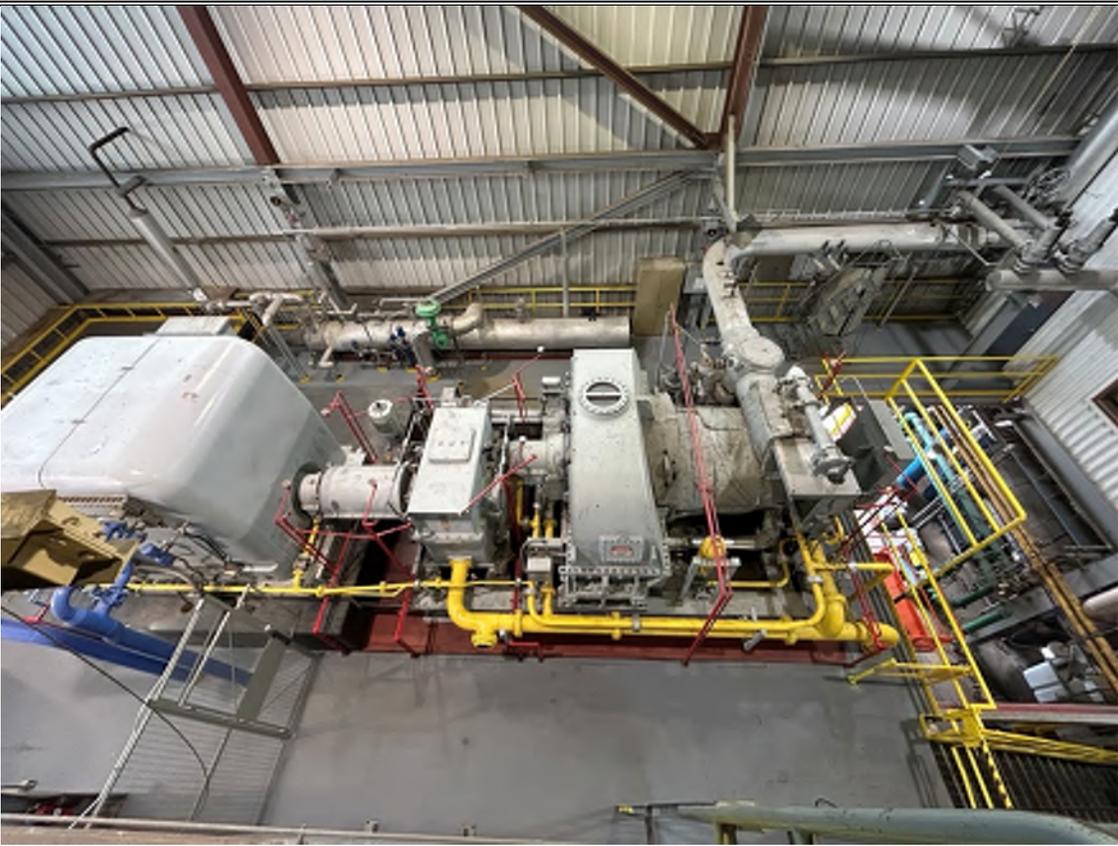
A closer, more detailed photograph of the turbine generator and its associated piping. The generator is a large, cylindrical metal unit with various access panels and pipes connected to it. The piping is a mix of grey and yellow. The surrounding area includes yellow safety railings and structural elements of the facility. The lighting is bright, highlighting the metallic surfaces and the complexity of the machinery.	<ul style="list-style-type: none">• Turbine-Generator.

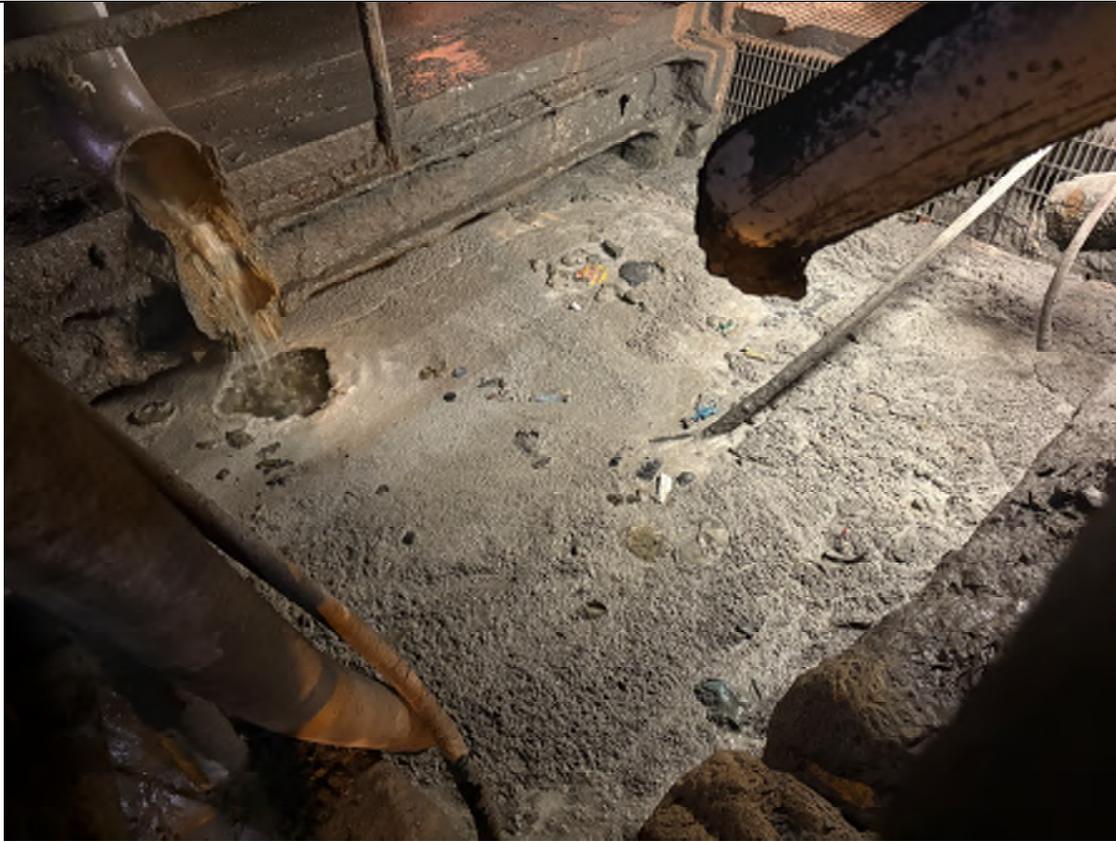
Photograph #56

- Wastewater treatment system to reuse dirty water. Mud separation.

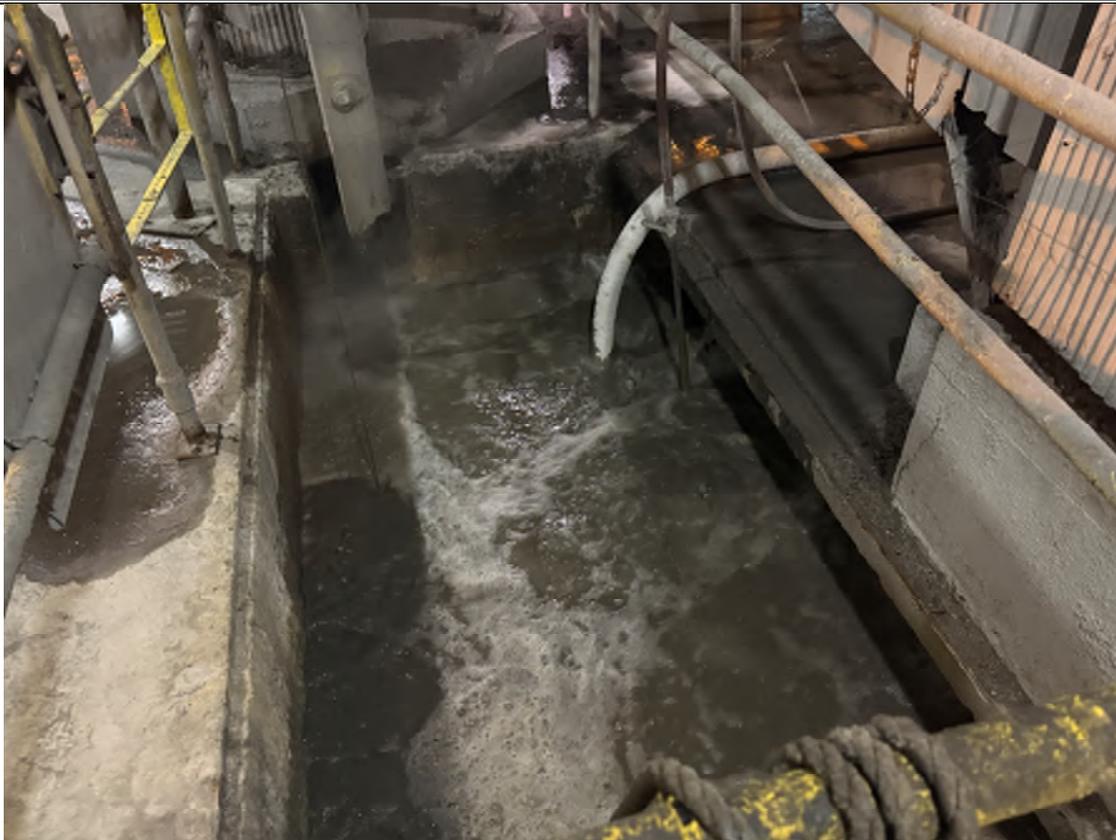
Photograph #57

- Dirty water sump.

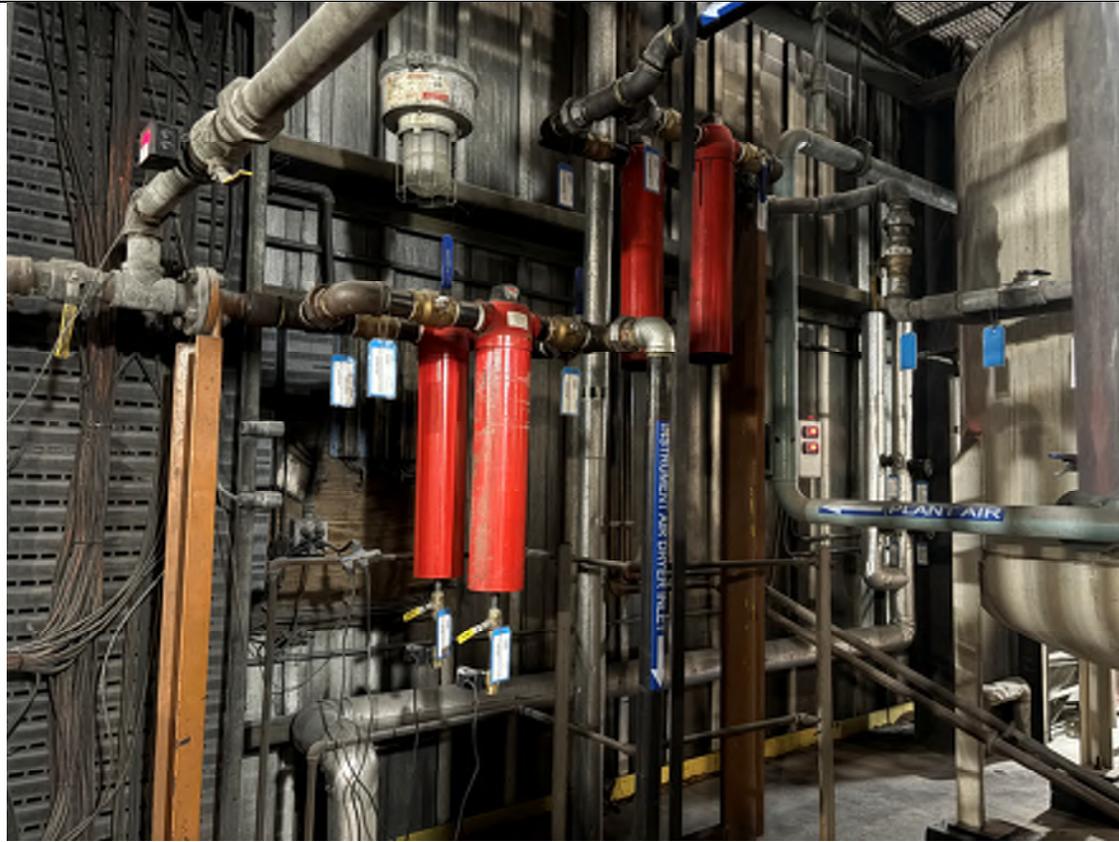
Photograph #60

- Compressed air piping.

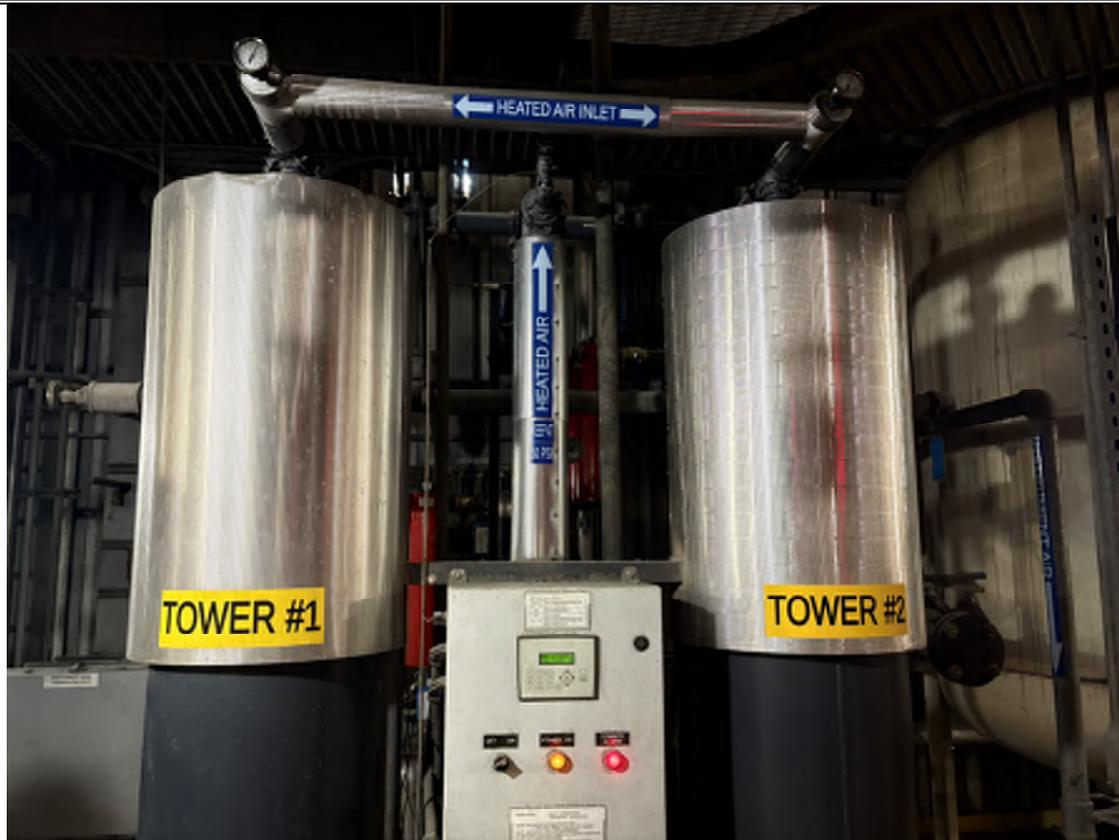
Photograph #61

- New Air preheaters recently installed.

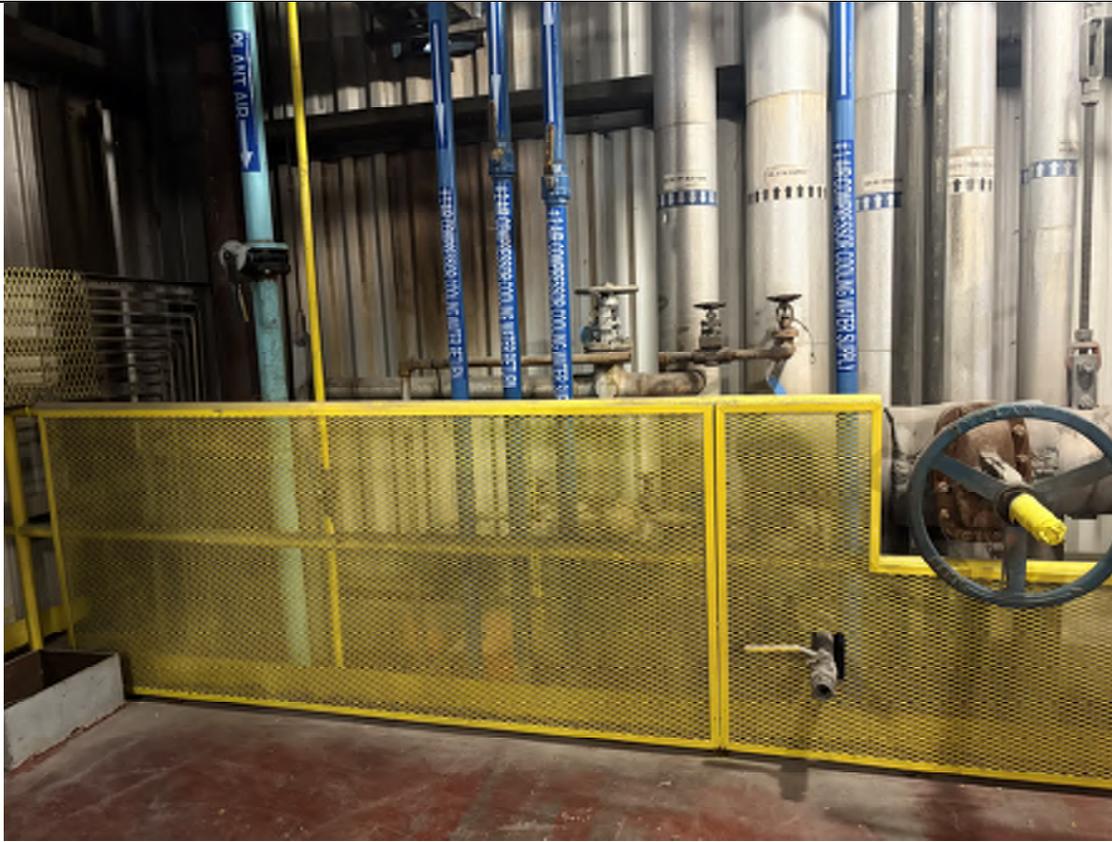
Photograph #62

- Air compressor cooling water.

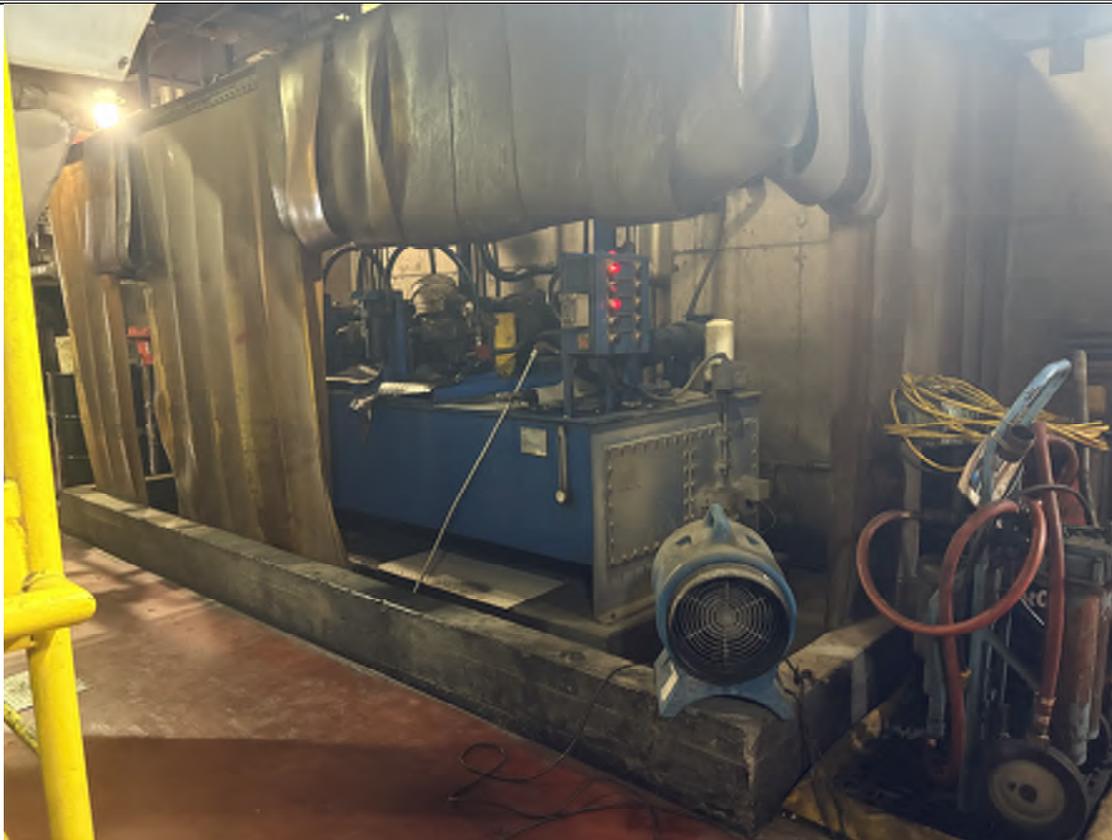
Photograph #63

- Hydraulic skid – requires additional cooling – alternative means should be investigated.

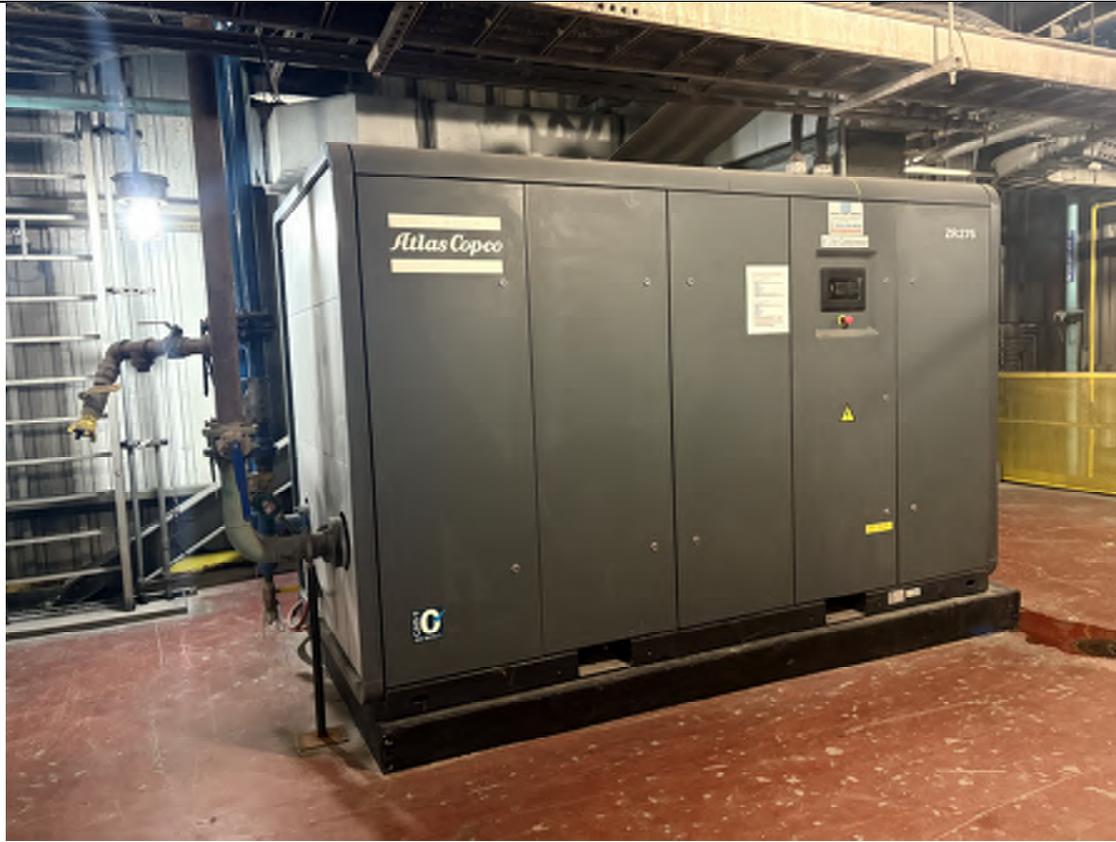
Photograph #64

- New Air Compressors recently installed.

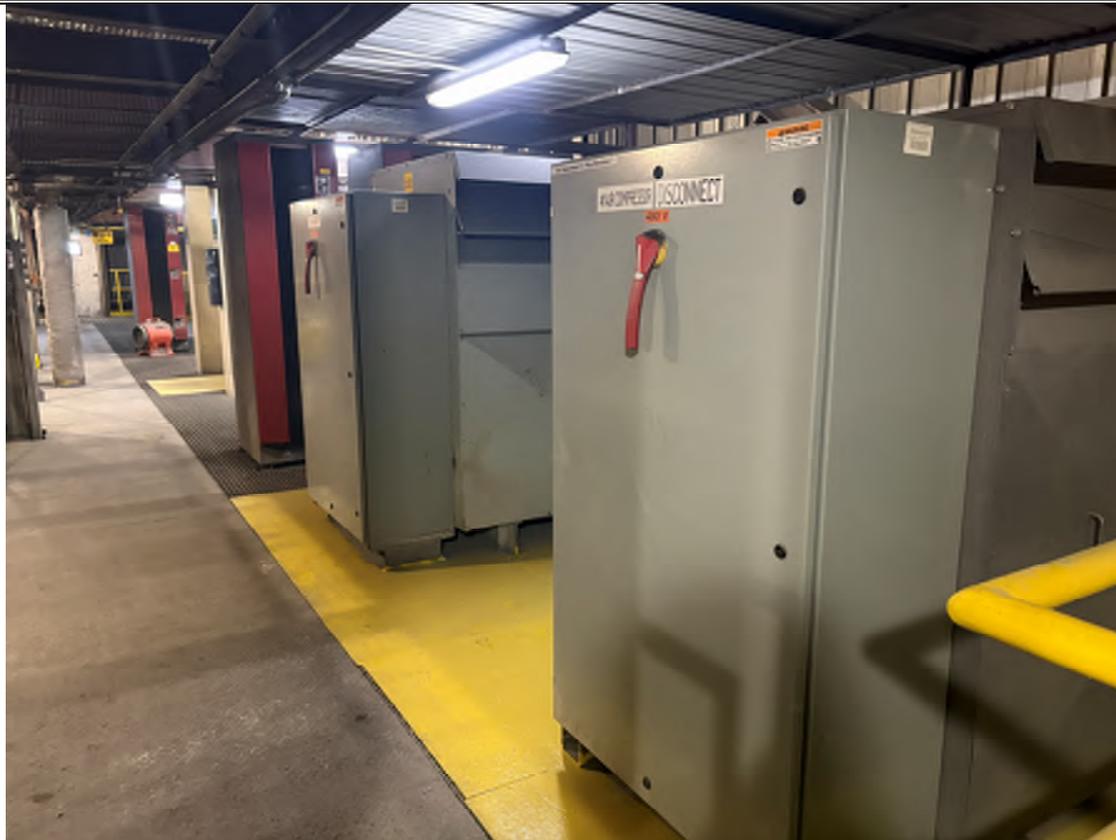
Photograph #65

- Air Compressors.

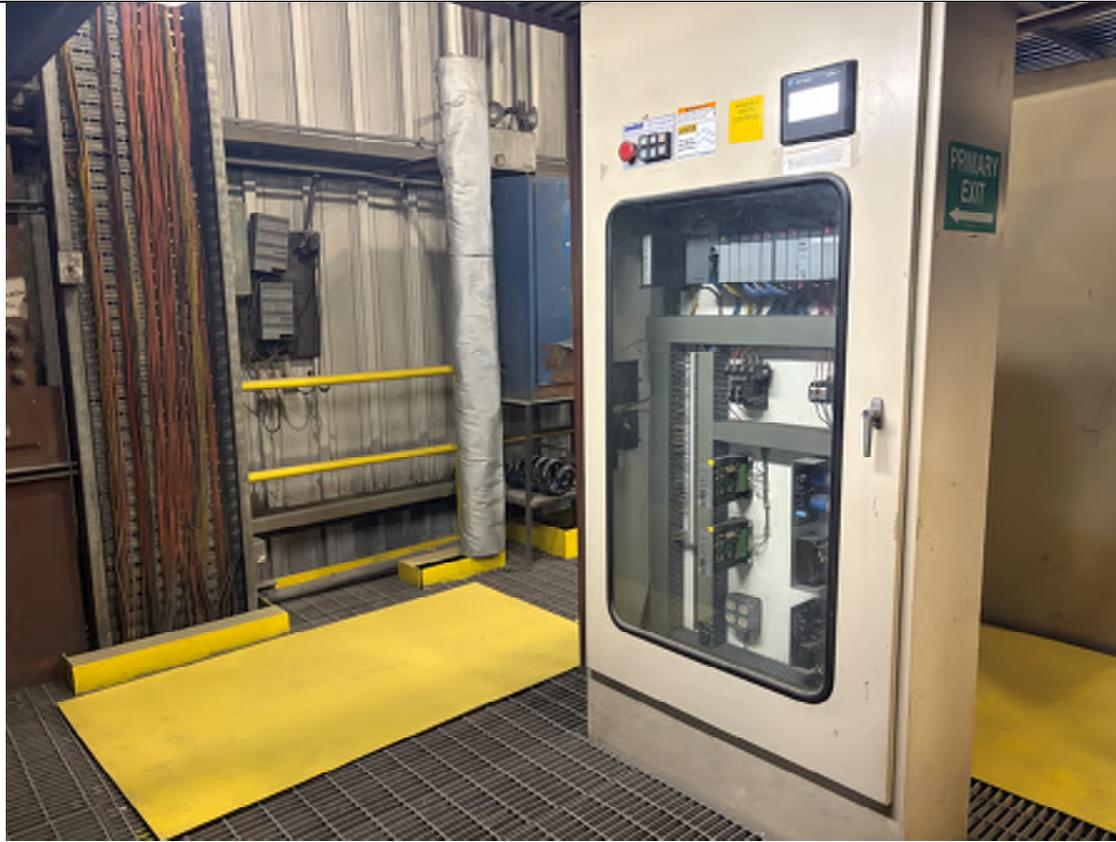
Photograph #66

- Air compressor control board.

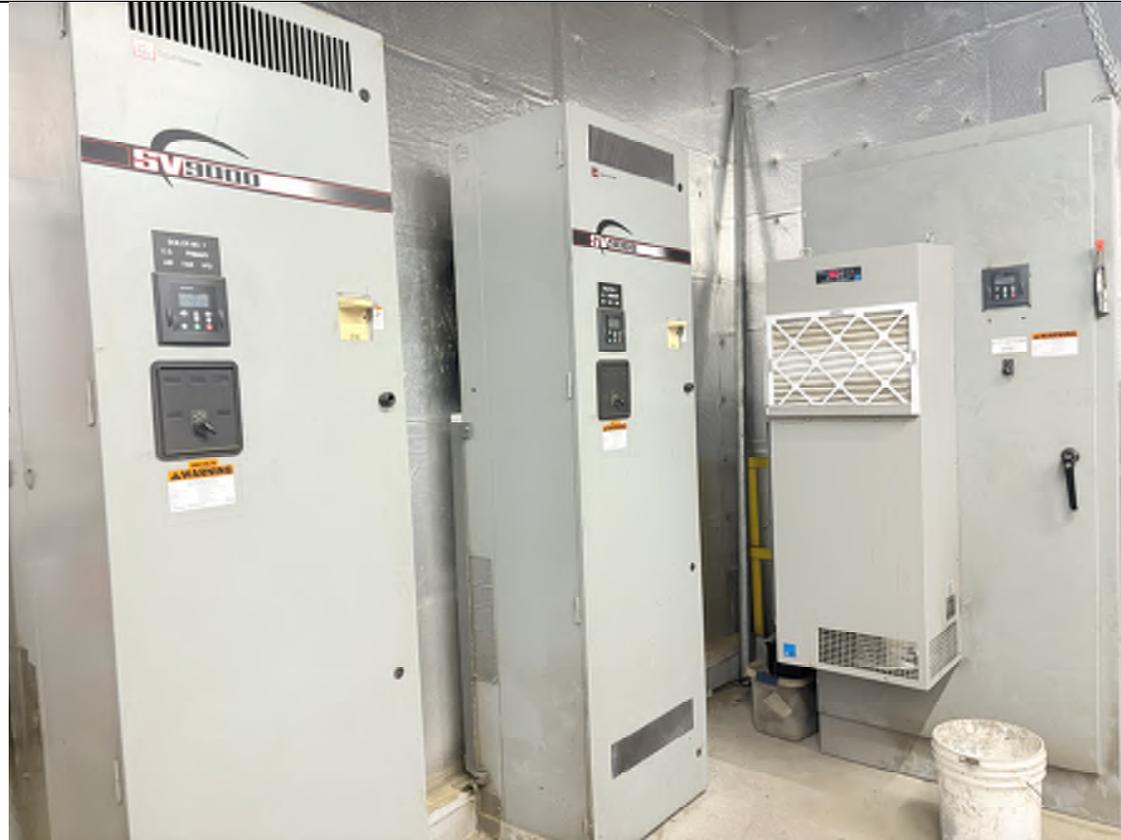
Photograph #68

- Motor VFD cabinets.

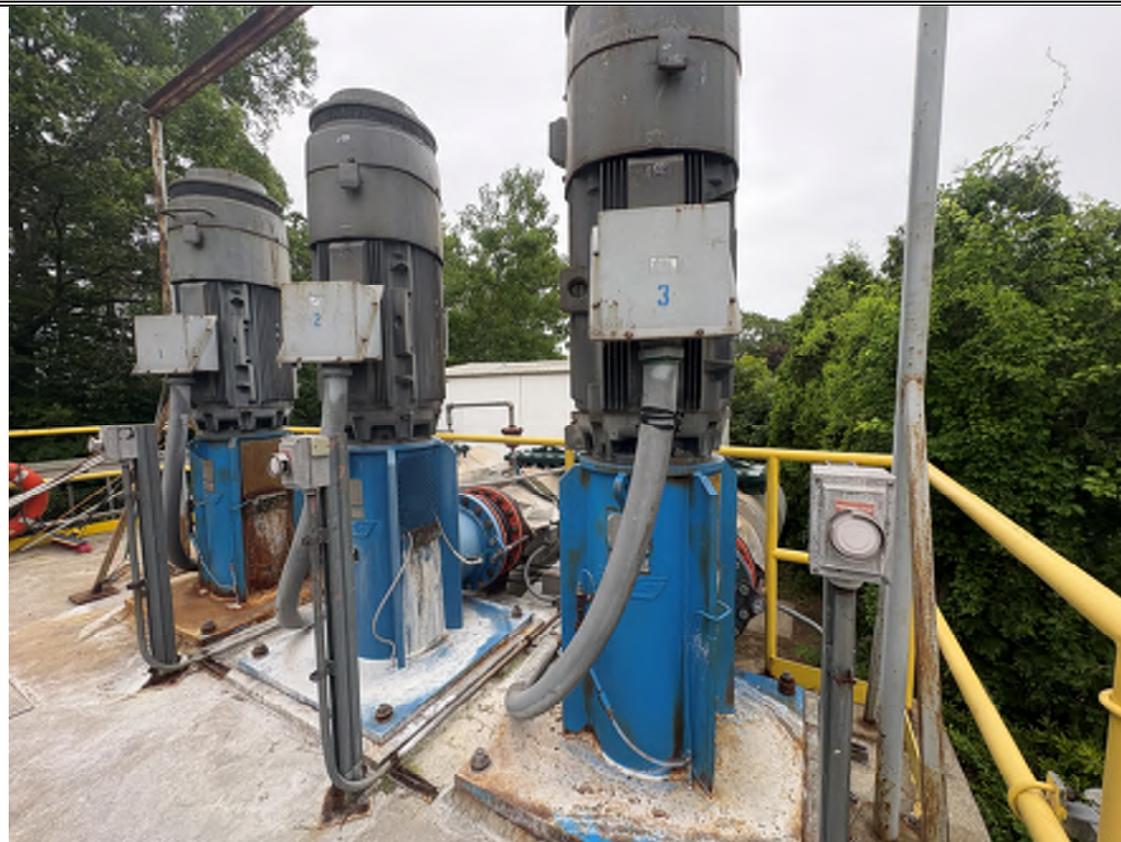
Photograph #69

- Circulating water pumps.

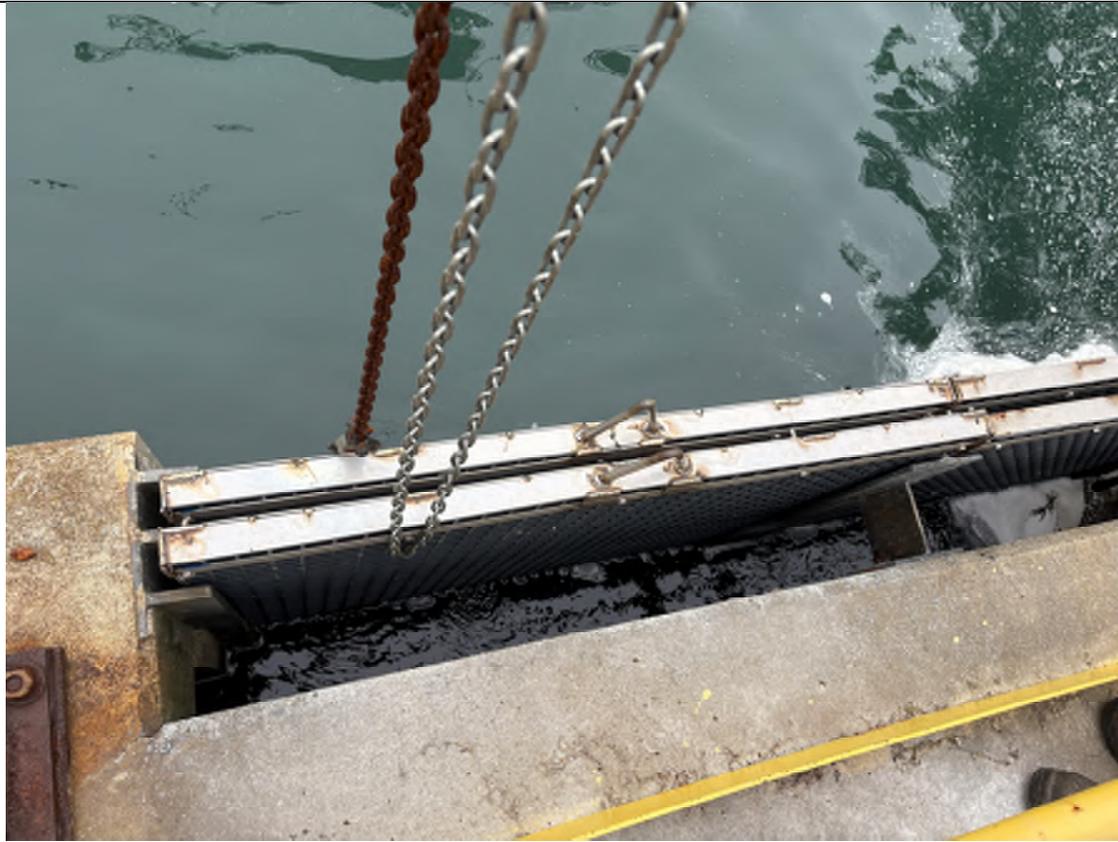
Photograph #70

- Dual screen prior to circulating water pumps to catch debris.
